1 Executive Summary

The City of Beavercreek has been experiencing flooding and erosion issues throughout the storm infrastructure network over the years and has not undergone a citywide study since 1983 when the last master plan was developed and identified \$30 million in improvements. Woolpert was chosen to develop a new drainage master plan report to assist the City with stormwater needs. The purpose of this project was to study culverts and streams throughout the City that have been previously identified as trouble areas, are considered public streams, or are 24-inch and larger diameter culverts. Culverts smaller than 24-inch diameter are routinely addressed by City maintenance crews as part of ongoing activities with their available equipment and resources.

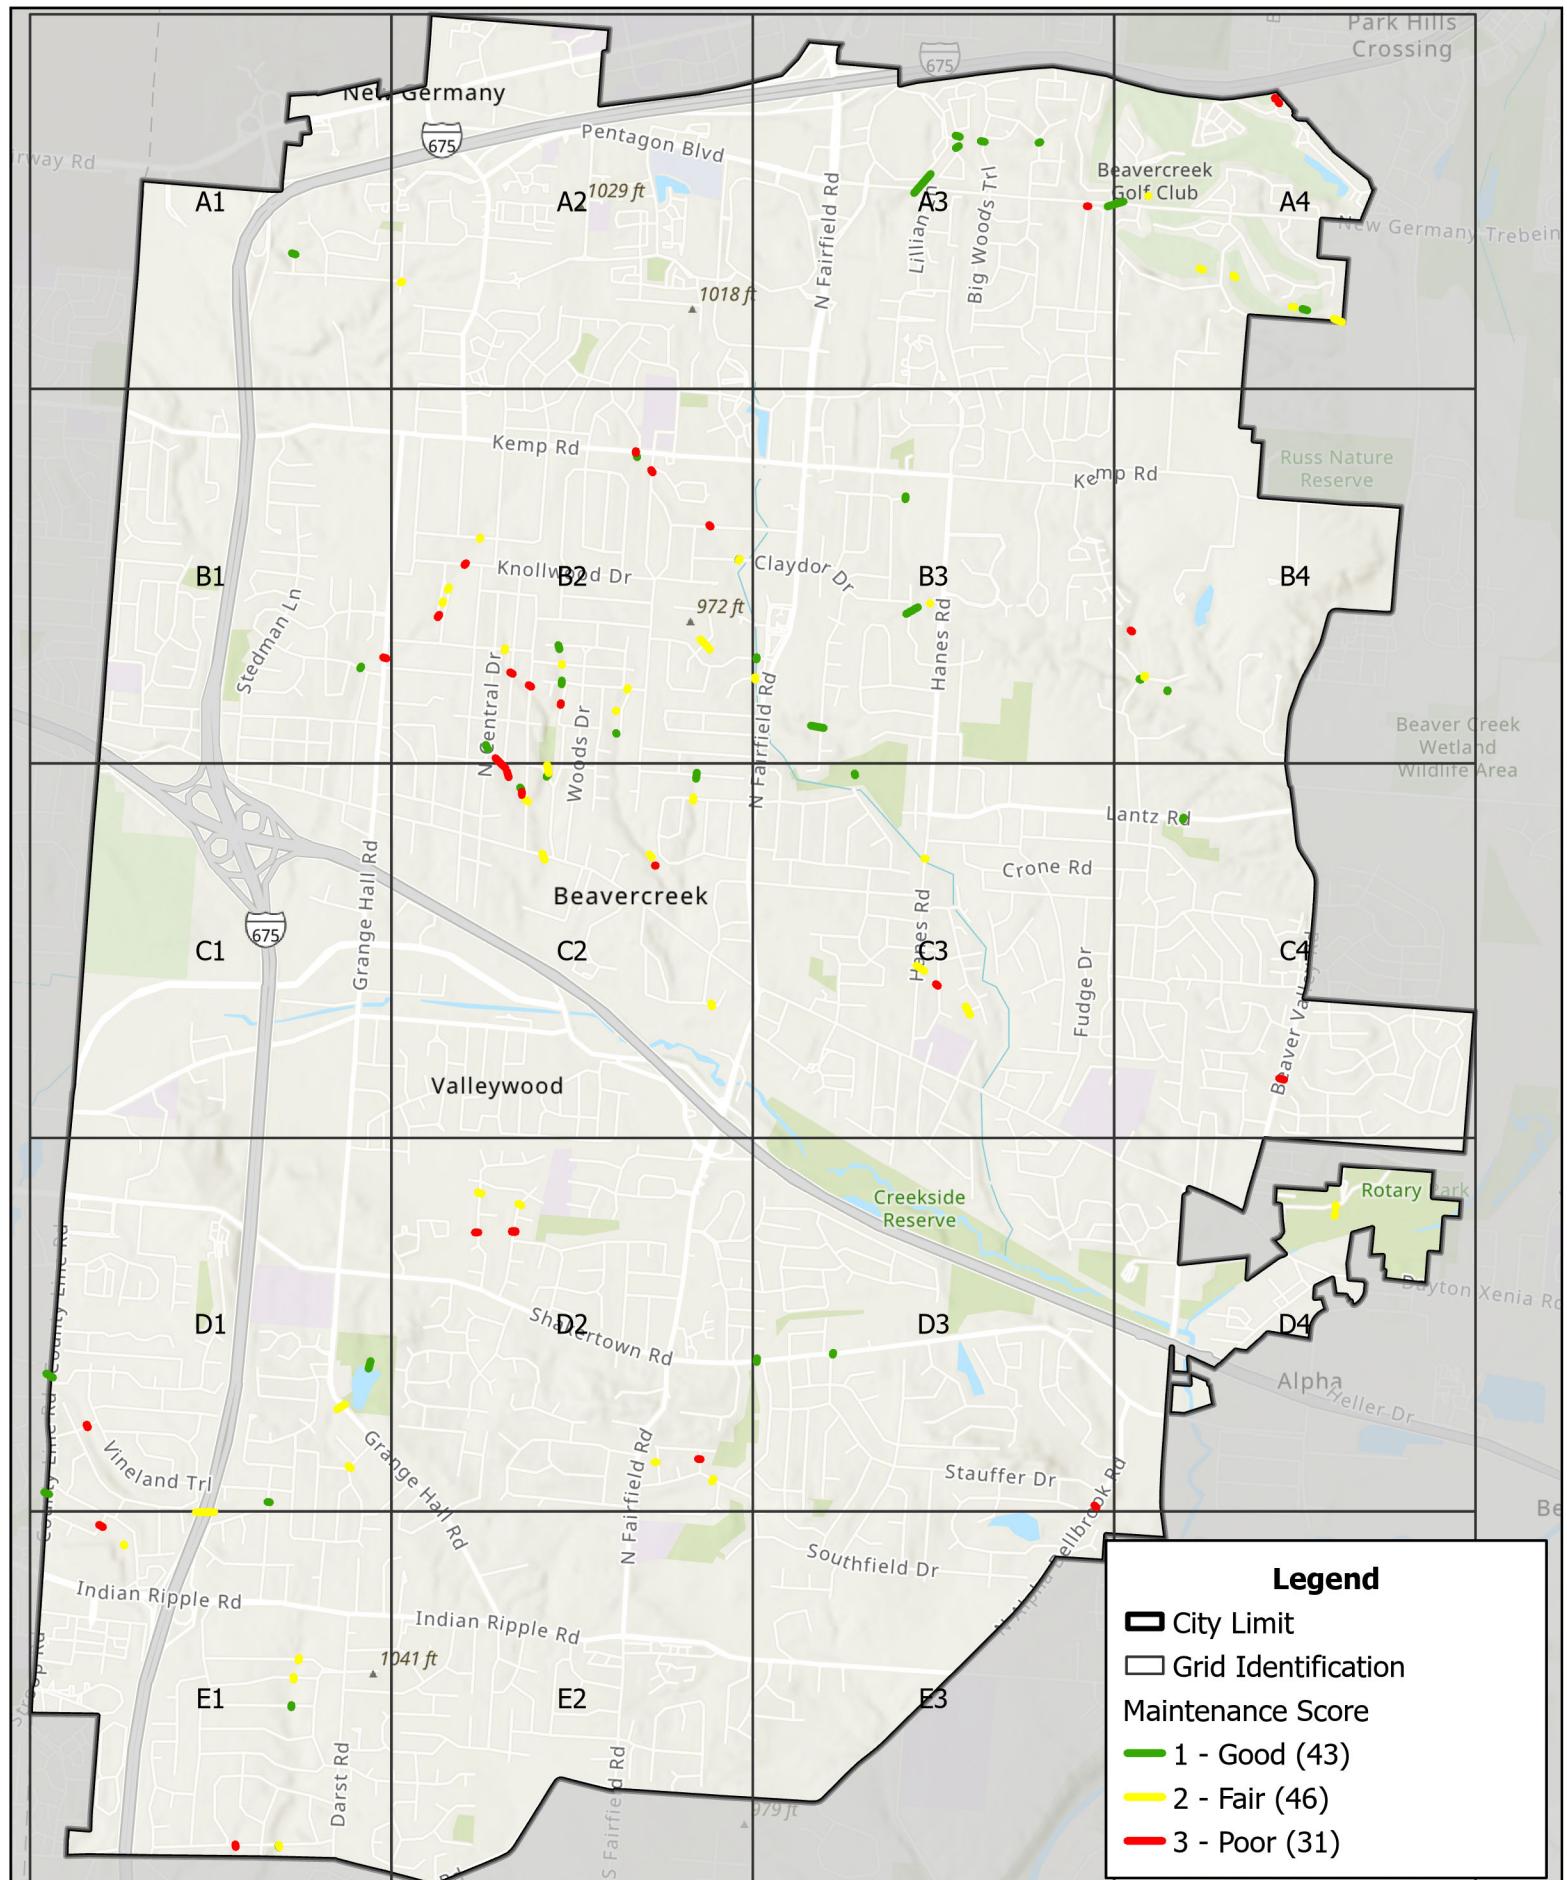
Culvert Inspections
Maintenance Condition Map
 City of Beavercreek, Ohio

There were 120 culverts inventoried and inspected as part of this study. Structurally the culverts were generally observed to be in good or fair condition, where only 13/120 (11%) received a rating of poor. Operationally the culverts did have maintenance concerns throughout, where 31/120 (26%) of the culverts received a maintenance rating of poor. There were 33/120 (28%) of culverts observed as primarily corrugated metal pipe, a distinction at the direction of the City to identify for replacement.

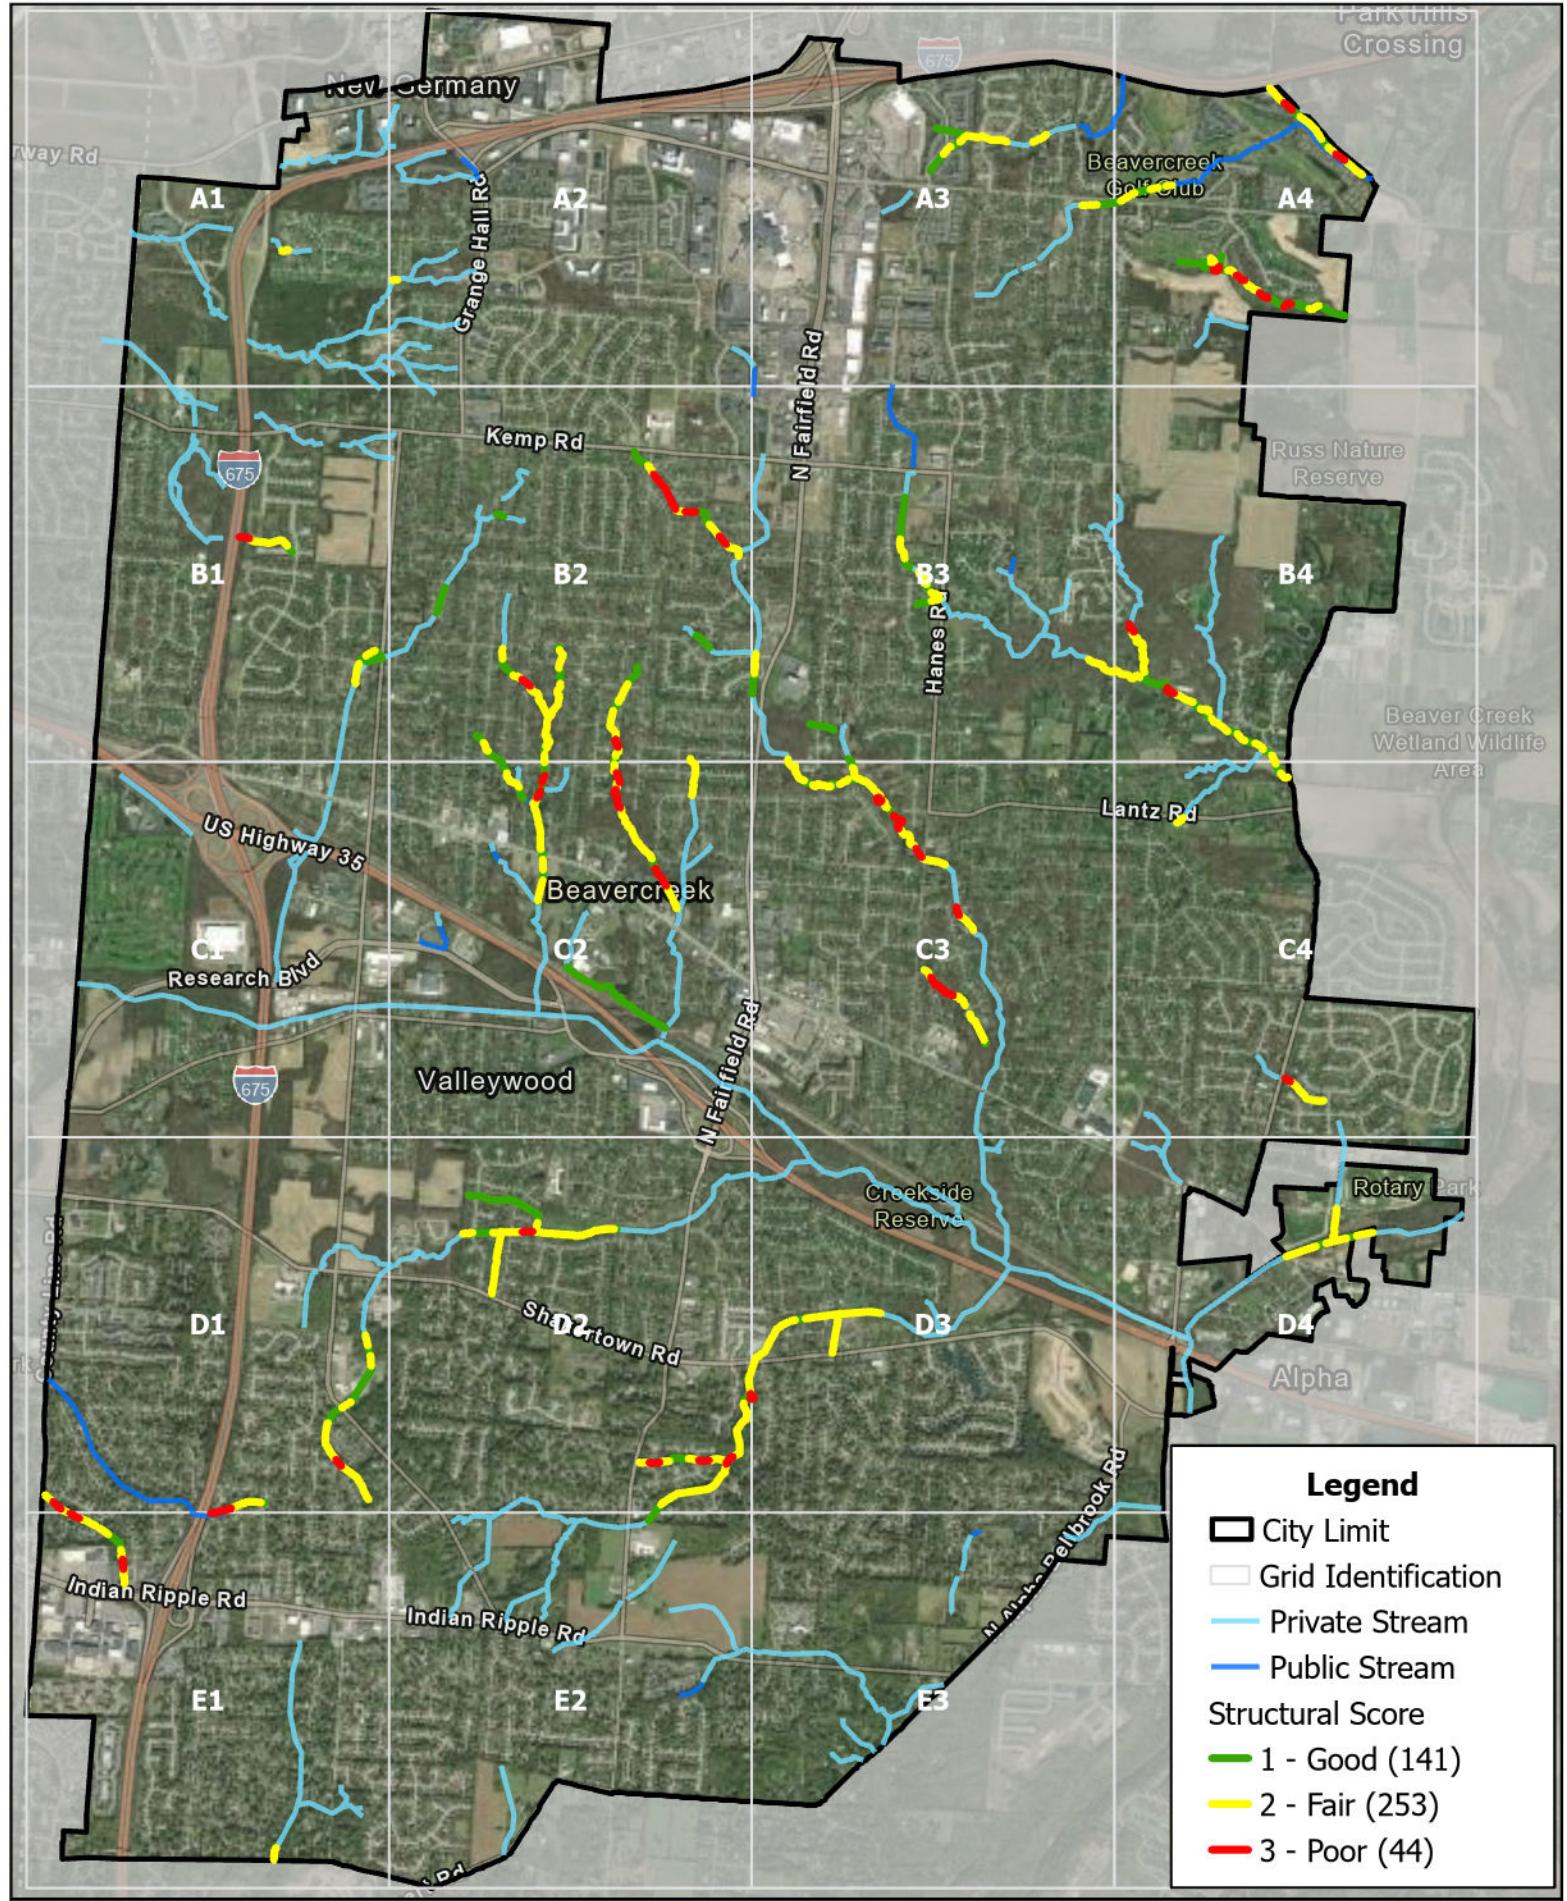
Stream Assessment Structural Condition Map

There were 15.12 miles of streams inventoried and inspected as part of this study. At the conclusion of the field work activities, the streams were broken up into 200 LF or less stream segments, depending on the entire inspected length, for a total of 438 stream segments. Structurally there were 44/438 (10%) stream segments to receive a rating of poor. Operationally there were 63/438 (14%) stream segments to receive a maintenance rating of poor. There were also 54/438 (12%) of stream segments that had an existing threat located within approximately 25 feet. Of the 15.12 miles of stream segments, ownership and maintenance responsibility is split with 10.72 miles considered public and 4.40 miles considered private.
