Drainage Master Plan Study Results

City of Beavercreek

October 13, 2025

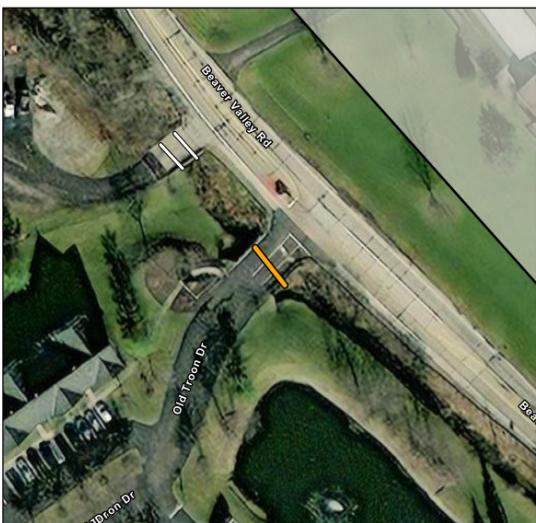
Culvert ID: A4_03

Culvert Shape: Arch

Culvert Material: RCP

Culvert Rise (ft): 6

Culvert Span (ft): 28

Culvert Length (ft): 44
