Project No. 10022676.00

City of Beavercreek Drainage Master Plan

City of Beavercreek

October 13, 2025

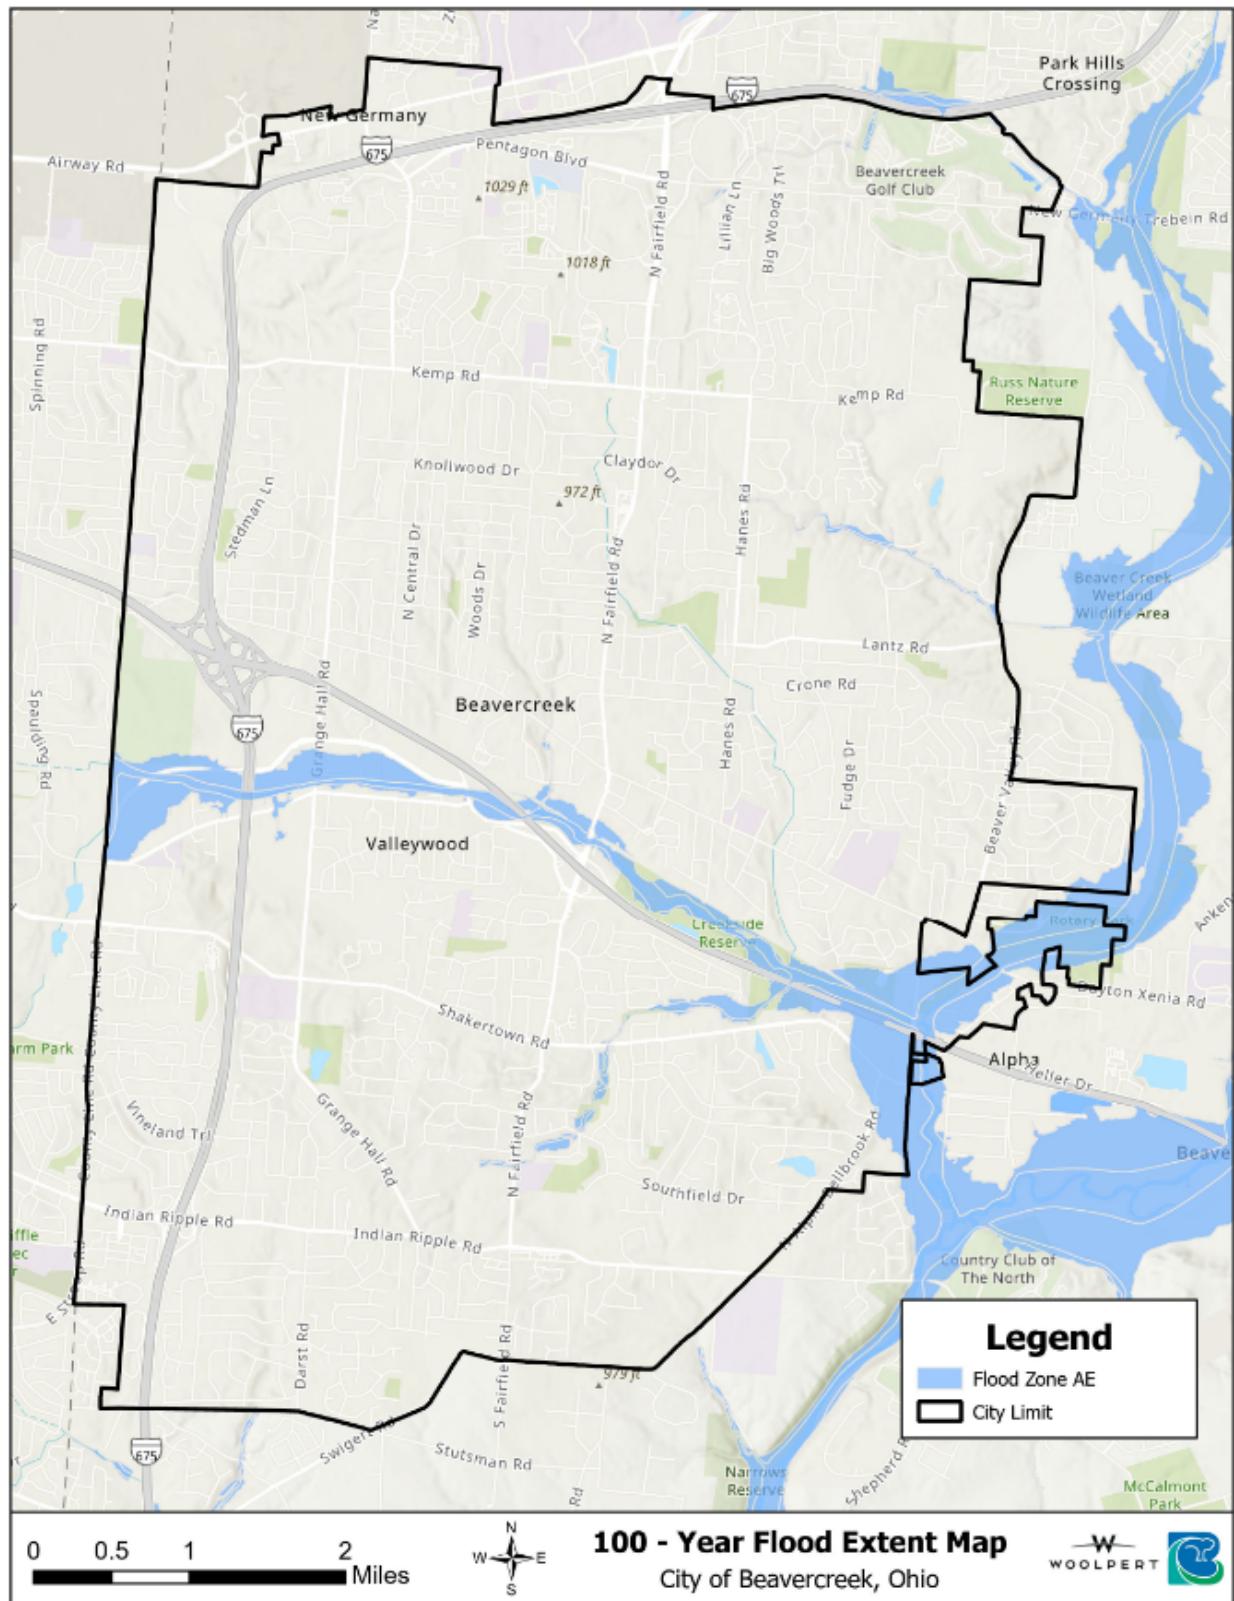
Figure 14. City of Beavercreek - 100-Year Flood Extent Map

FEMA flood zone data was reviewed and considered during model development. As shown in *Figure 14*, the eastern section of the City primarily along Beaver Creek and the middle section primarily along the Little Beaver Creek are largely composed of AE special flood hazard areas (SFHA) in all but the most elevated areas. The area beyond the northern border of the study area is comprised of SFHA A zones along the Mad River.
