Project No. 10022676.00

City of Beavercreek Drainage Master Plan

City of Beavercreek

October 13, 2025

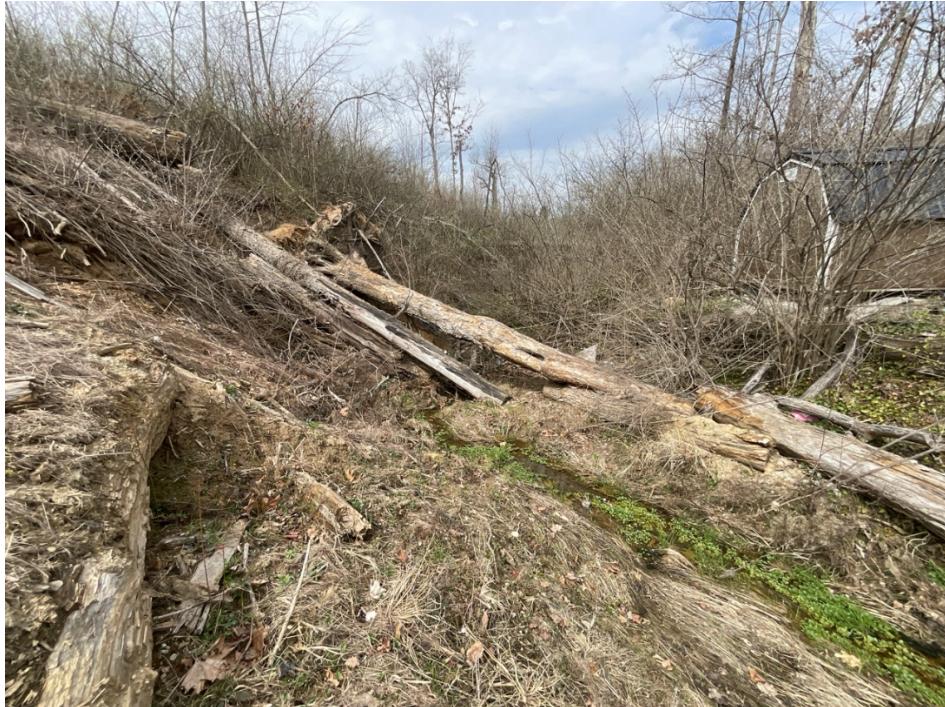
8.2.1 Grid A1

There is 1 culvert (~80 LF) and 1 stream segment (~135 LF) present in this grid. The channel was included as part of the Murwood Court trouble area. Culvert A1_01 is a CMP in good condition proposed to be increased in size to accommodate flooding concerns. The private downstream channel A1_S_01 contained vegetation that should be removed to restore functionality.

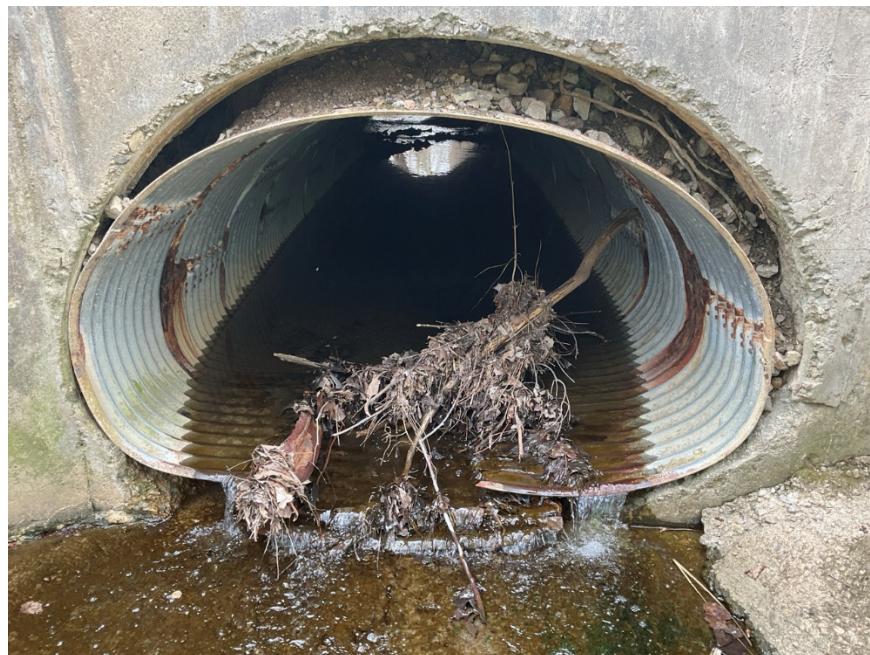
There are 6 culverts (~811 LF) and 19 stream segments (~3,417 LF) present in this grid. Five of the six culverts are in good condition, but culvert A3_06 is a CMP in poor condition proposed to be increased in size. This culvert is in the North Emerald Drive trouble area impacting the road, with prior repairs evident and aggregate visibly entering the downstream channel.

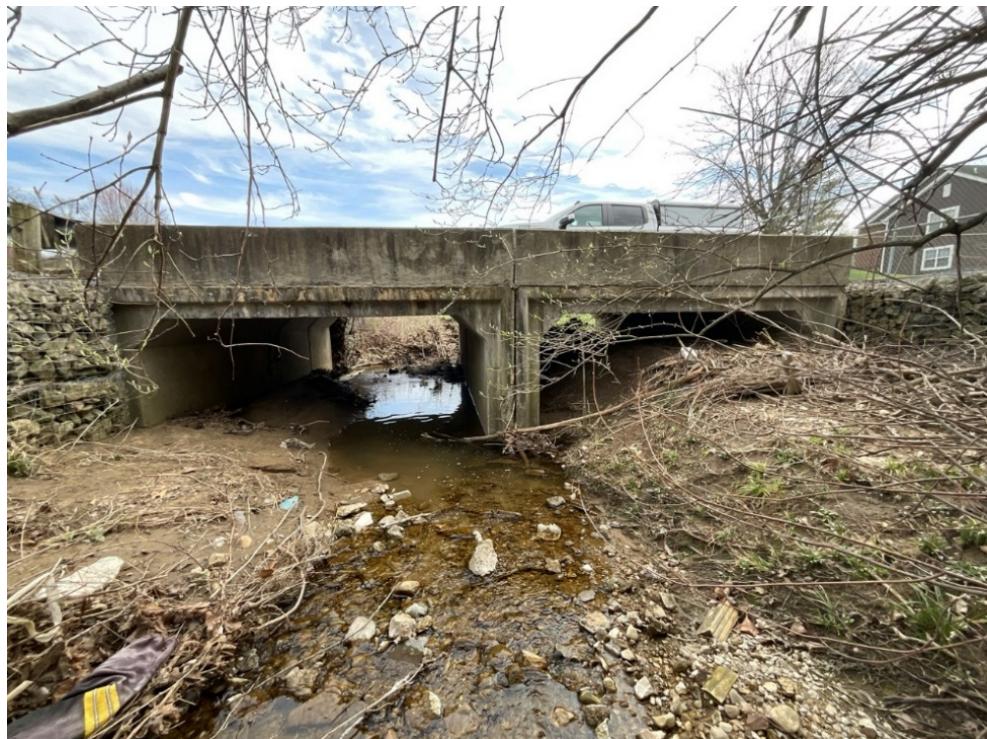
Three culverts located along the trouble area of Beaver Valley Road A4_01, A4_02, and A4_03 require sediment and tree removal, specifically near the Old Troon Drive crossing.

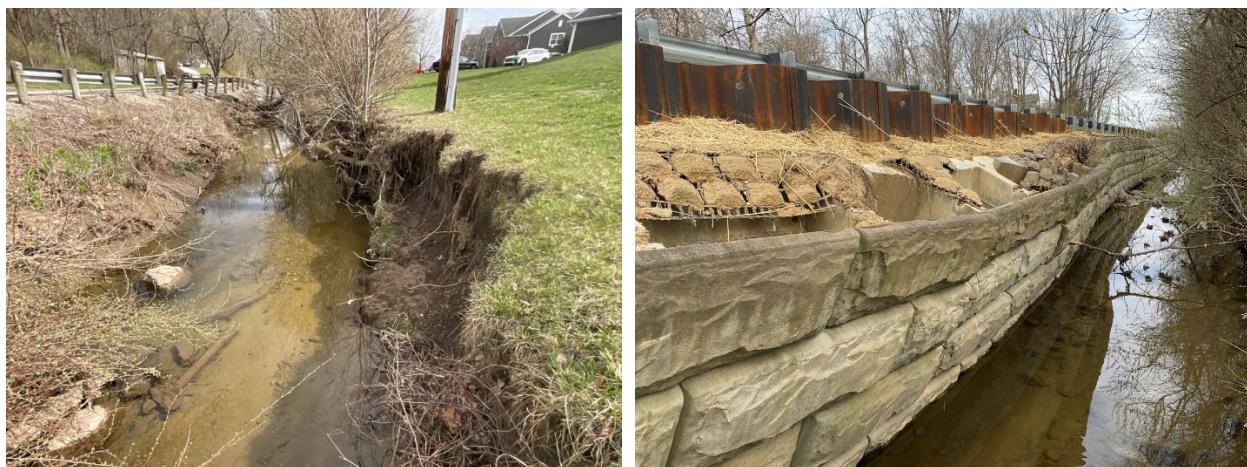
The entire channel along Beaver Valley Road has historically experienced erosion issues and been mitigated with armoring under the roadside edge. Additional utilities are still at risk behind the properties of Patrick Boulevard along with the need for sediment removal.

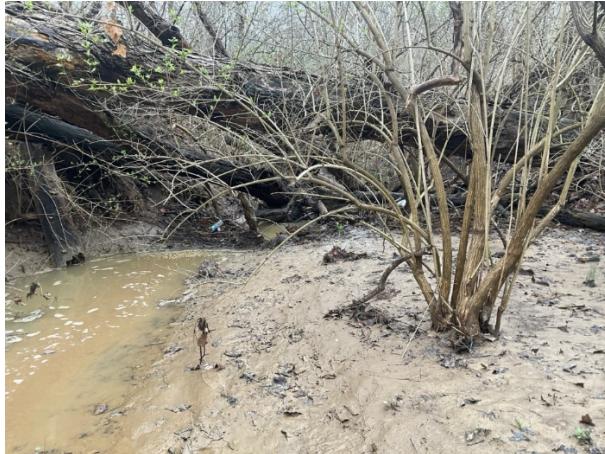
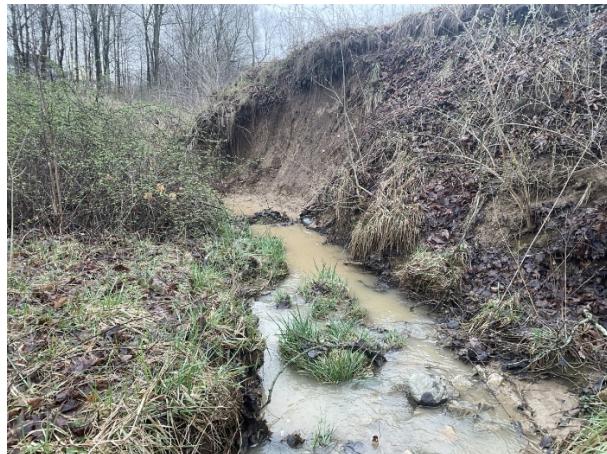
The channel behind Wyndham Drive and Muirfield Drive is experiencing erosion and debris buildup requiring stabilization and debris removal.

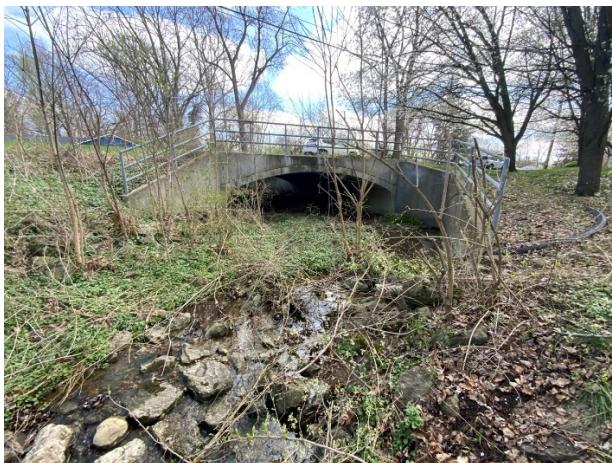
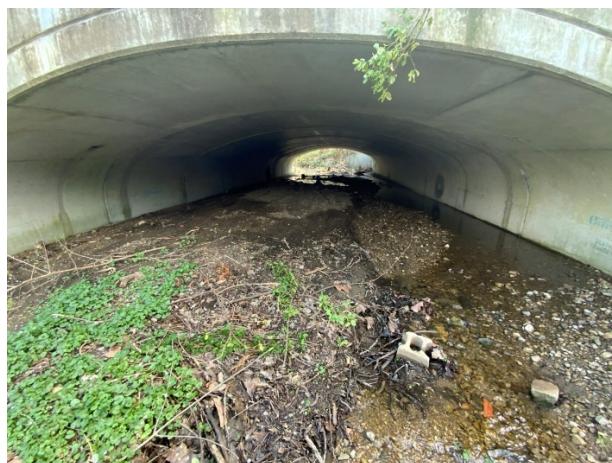
There are 2 culverts (~117 LF) and 13 stream segments (~2,396 LF) present in this grid. Culvert B1_03 is an arched CMP that is recommended to be replaced with a larger box culvert to accommodate flooding concerns and material consideration. Culvert B1_02 under Grange Hall Road is recommended for debris removal.

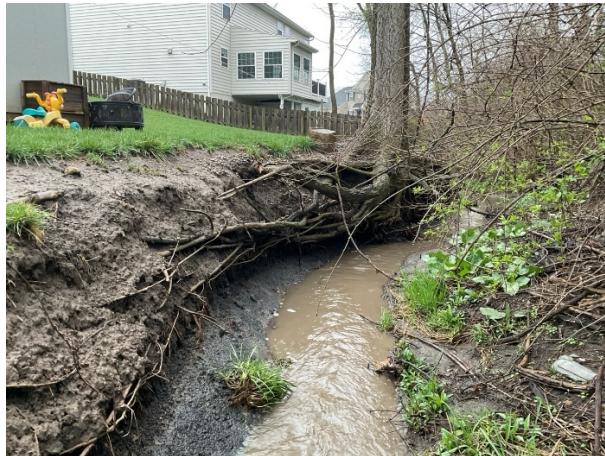
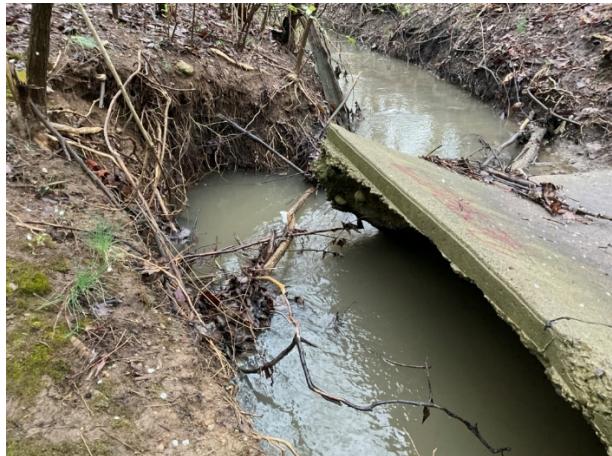
The public stream located behind Isaac Drive is experiencing erosion along the banks with debris buildup and scouring near the inlet structure to the culvert crossing under Interstate 675.

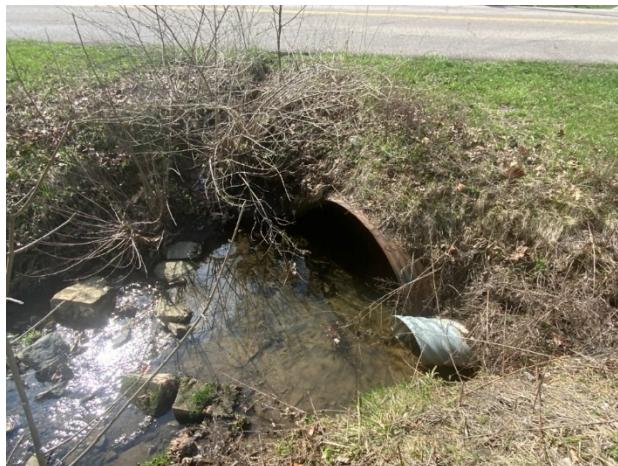
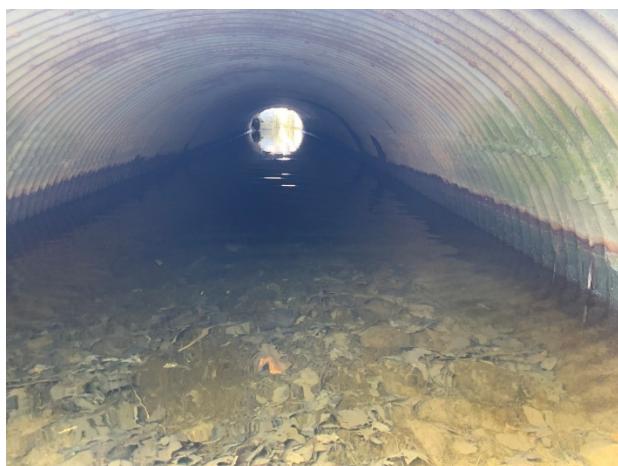
Culvert B2_04 at Turnbull Road is CMP and is being proposed to be replaced at the same size as it was found to be hydraulically sufficient. Sediment buildup in the pipe could have been contributing to the flooding issues in the past.

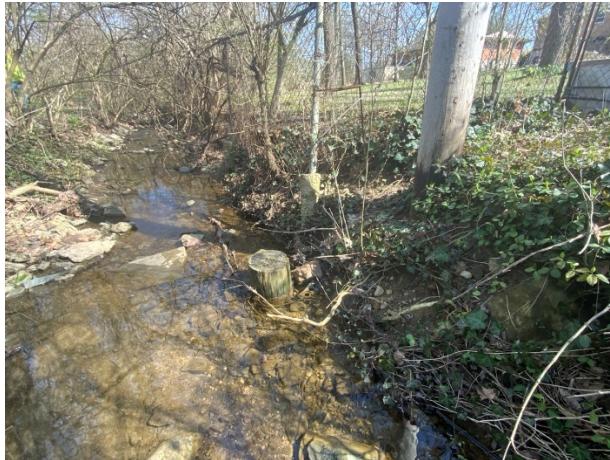
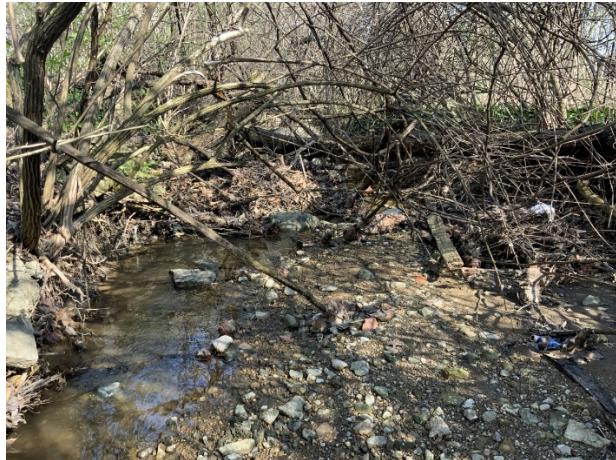
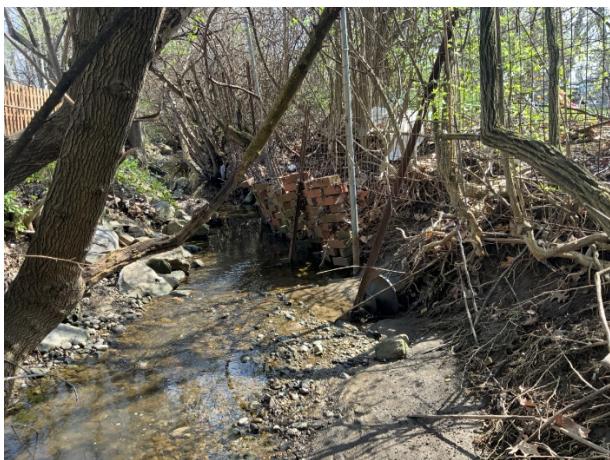
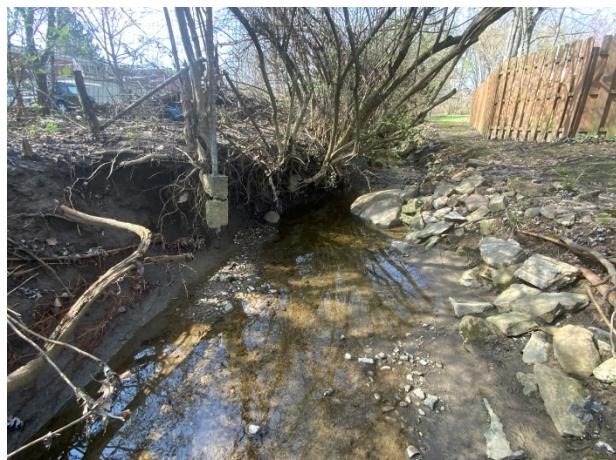
Stream segments north of the properties on Homeacres Avenue and Brookridge Drive are experiencing erosion while actively threatening private property fence and utility poles. Fence post bases are exposed along the top of bank and debris has built up, requiring both bank stabilization and debris removal. This stream is attributed as private and should be mitigated with property owners.

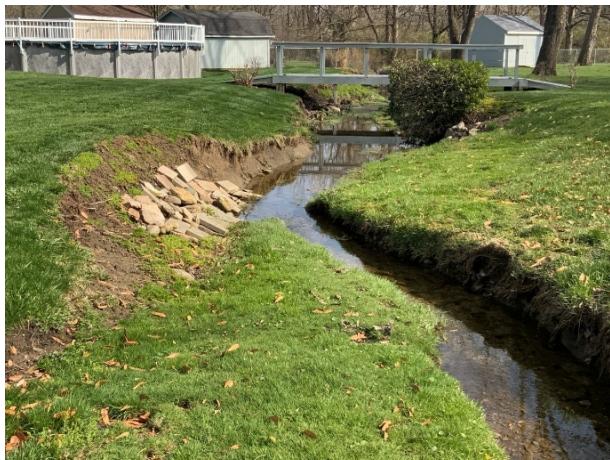
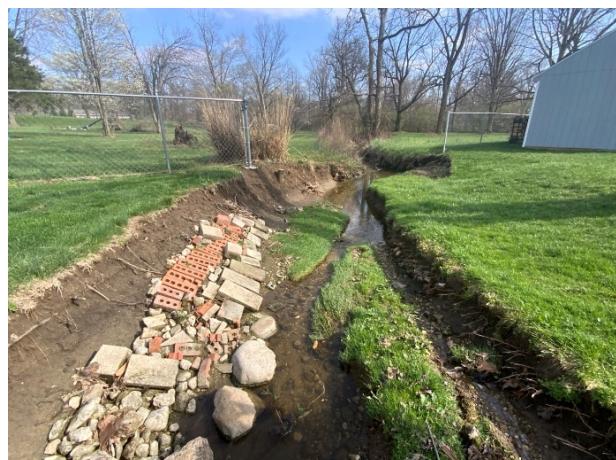
The stream segments between Homeacres Avenue and Claydor Drive are also experiencing erosion. It is evident that property owners have begun to use their own materials to mitigate the erosion.

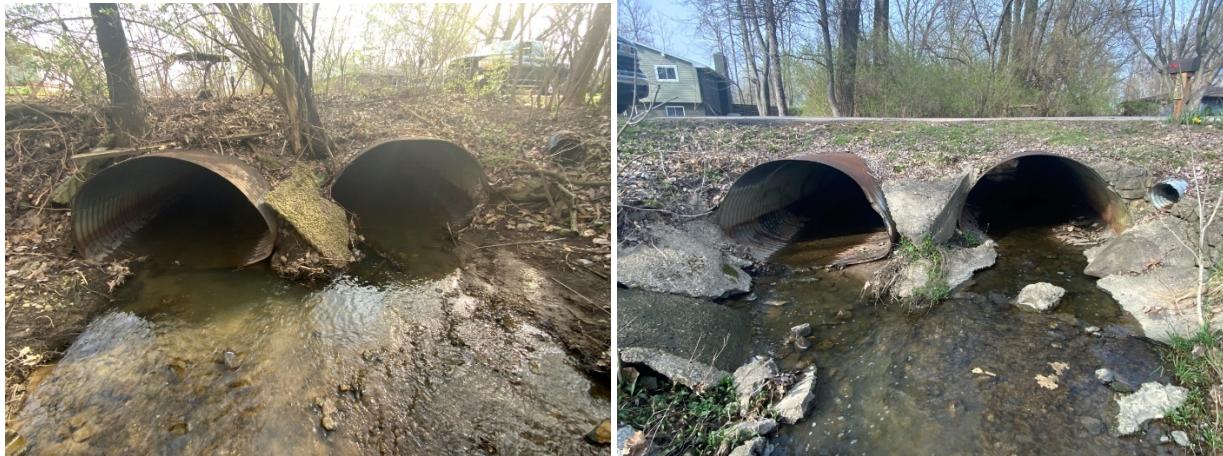
There is a dual barrel CMP culvert system at Claydor Drive that is being proposed to increase in size to accommodate flooding concerns.

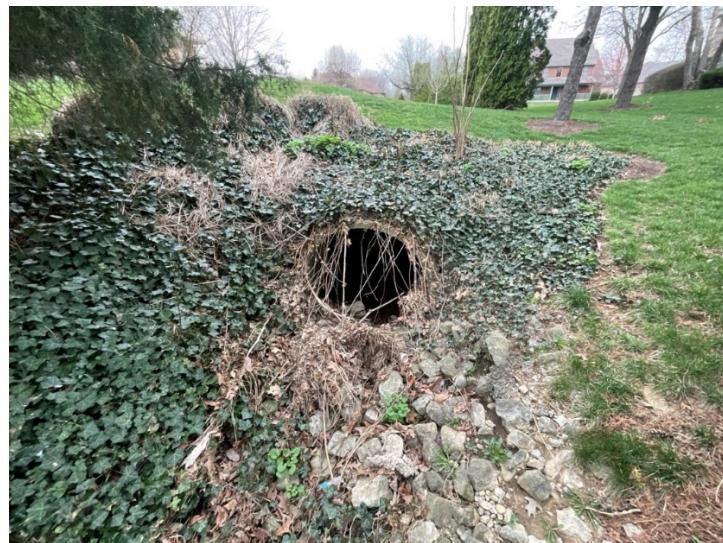
Culvert B2_15 at Rich Road is being proposed to increase in size to accommodate flooding concerns. Some minor maintenance is needed at the pipe ends to clear up the channel.

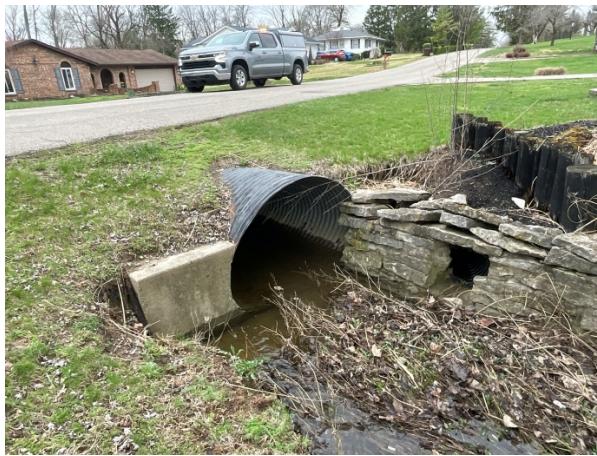
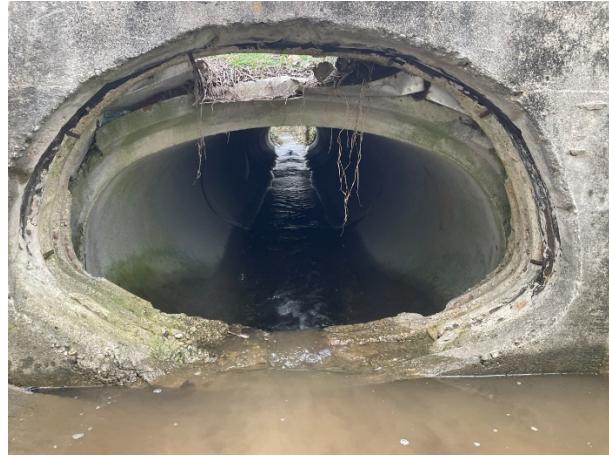
Culverts B2_07 at Winthrop Drive and B2_10 at Knollwood Drive are both proposed to increase in size to accommodate flooding concerns along this channel. Culvert B2_10 is an elliptical RCP found to be structurally deficient, this is a potential cause for the historical flooding in the area.

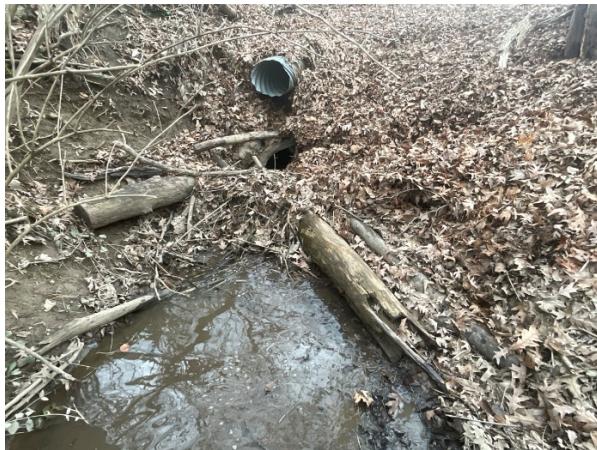
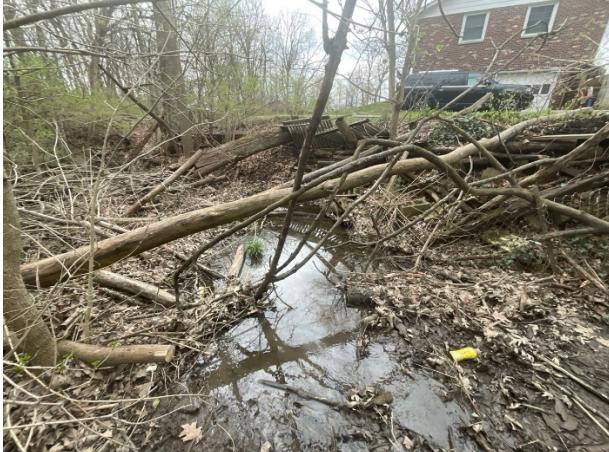
Culvert B2_18 at Forestdale Avenue and the upstream stream segment to the west were both found to need maintenance. The culvert is proposed to be increased in size and the stream bank stabilized after debris removal. There are fences along the bank that have been smashed with fallen trees and other trees blocking the channel. This stream is attributed as private and should be mitigated with property owners.

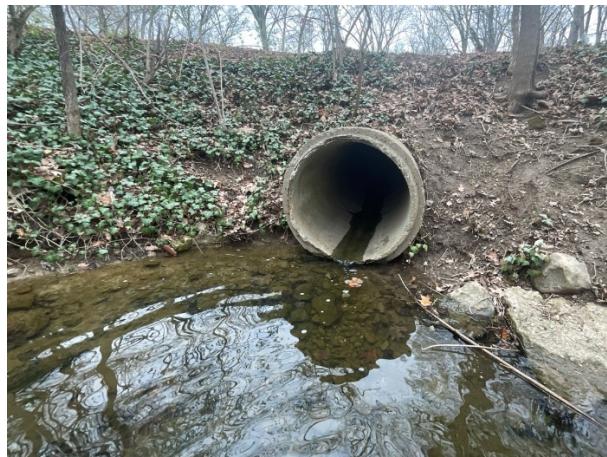
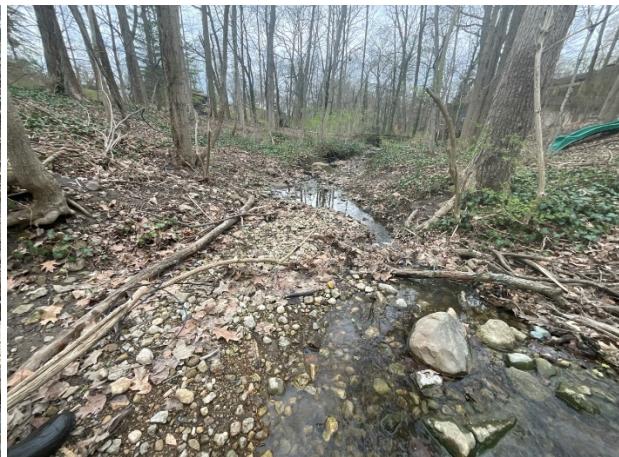
Culvert B2_21 at Harry Truman Road is in fair condition, but it is being proposed to be increased in size to accommodate flooding concerns. The downstream private stream segments have some sediment across the entire channel cross section.

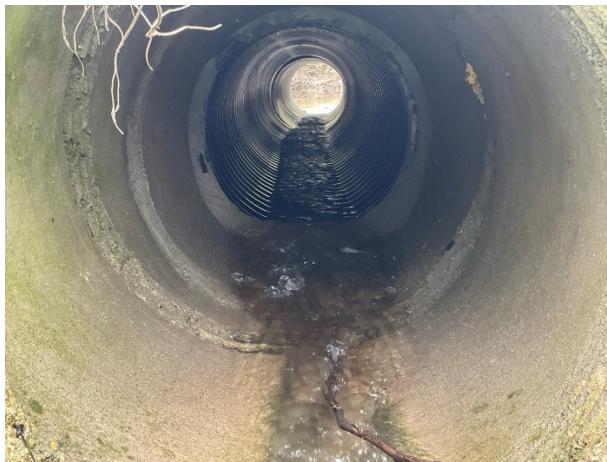
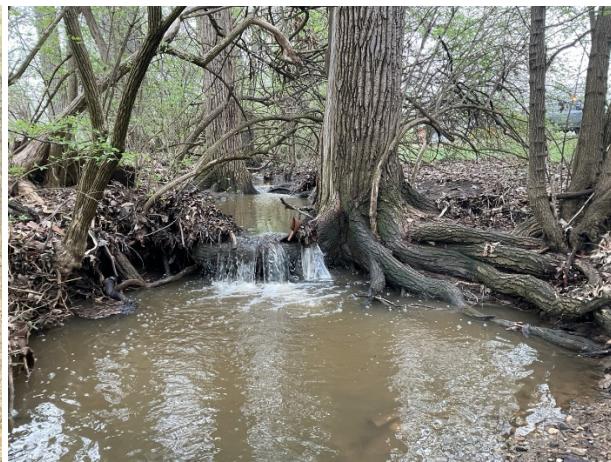
Culvert B2_23 at Harry Truman Road and Stansberry Road is comprised of two materials and is being proposed to increase in size to accommodate flooding concerns. The downstream private stream segments have trees growing in the channel impeding flow.

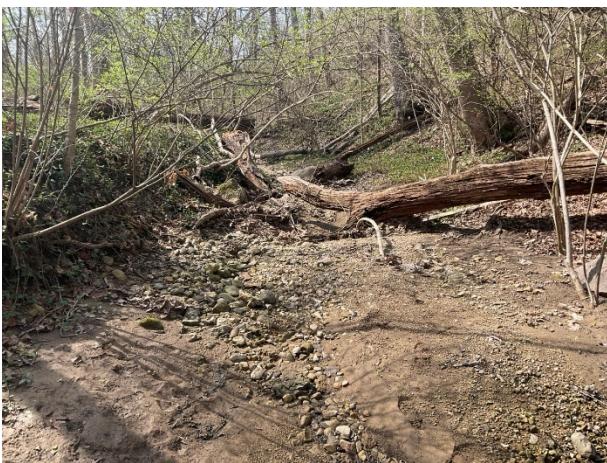
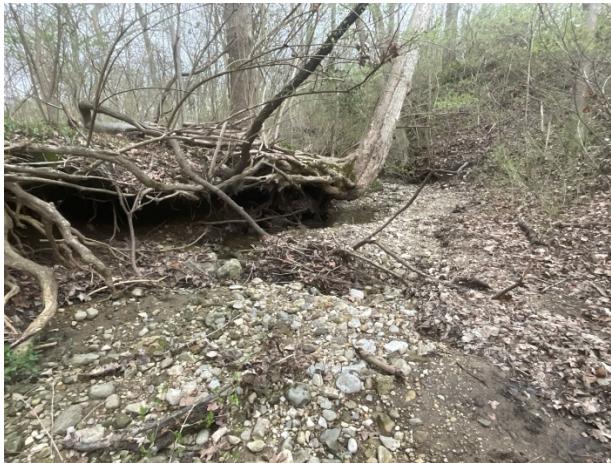
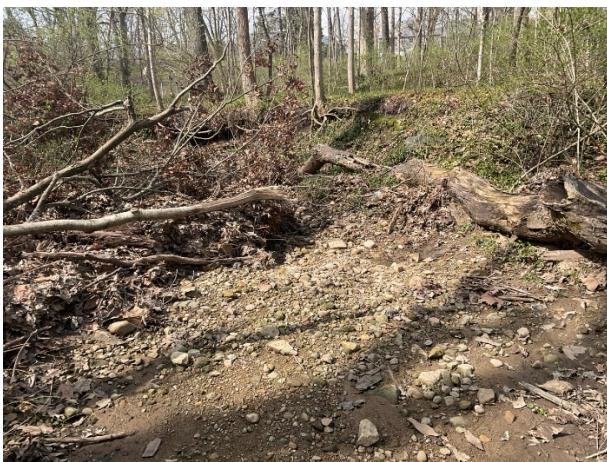
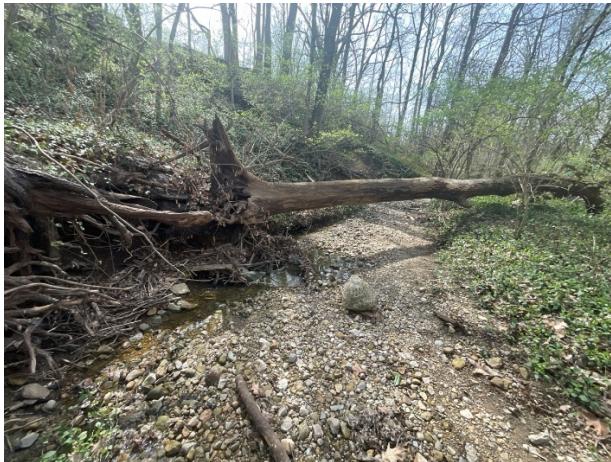
C.I. Beaver Park has minor erosion present throughout the entire public stream with fallen trees. The area should be cleaned of debris and observed for stabilization needs.

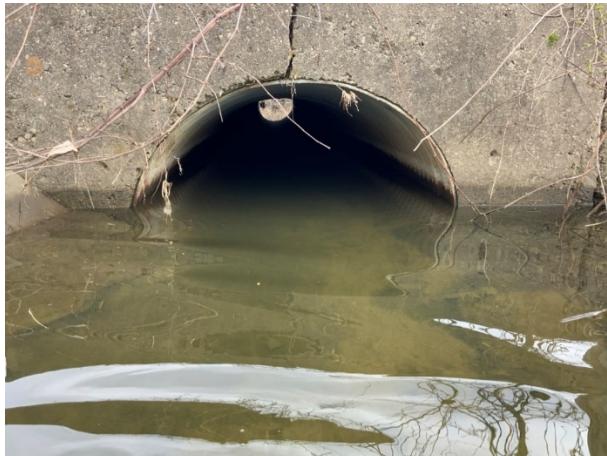
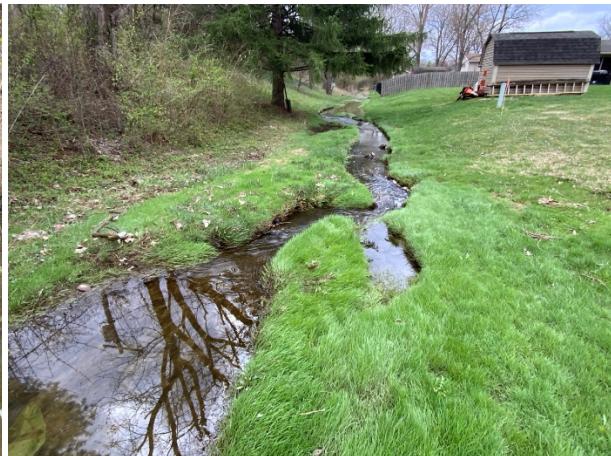
There are 7 culverts (~698 LF) and 24 stream segments (~4,565 LF) present in this grid. Crystal Marie Drive was identified as a problem area for both erosion and flooding with an undersized culvert. Culvert B3_01 at Felton Drive crossing is proposed to be increased in size to accommodate flooding concerns, the channel was very active at the time of inspection.

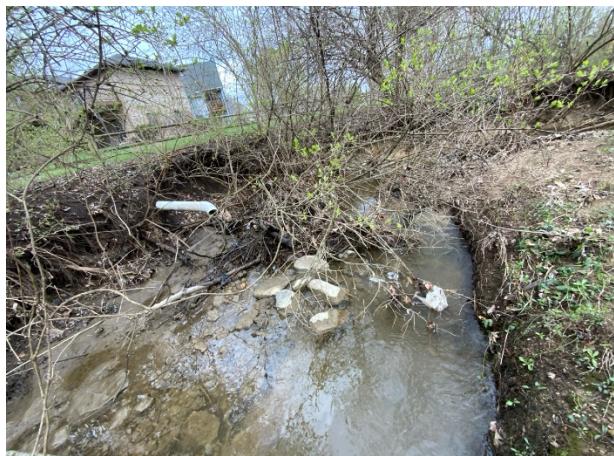
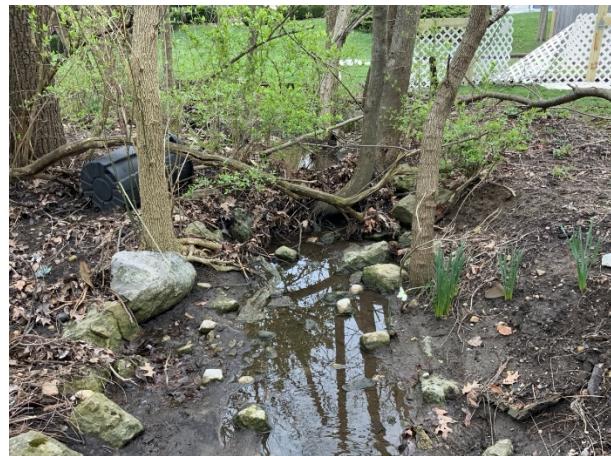
The two channelized areas between King James Drive and Hanes Road have some erosion and maintenance needs due to debris buildup.

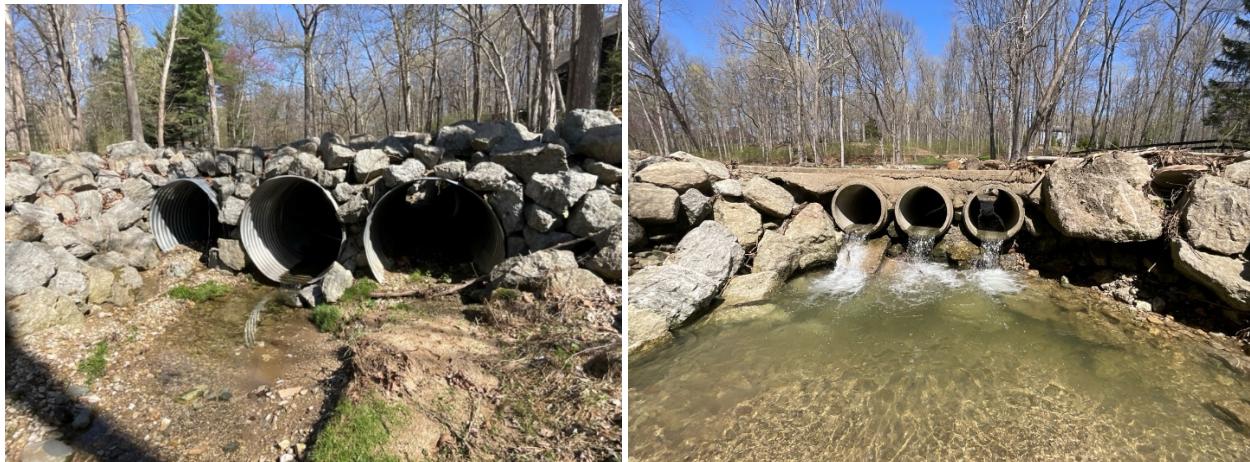
There are 11 culverts (~320 LF) and 27 stream segments (~5,299 LF) present in this grid area. Privately attributed Cinnamon Run was the main channel inspected in this grid, identified as a trouble area with several triple- and quad-barrel crossings. Triple barrel B4_02, B4_03, and B4_04 are all CMP and proposed to be replaced due to material. Triple barrel B4_09, B4_10, and B4_11 are all RCP, but are proposed to be replaced with larger elliptical pipes to meet flooding concerns.

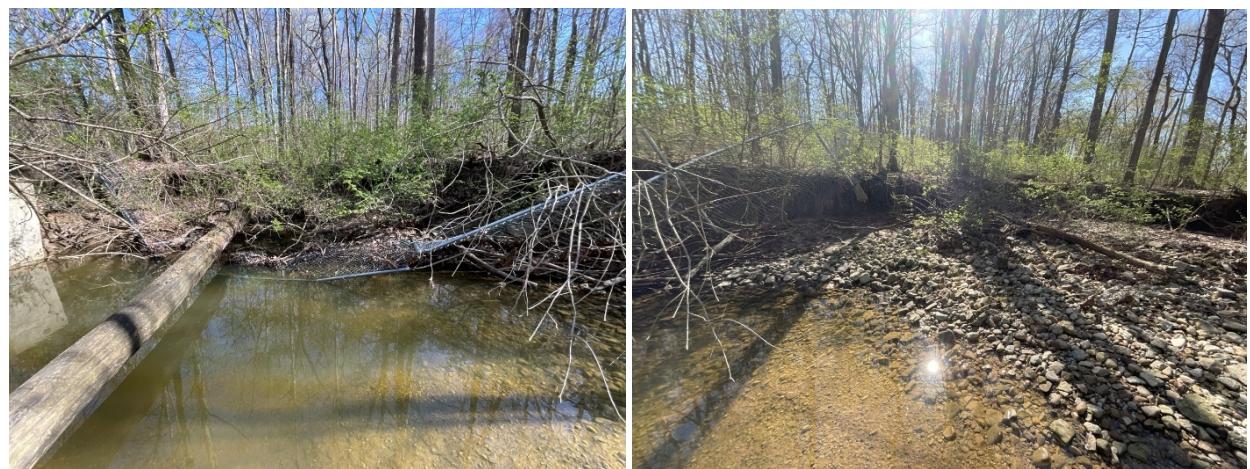
North of Cinnamon Run behind Sumac Court there is a large tree that is laying over fencing at an outfall.

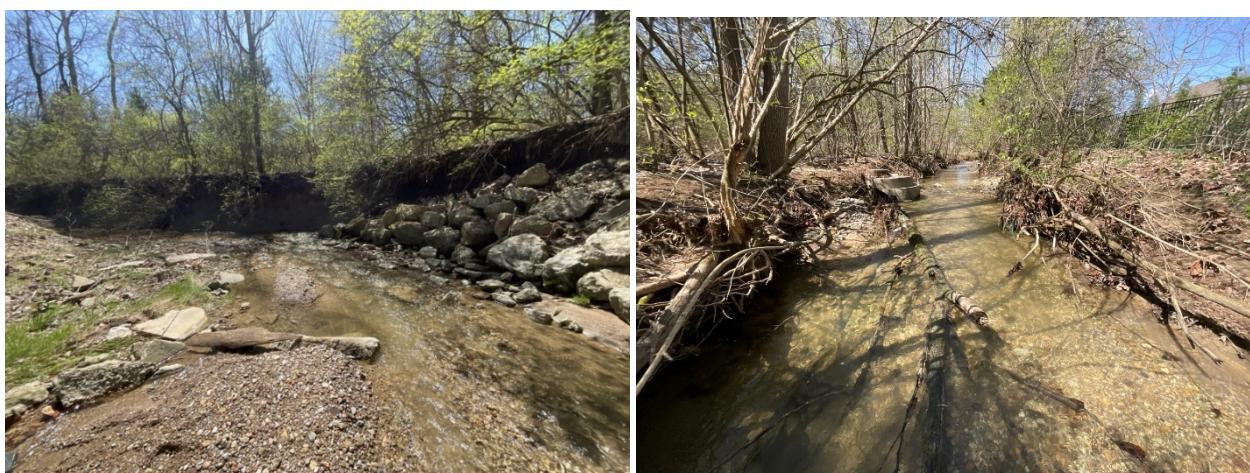
As Cinnamon Run continues through the area to Beaver Valley Road there are signs of erosion of the banks that need to be further stabilized. Large rocks from previous stabilization efforts were also observed.

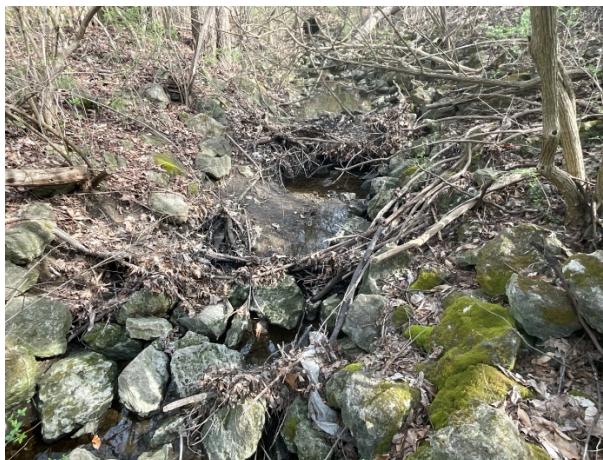
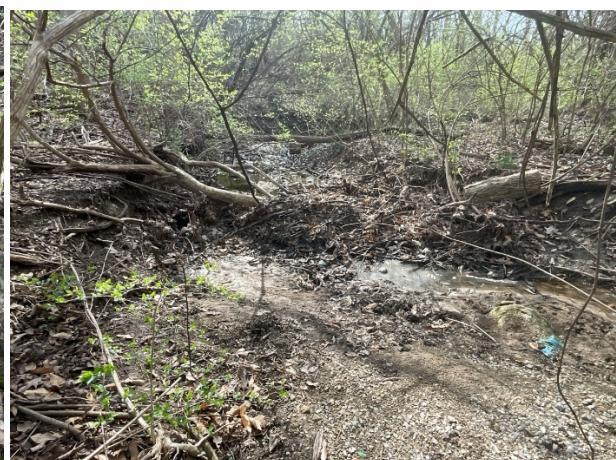
Mill Run Drive culvert C2_09 was found to be in good condition and operating at adequate capacity. The channel upstream of the culvert crossing is experience some erosion that is encroaching on private property. The channel downstream of the culvert crossing has debris buildup and could be cleaned.

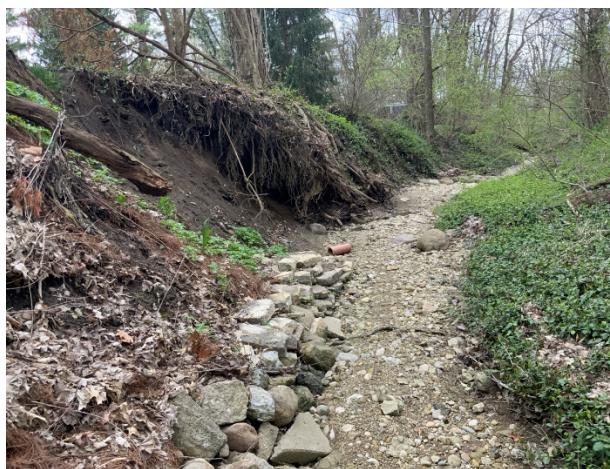
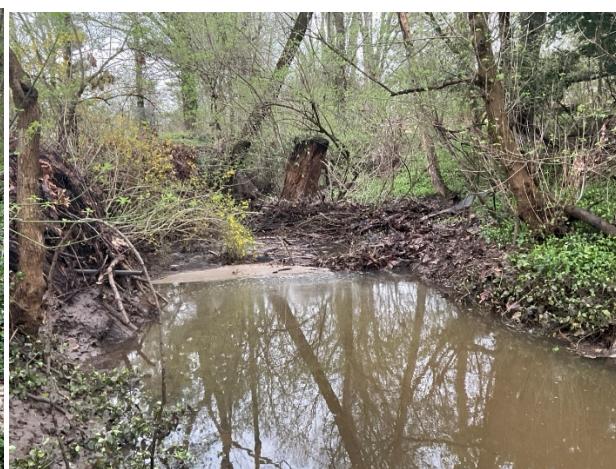
The Beaverbrook Drive channel was dry in some areas with pooling in other areas due to debris buildup, and has evidence of erosion to the banks. Several electrical poles line the banks through this area.

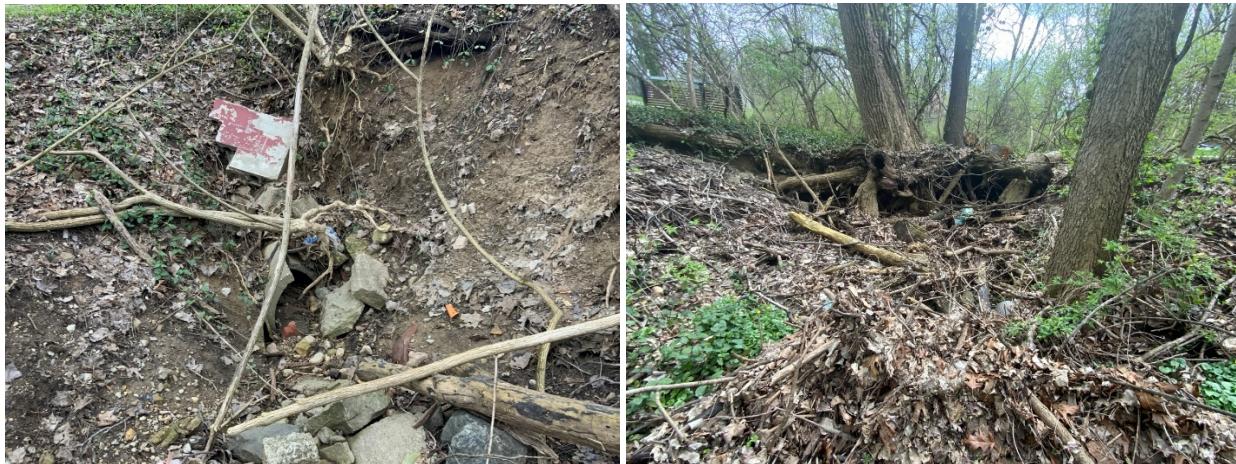
Several culverts on the private stream west of Forestdale Avenue were structurally deficient and completely blocked with debris. Replacement and maintenance of these culverts should be coordinated with property owners.

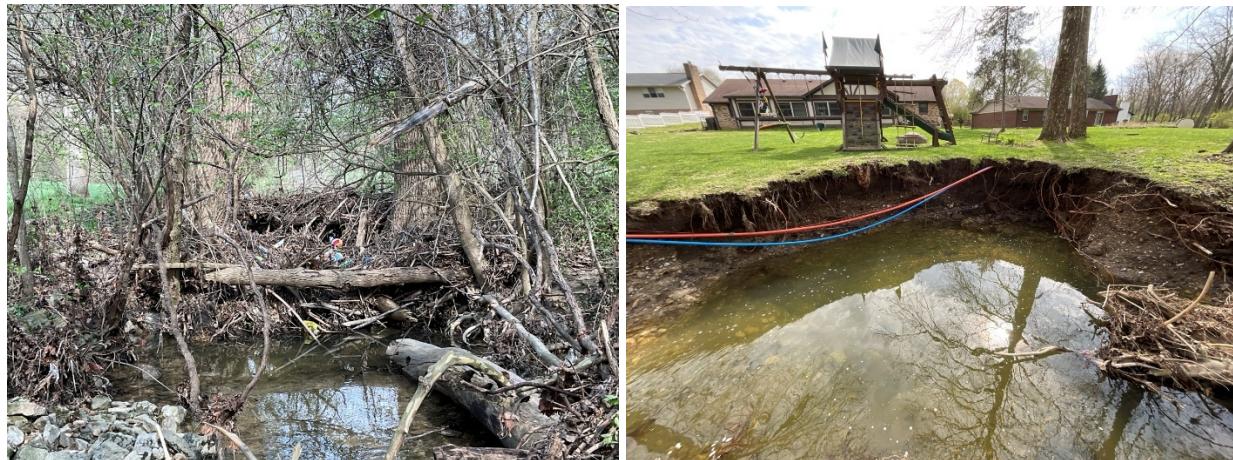
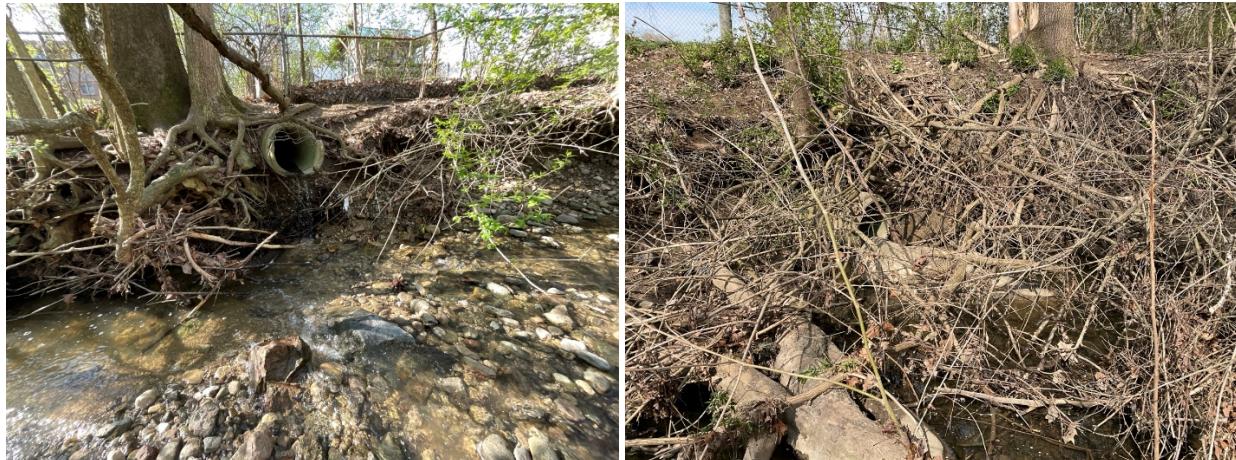
There are 6 culverts (~691 LF) and 40 stream segments (~7,502 LF) present in this grid. Multiple trouble areas were reported near Hillside Side for erosion, Hanes Road for erosion, Hickory Drive for flooding, and Ferguson Drive for flooding with erosion. Little Beaver Creek runs behind Suburban Drive and Hillside Drive that is experiencing erosion to the banks, debris buildup, and threats to several utilities.

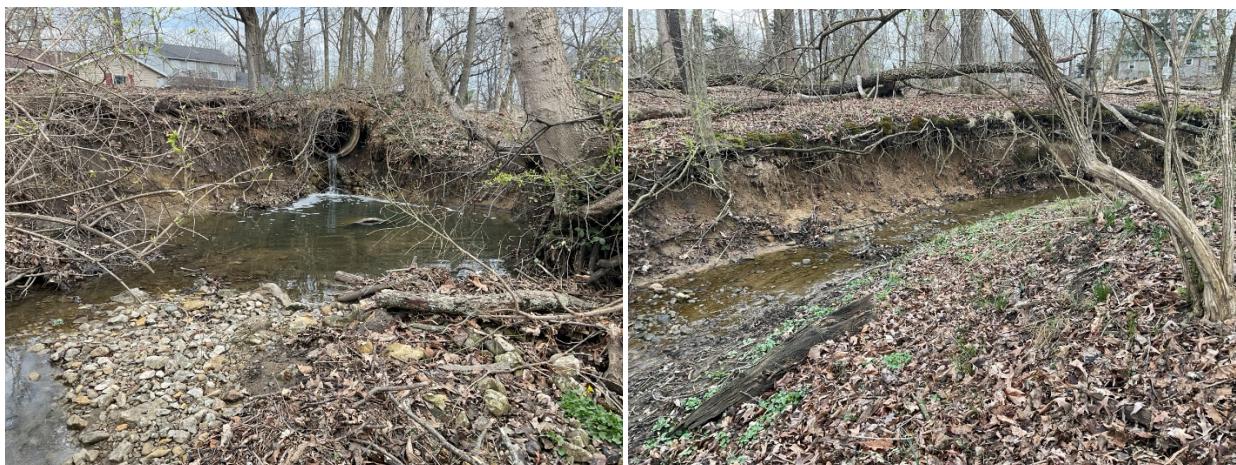
The Hickory Drive area has a culvert that is proposed to be increased in size and the outfall area stabilized. This stream is attributed private and needs to be coordinated accordingly with property owners.

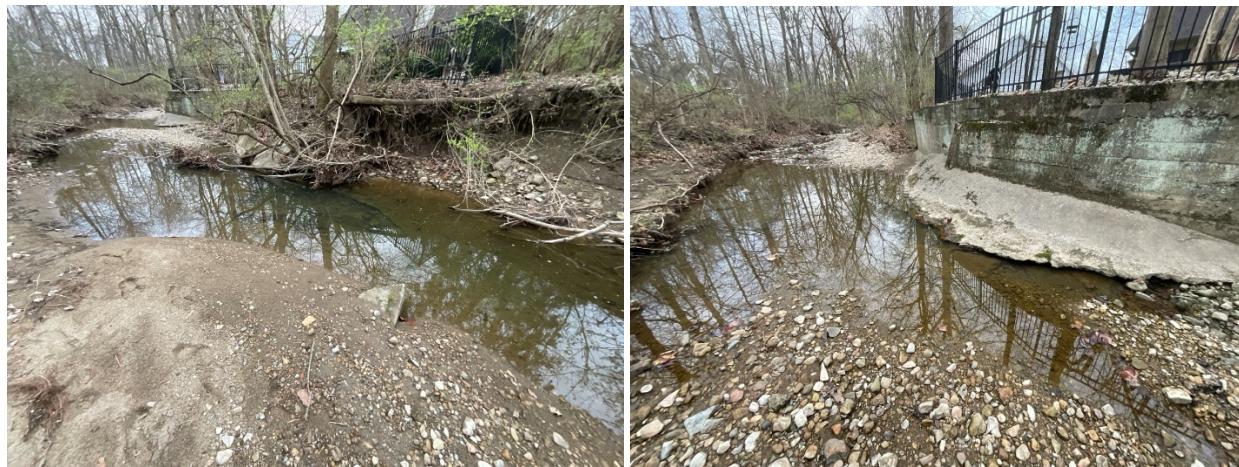
Another area of Little Beaver Creek behind private property is eroding away structures near the intersection of Eileen Drive and Forest Glen Court. Stabilization of these structures and banks should be mitigated with the property owners.

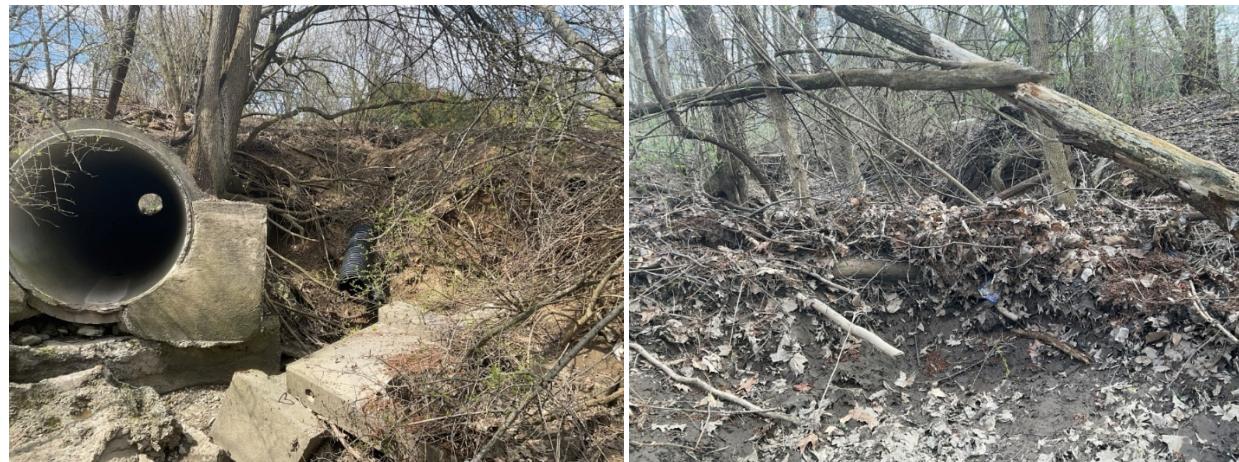
There are 2 culverts (~153 LF) and 8 stream segments (~1,503 LF) present in this grid. The trouble area of Lantz Road near Vigallito Park has a culvert that is in good condition. The headwall outlet for culvert C4_02 under Beaver Valley Road is failing and it is recommended for it to be fully inspected to determine if the pipe joints are also failing or just the headwall. Stream segment C4_S_08 is associated with this area and is identified for bank stabilization and debris removal.

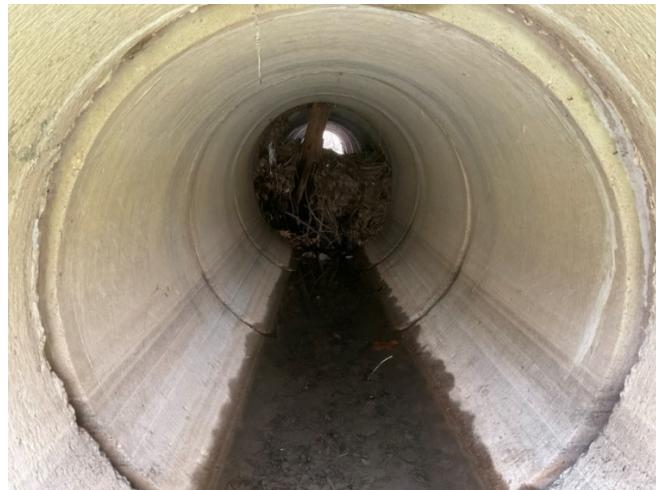
There are 9 culverts (~896 LF) and 32 stream segments (~5,443 LF) present in this grid. The City recently completed a stabilization project in the Vineland Trail area upstream/south of the culverts that cross Tredwell Place. The two culverts D1_02 and D1_03 at Tredwell Place were found to be lacking hydraulic capacity and in need of maintenance, with one of them almost completely blocked with debris. These two culverts are proposed to be replaced with larger box culverts to accommodate flooding concerns.

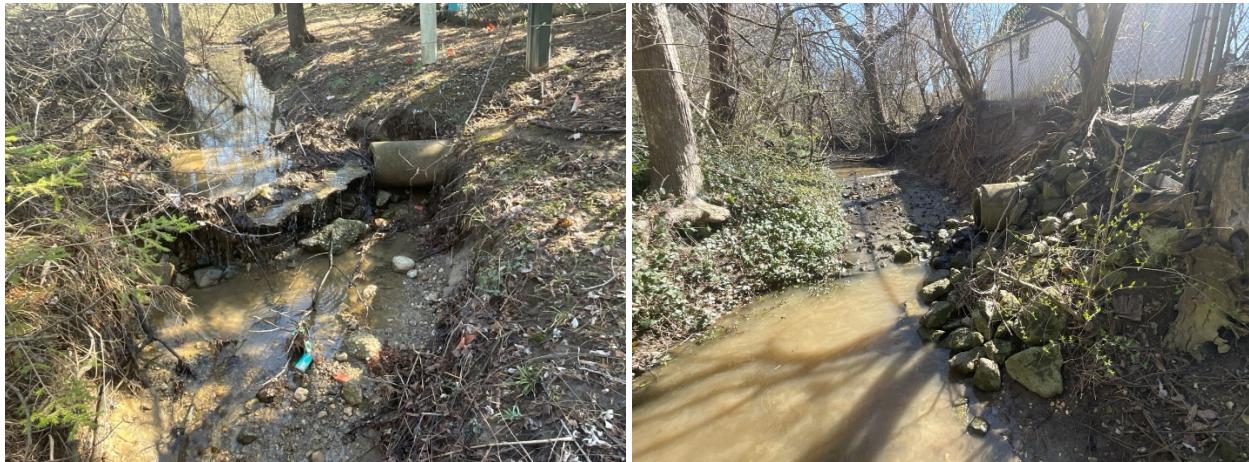
The channel behind Tallman Trail is experiencing erosion and has several existing threats that need to be mitigated with bank stabilization. Private property fencing lines the top of bank for most of the public channel with several portions of the fence in danger of falling.

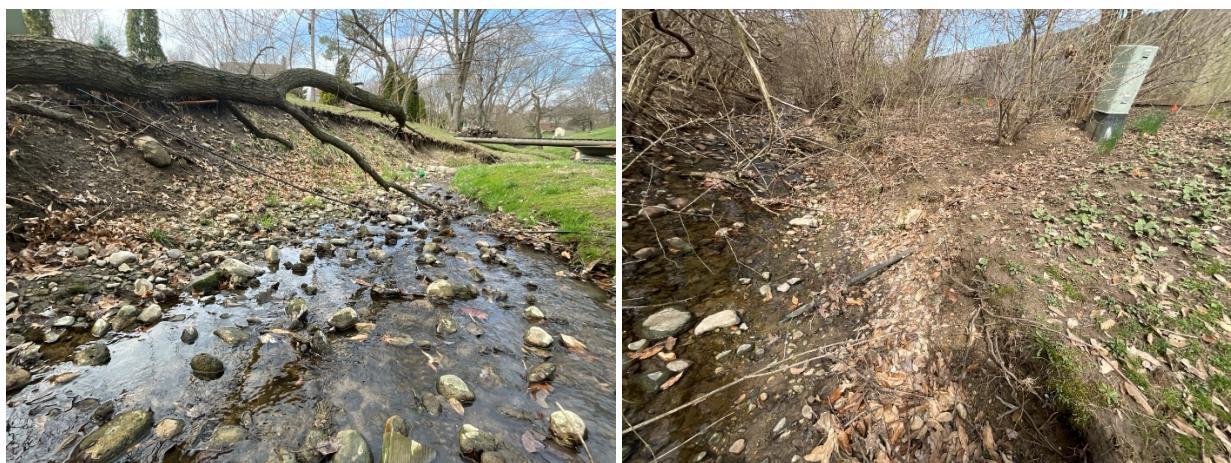
The trouble area behind Wenlan Court off Danern Drive is experiencing erosion of the public channel, exposing an unknown small diameter cable behind several properties. It should be considered for bank stabilization and coordination with utilities to bury the exposed cables.

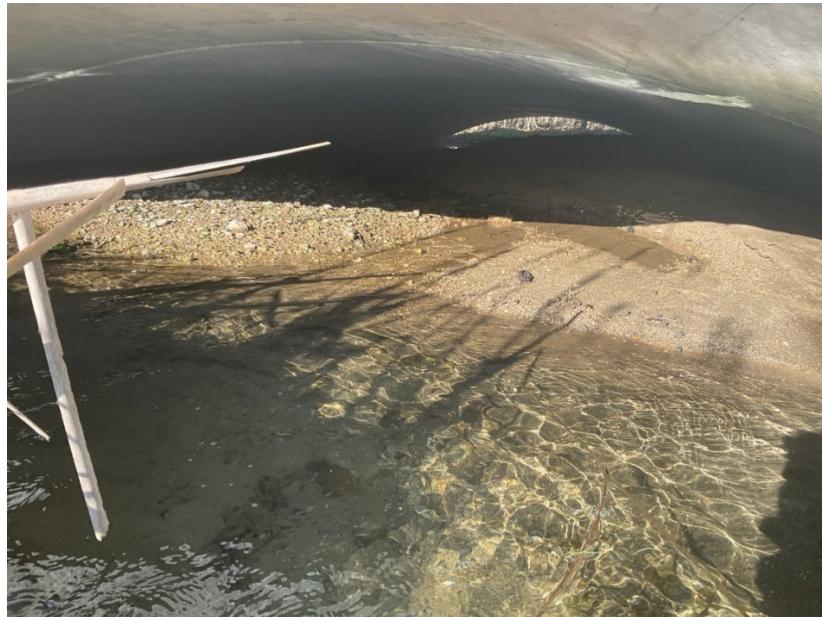
There are 9 culverts (~598 LF) and 63 stream segments (~11,863 LF) present in this grid. None of the culverts require replacement, four of them require maintenance. Culvert D2_03 is a very large arch that is almost completely blocked with sediment.
