Project No. 10022676.00

City of Beavercreek Drainage Master Plan

City of Beavercreek

October 13, 2025

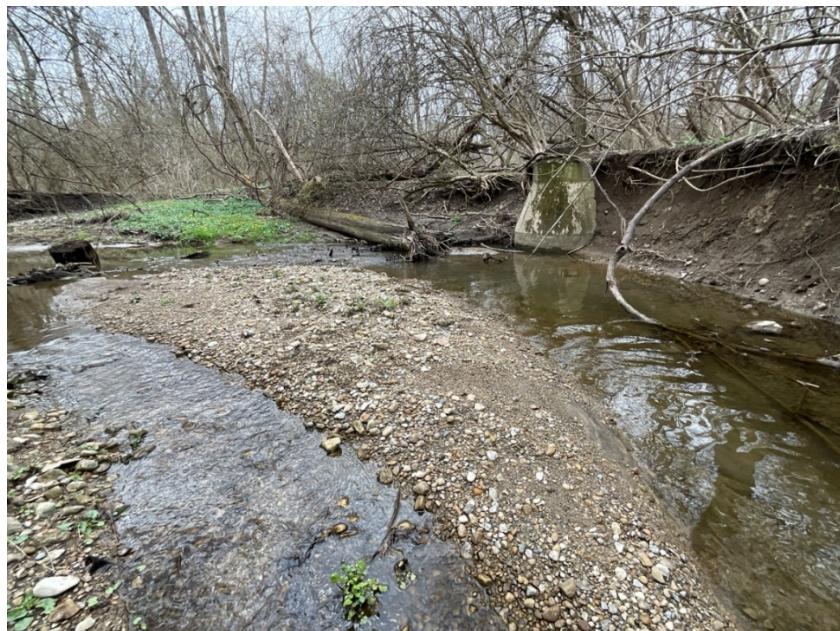
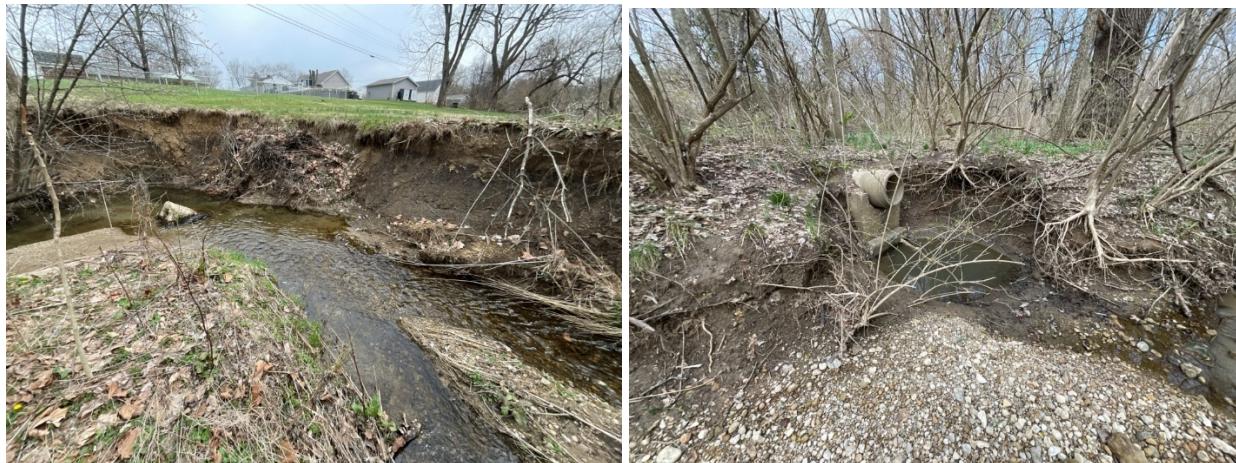
There are five stream segments that require bank stabilization and eleven stream segments that require debris removal. Two trouble areas focused on erosion are in this grid, the channel behind Bridlewood Street and the channel behind Carthage Drive. Erosion present in the Bridlewood Street area was mostly rated fair with no major existing threats. Erosion present in the Carthage Drive area was evident with major existing threats to exposed manhole structures and bank failure in some locations, there was also sediment throughout the cross section and fallen trees.

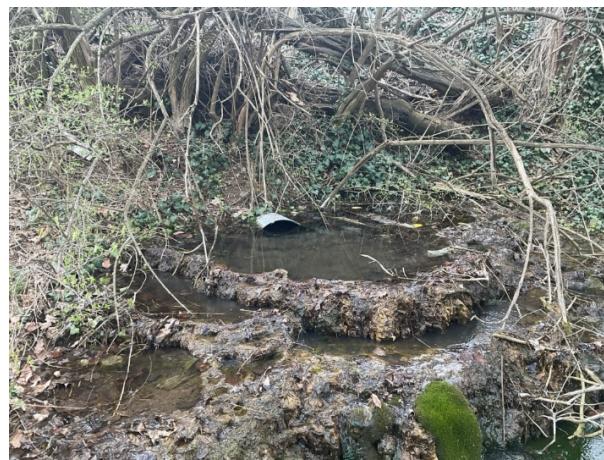
There are 3 culverts (~179 LF) and 21 stream segments (~3,824 LF) present in this grid. Two culverts are proposed for replacement and debris removal for stream segments. The trouble area around an outfall of North Alpha Bellbrook Road was inspected and crews found the outlet of the 24" CMP to be completely blocked. This pipe conveys flow from a storm pipe network and was modeled to require a 36" pipe.

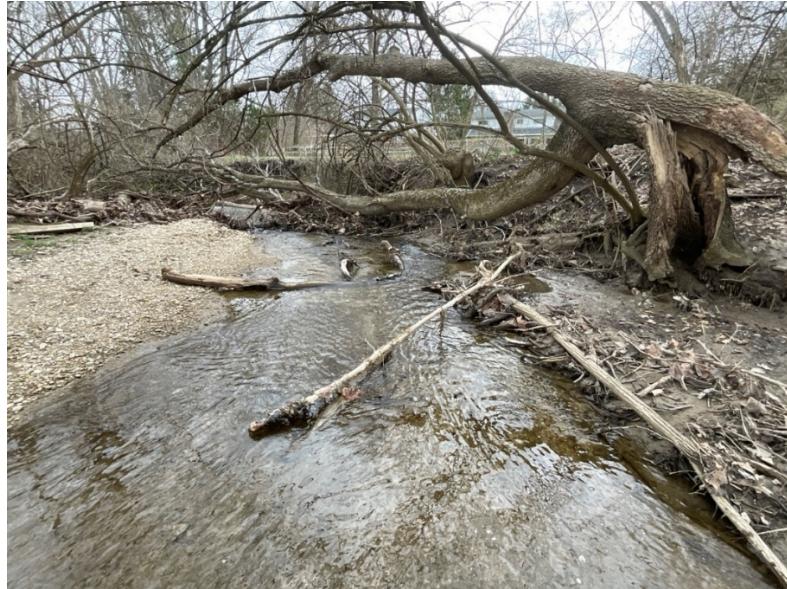
The stream through Merrick Park has large trees blocking flow and potentially impacting area storm sewers that discharge into the stream.

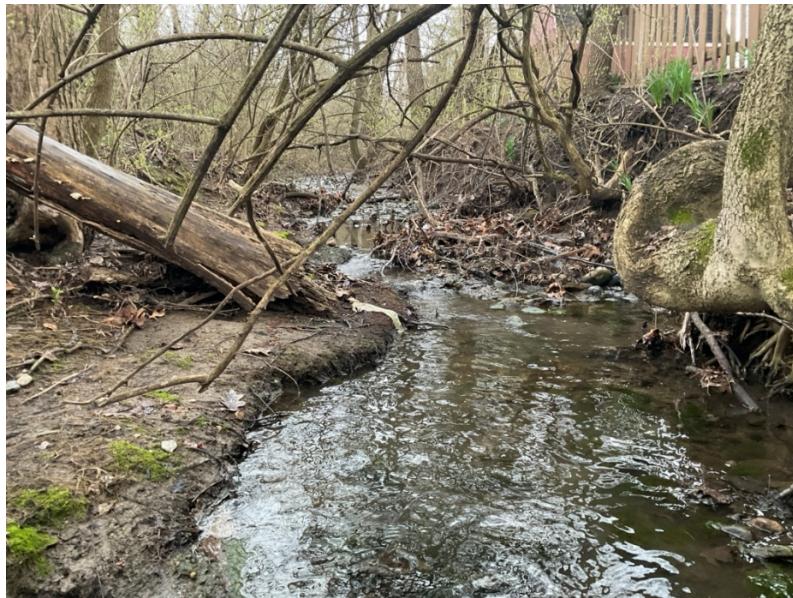
Stream segment D3_S_18 has erosion of a public stream affecting a private property fence line that should be mitigated with the property owner.

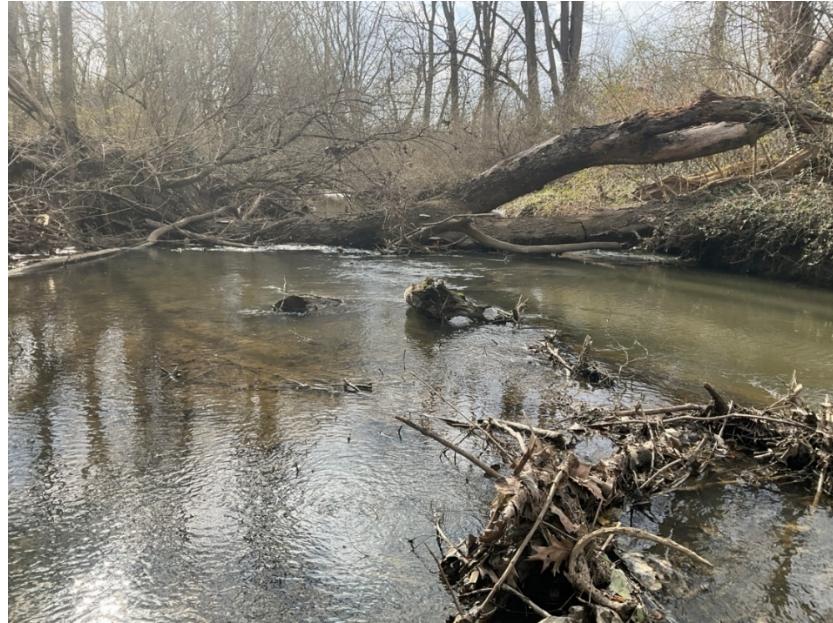
A large tree is blocking stream segment D4_S_06 along Beaver Creek east of Dayton Xenia Road that should be removed to maintain the channel.

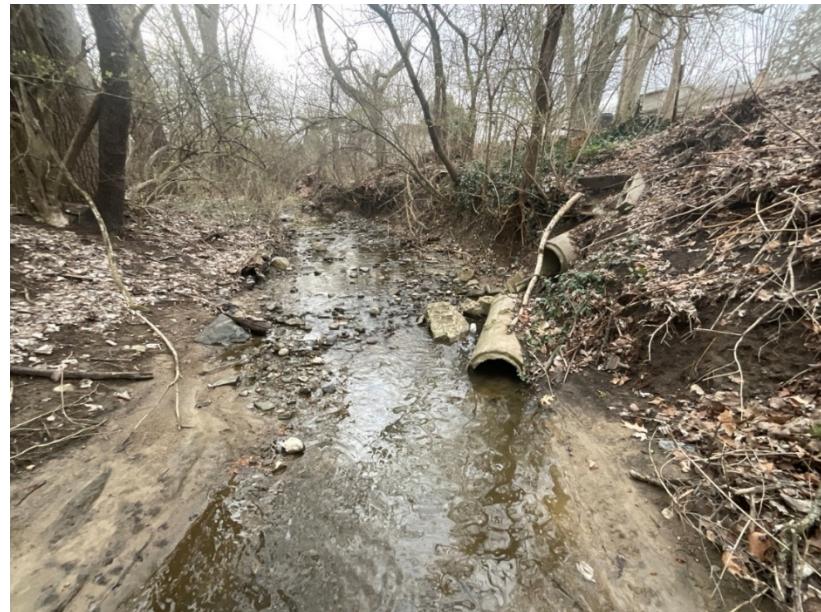
Stream segment E1_S_01 has several utility threats that need to be mitigated through stabilization and coordinated with the governing utility department.

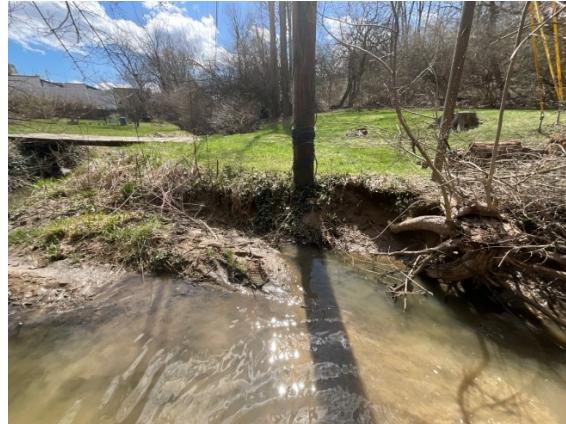
Stream segments E1_S_07 and E1_S_08 have several utility threats that need to be mitigated through stabilization and coordinated with the governing utility department.

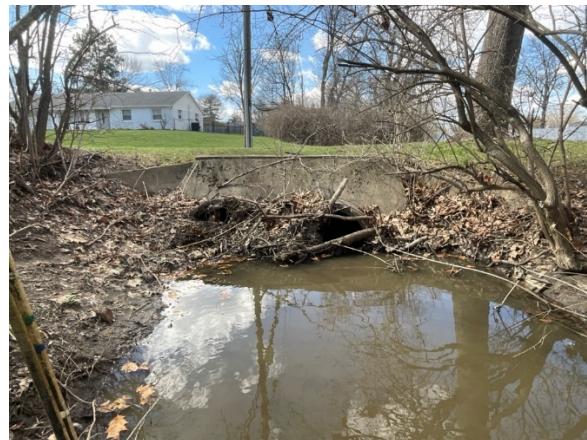
Culverts were checked at the trouble area of Rushmore Place and a significant amount of debris is blocking the inlets that requires cleaning.

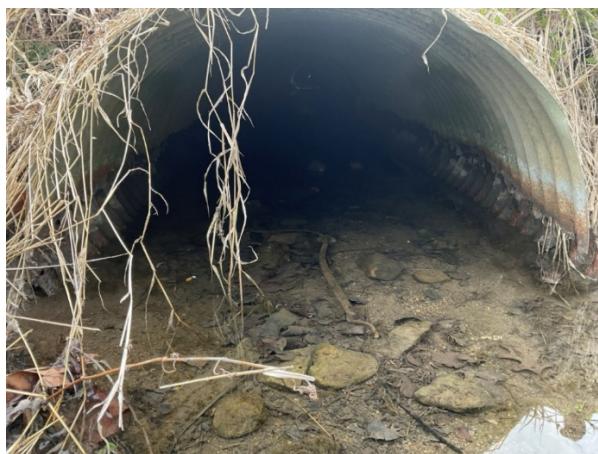
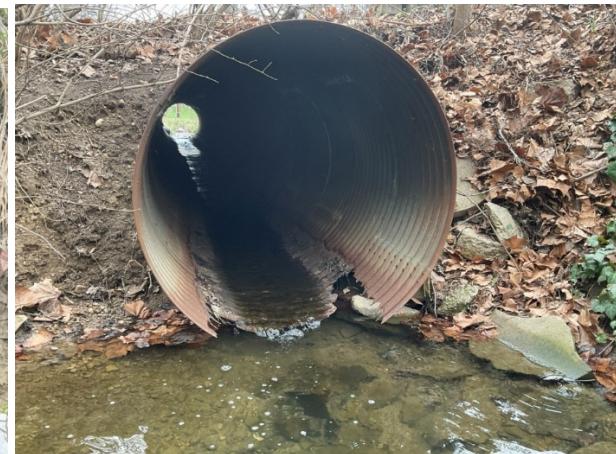
Culverts were checked at the trouble area between Chalfonte Drive, Carondelet Drive, and Chalmette Drive. Culvert E1_06 at Chalmette Drive has already been replaced with SLHDPE and does not have any recommendations. E1_10 at Chalfonte Drive is CMP and E1_05 at Carondelet Drive is CMP, both of which are proposed to be replaced.

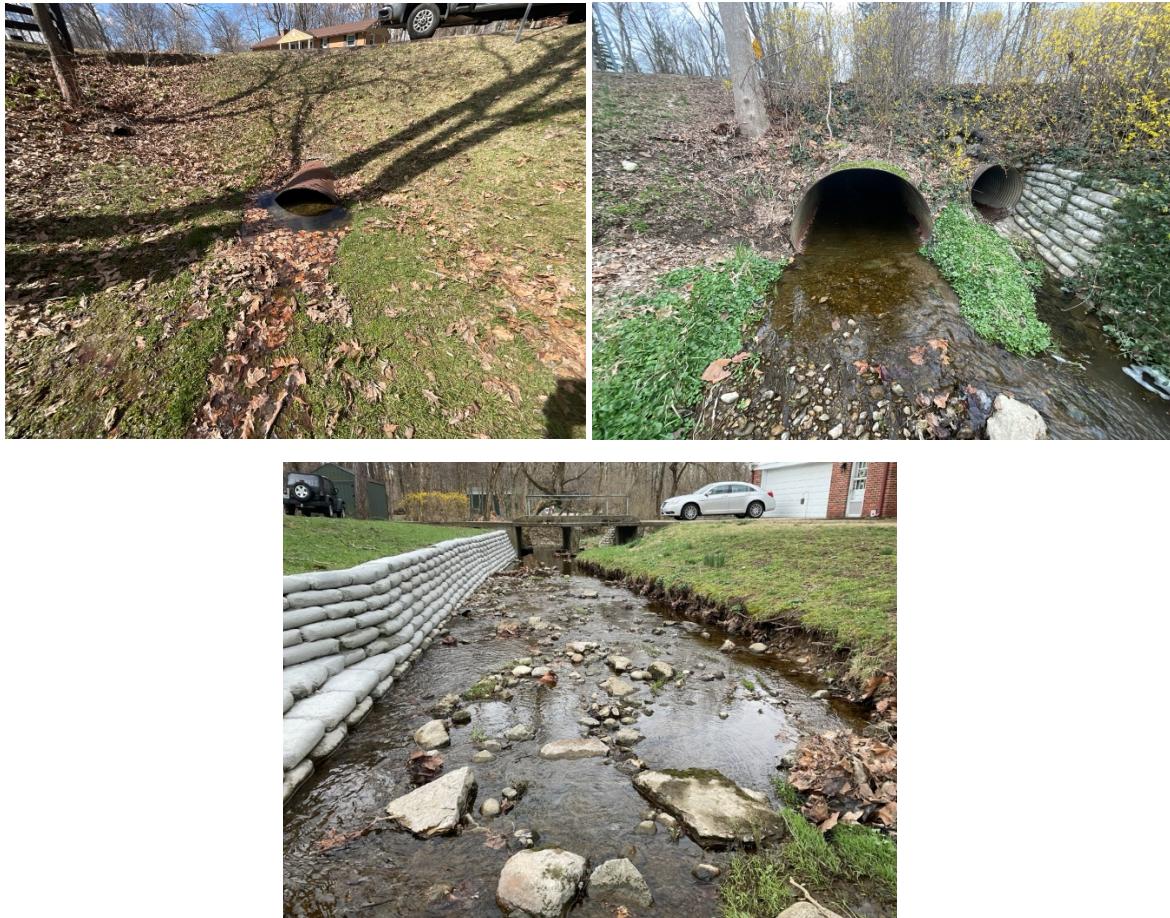
Culverts were checked at trouble area Sunbeam Avenue and the channel south of Sunbeam Avenue. Three culverts on Sunbeam Avenue are CMP and identified for replacement, E1_07 is proposed to be replaced with a slightly bigger 42" pipe, E1_08 and E1_09 are to be replaced with 43"x68" elliptical pipes, while the channel was experiencing some erosion and minor sediment.

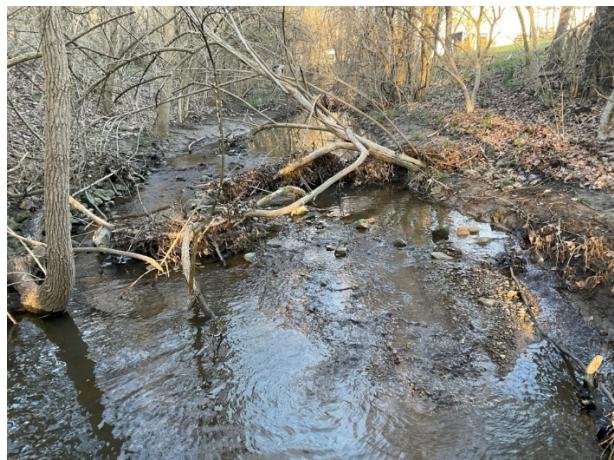
8.2.18 Grid E2

Woolpert did not inspect any culverts in this grid area. There is 1 stream segment (~200 LF) present in this grid off of Arlington Place with tree debris.

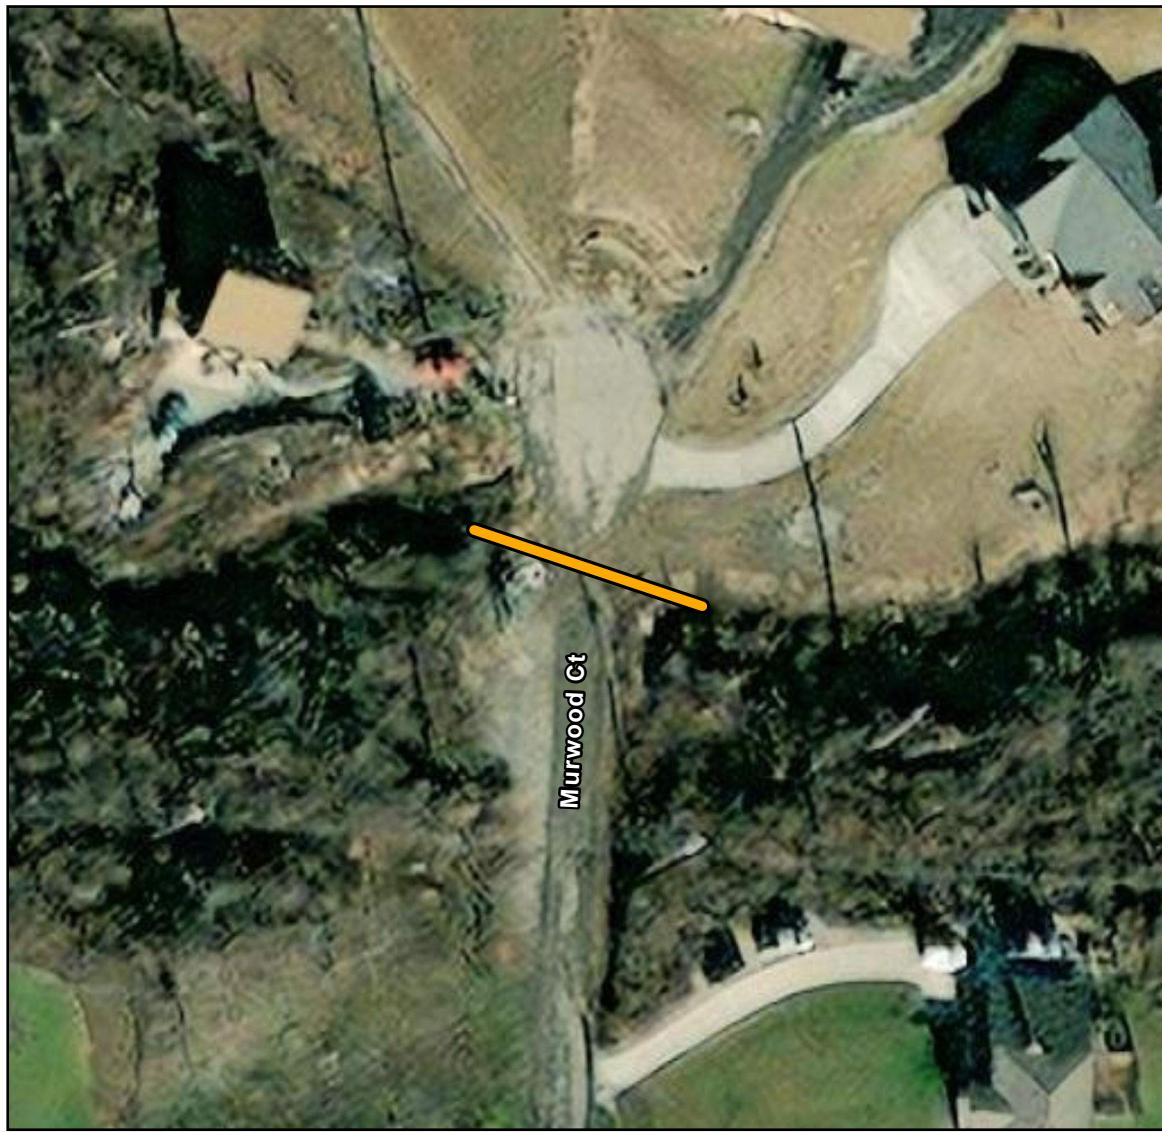
Culvert ID: A1_01

Structural Score: 1

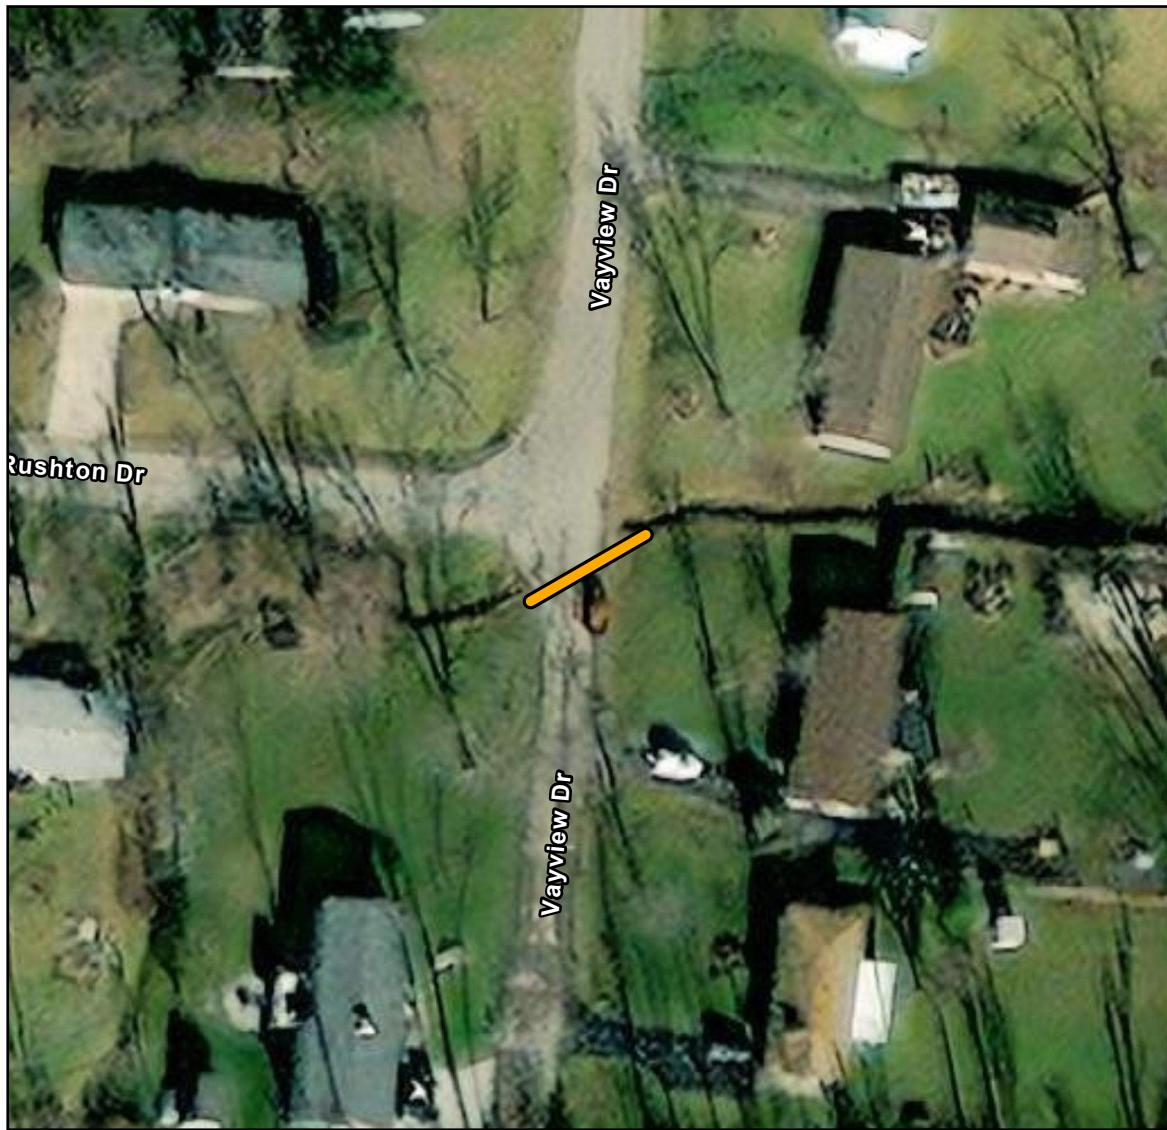
Culvert ID: A2_01

Structural Score: 2

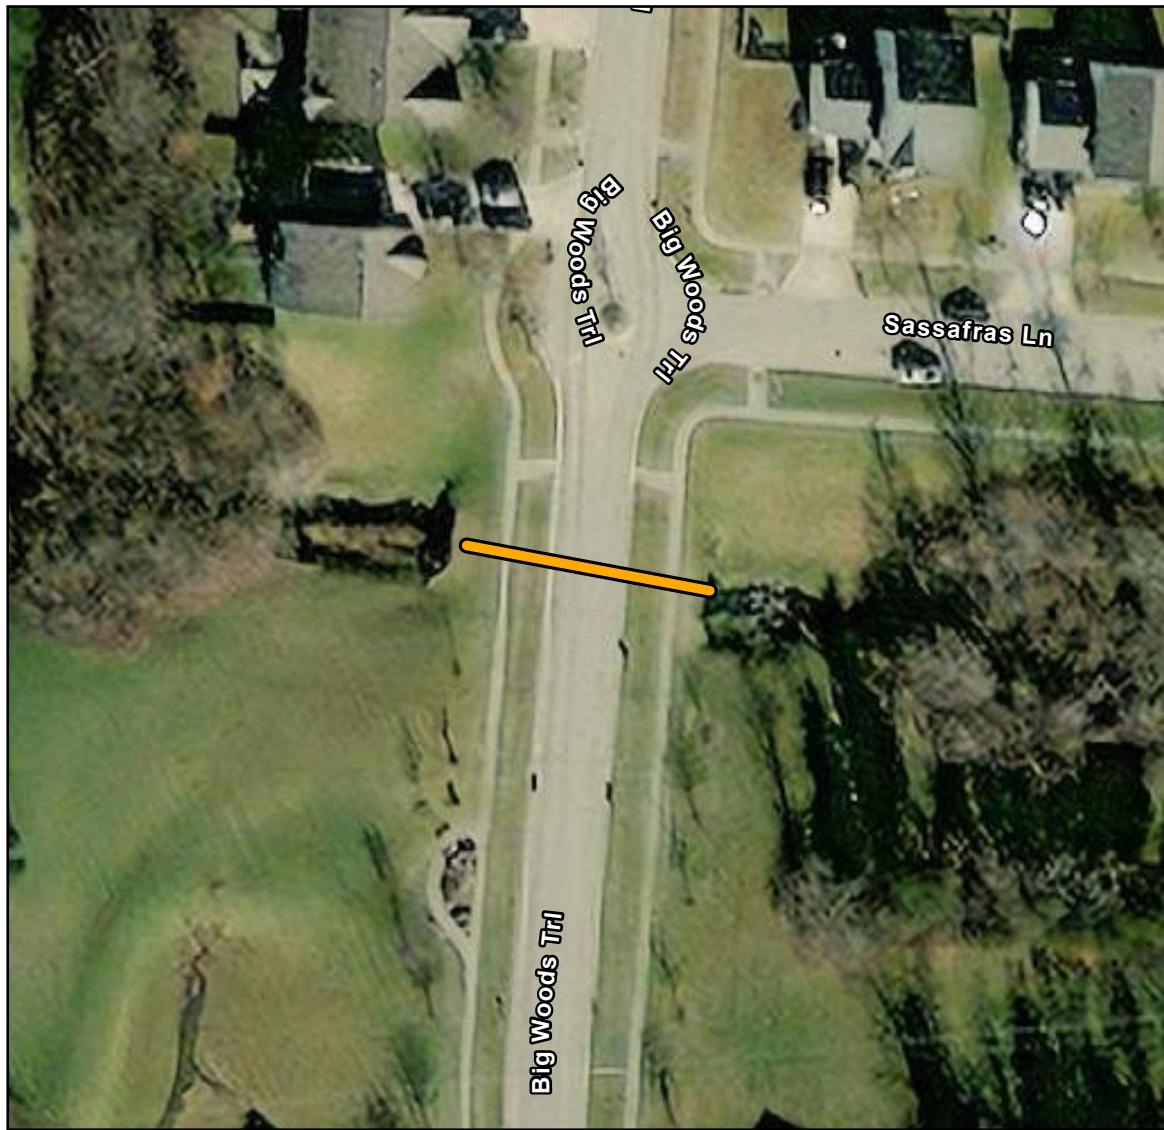
Culvert ID: A3_03

Structural Score: 1

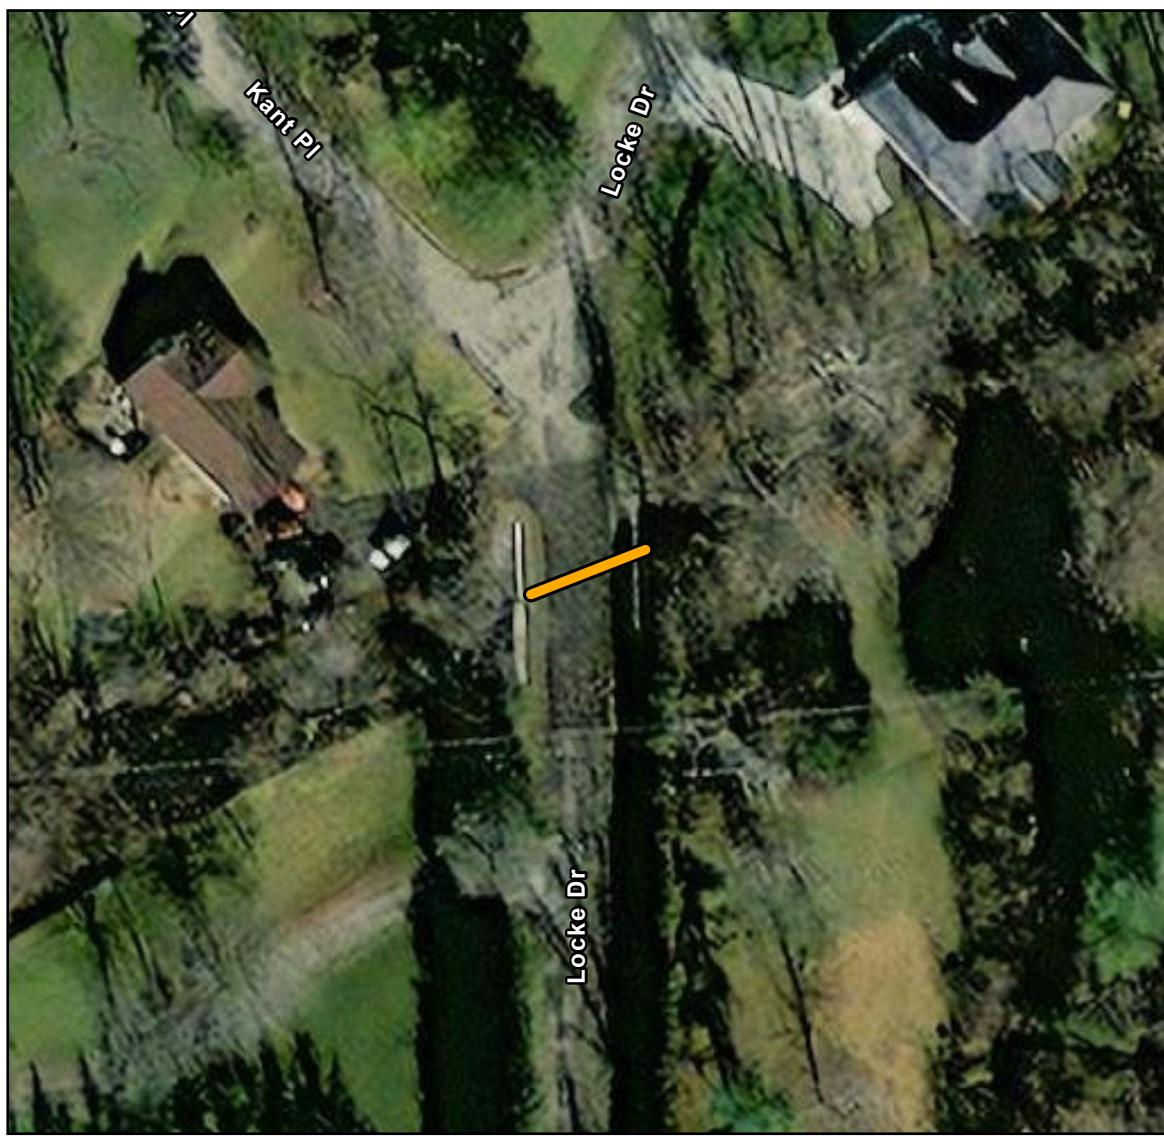
Culvert ID: A3_04

Structural Score: 1

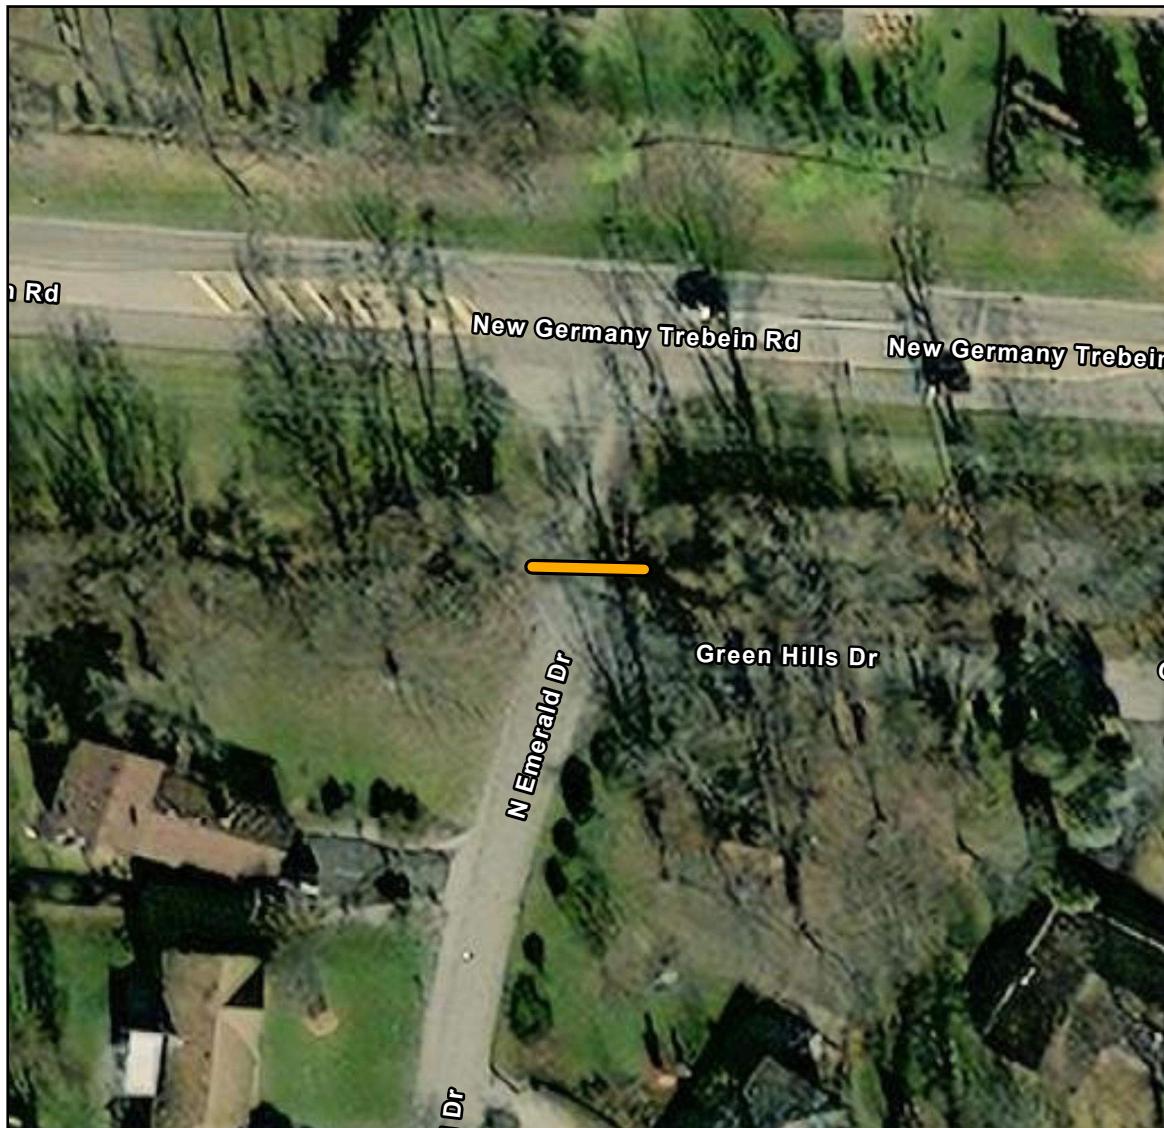
Culvert ID: A3_06

Structural Score: 3

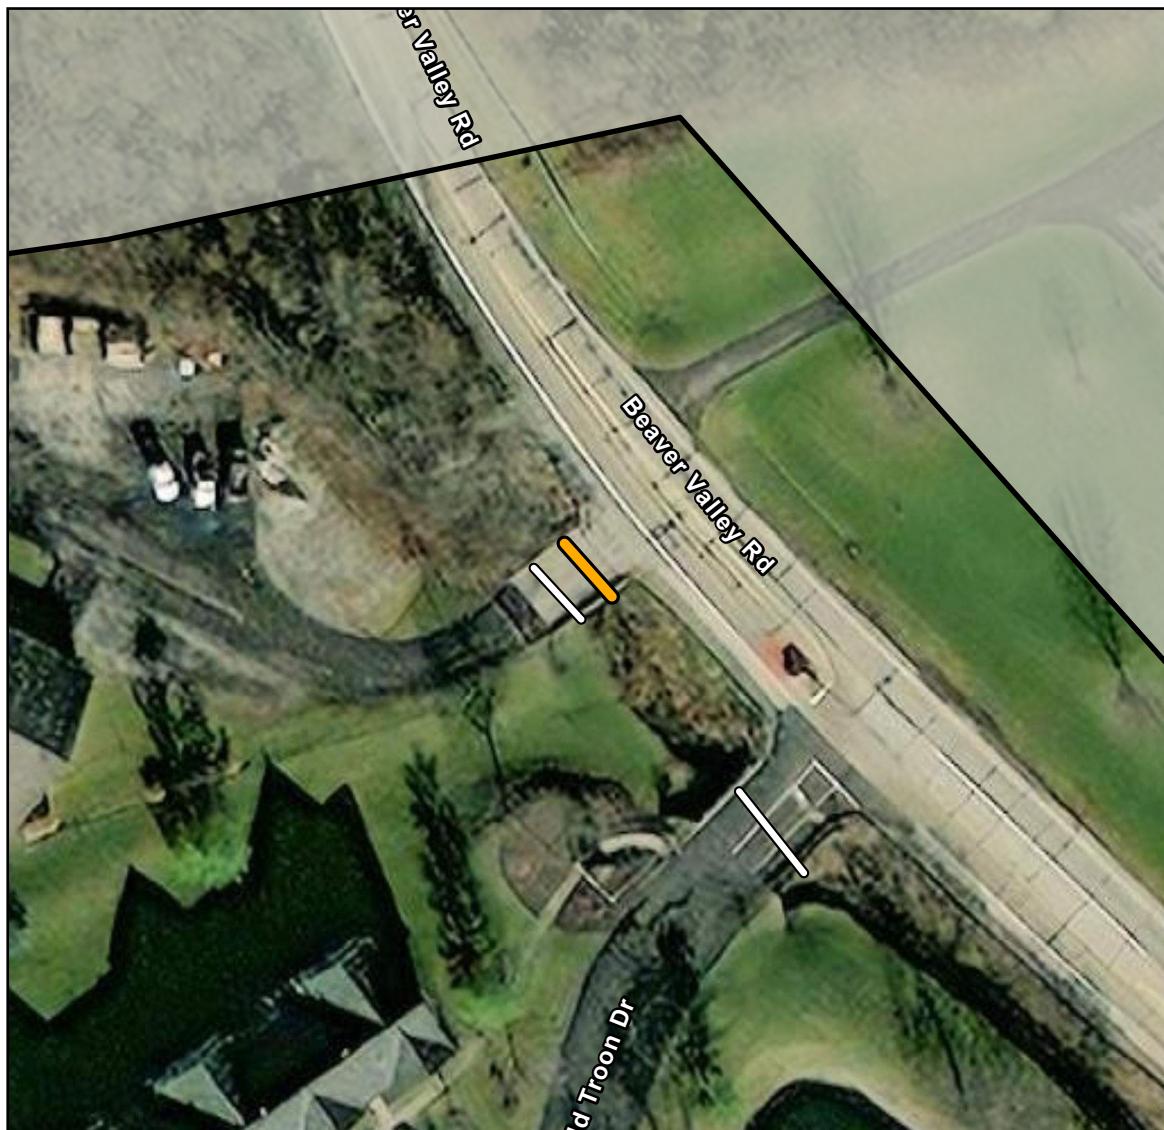
Culvert ID: A4_01

Structural Score: 2

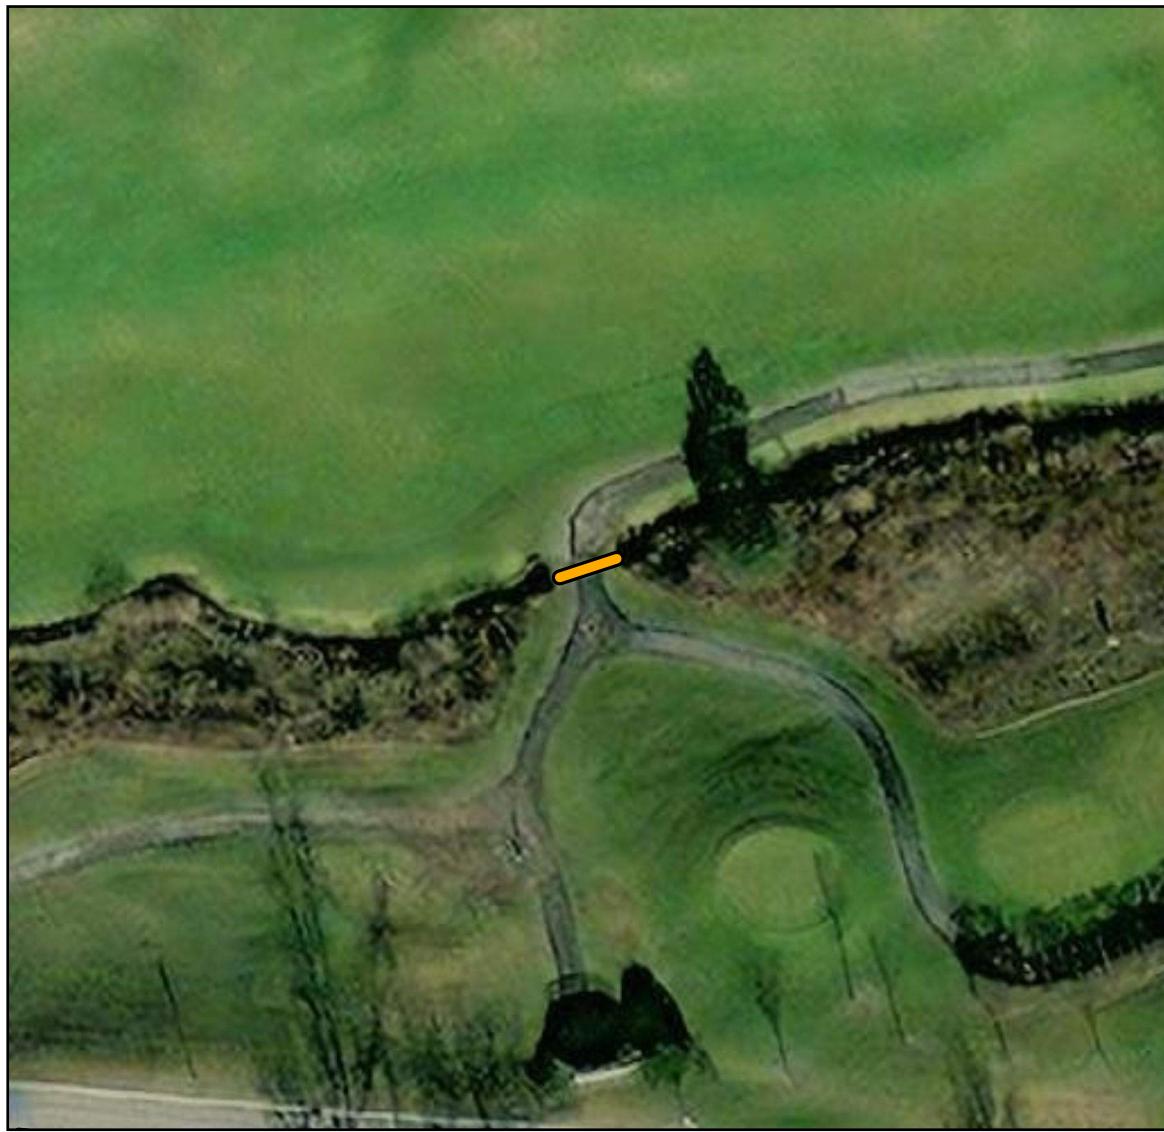
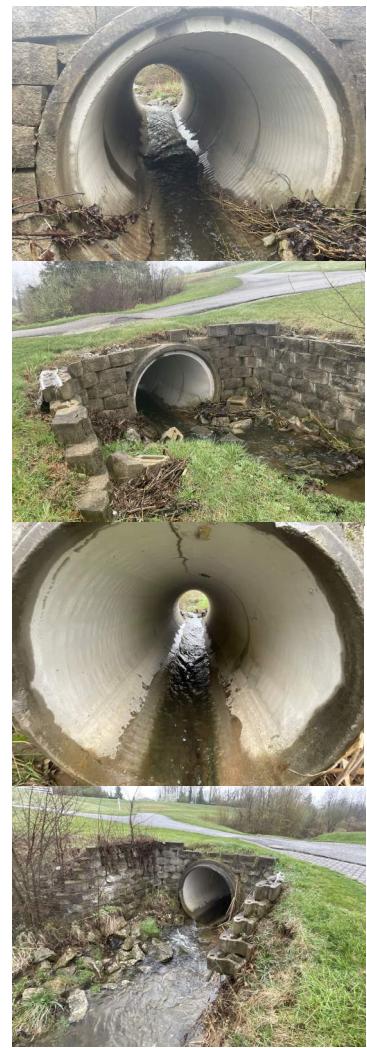
Culvert ID: A4_03

Structural Score: 1

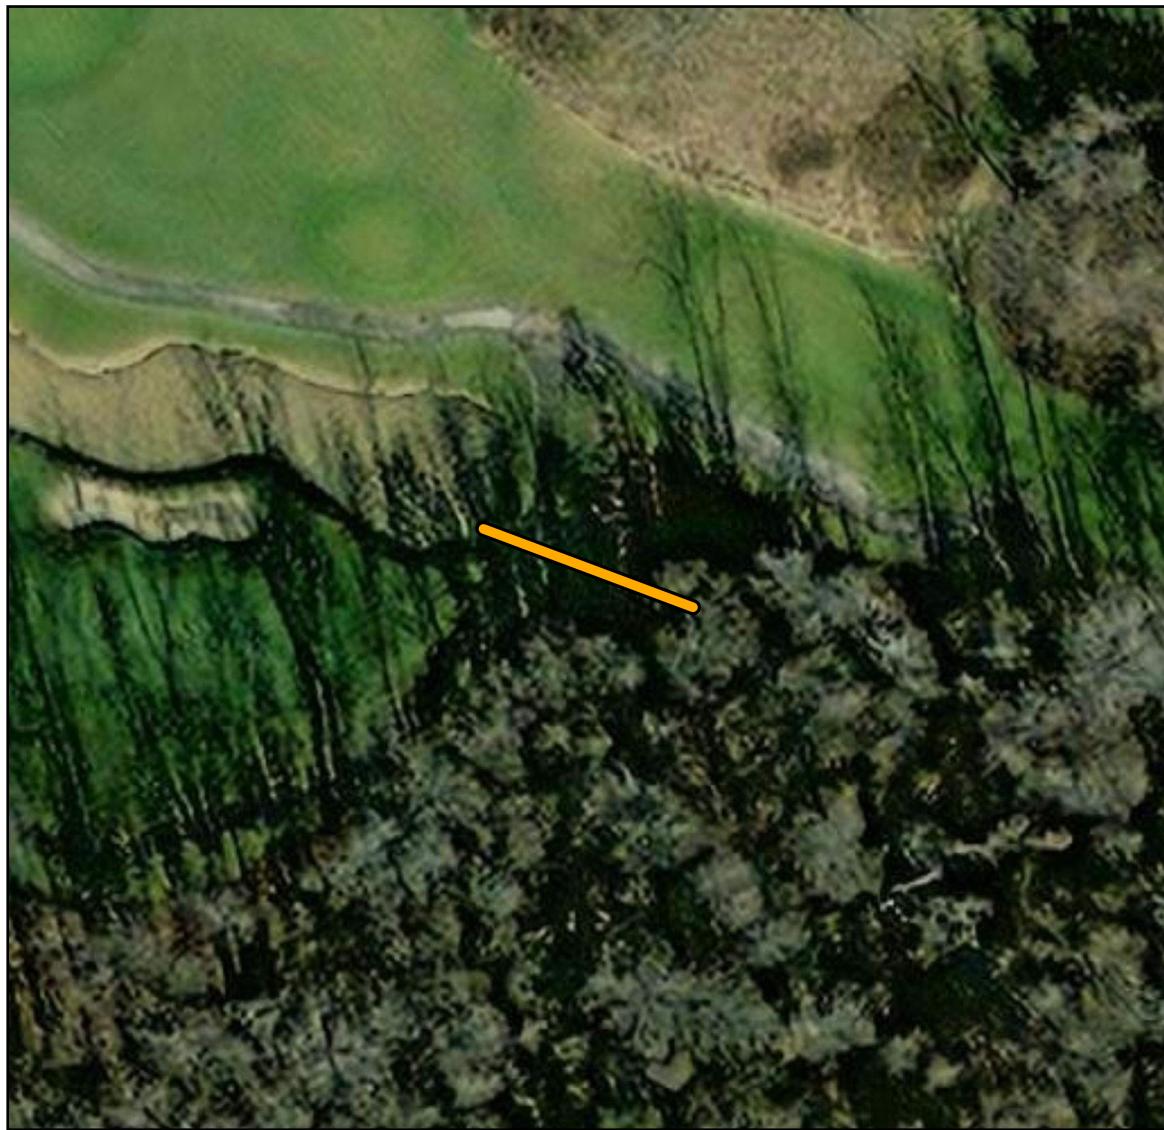
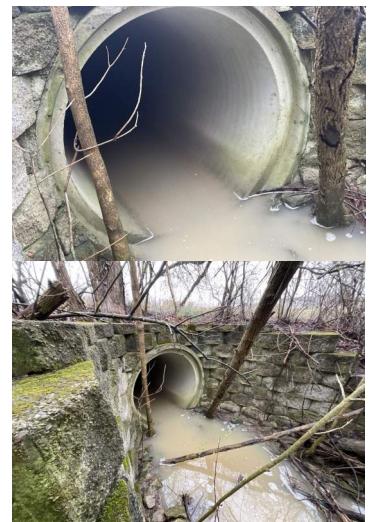
Culvert ID: A4_04

Structural Score: 2

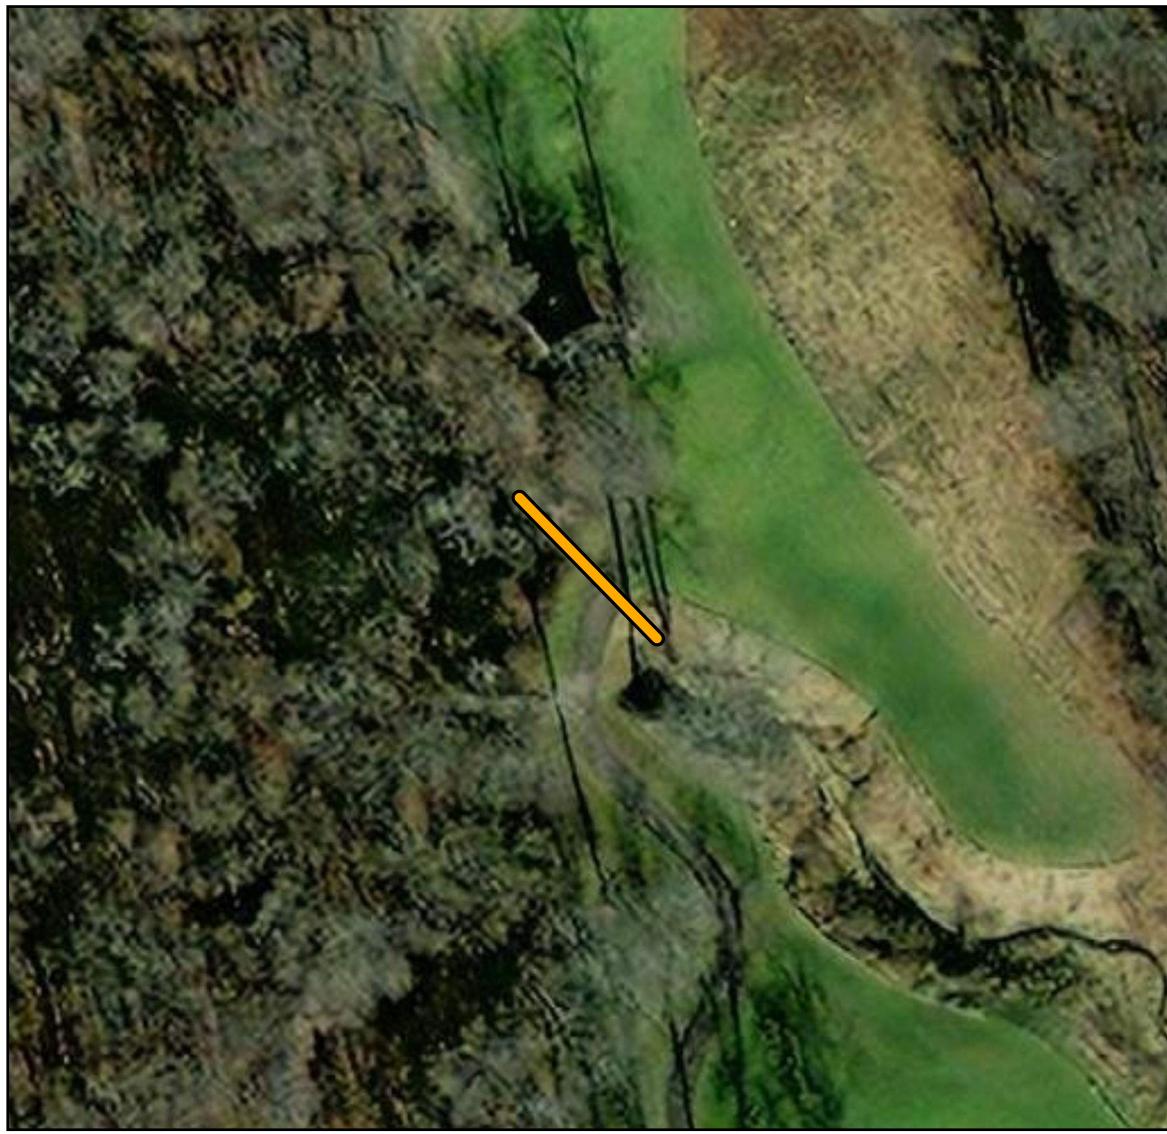
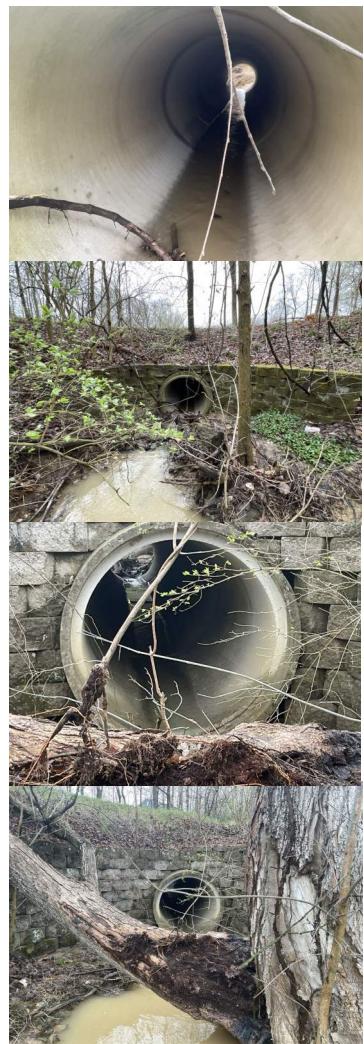
Culvert ID: A4_05

Structural Score: 2

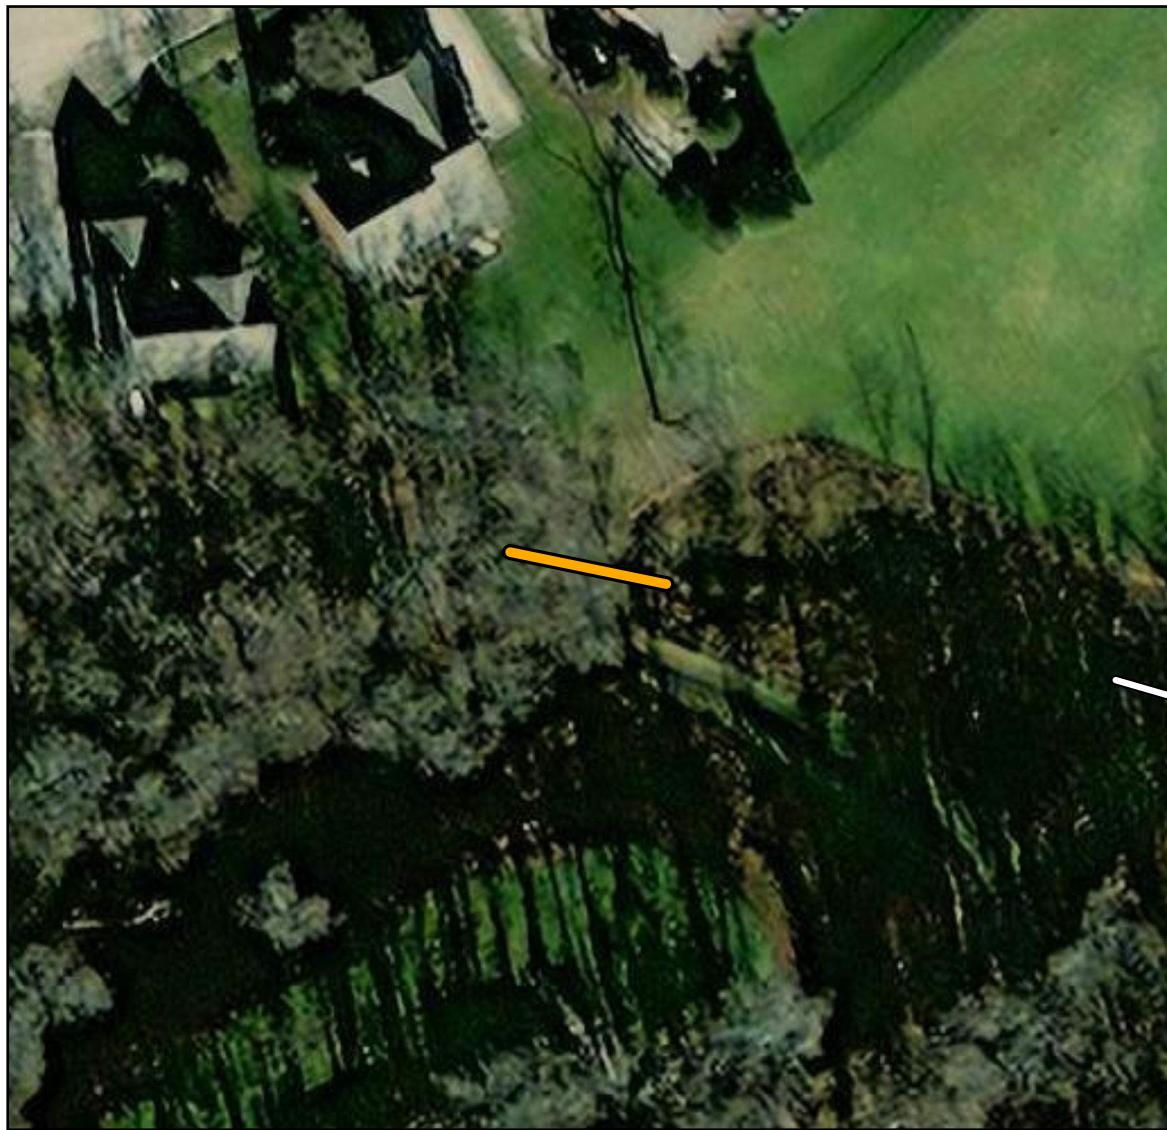
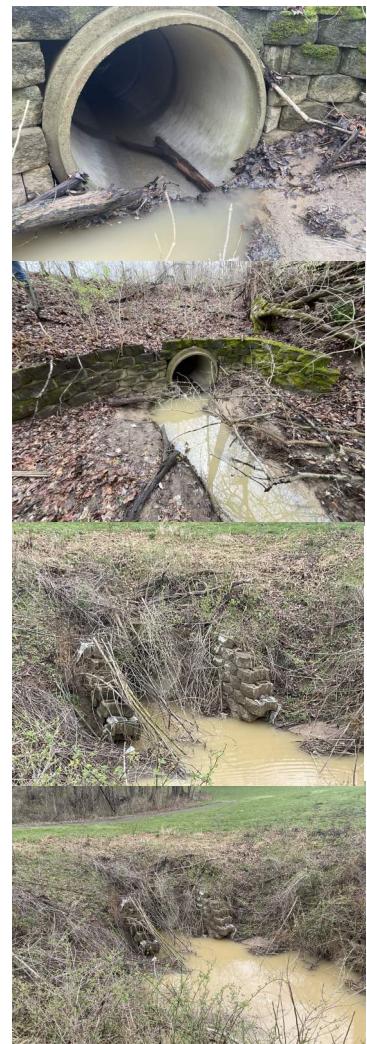
Culvert ID: A4_06

Structural Score: 2

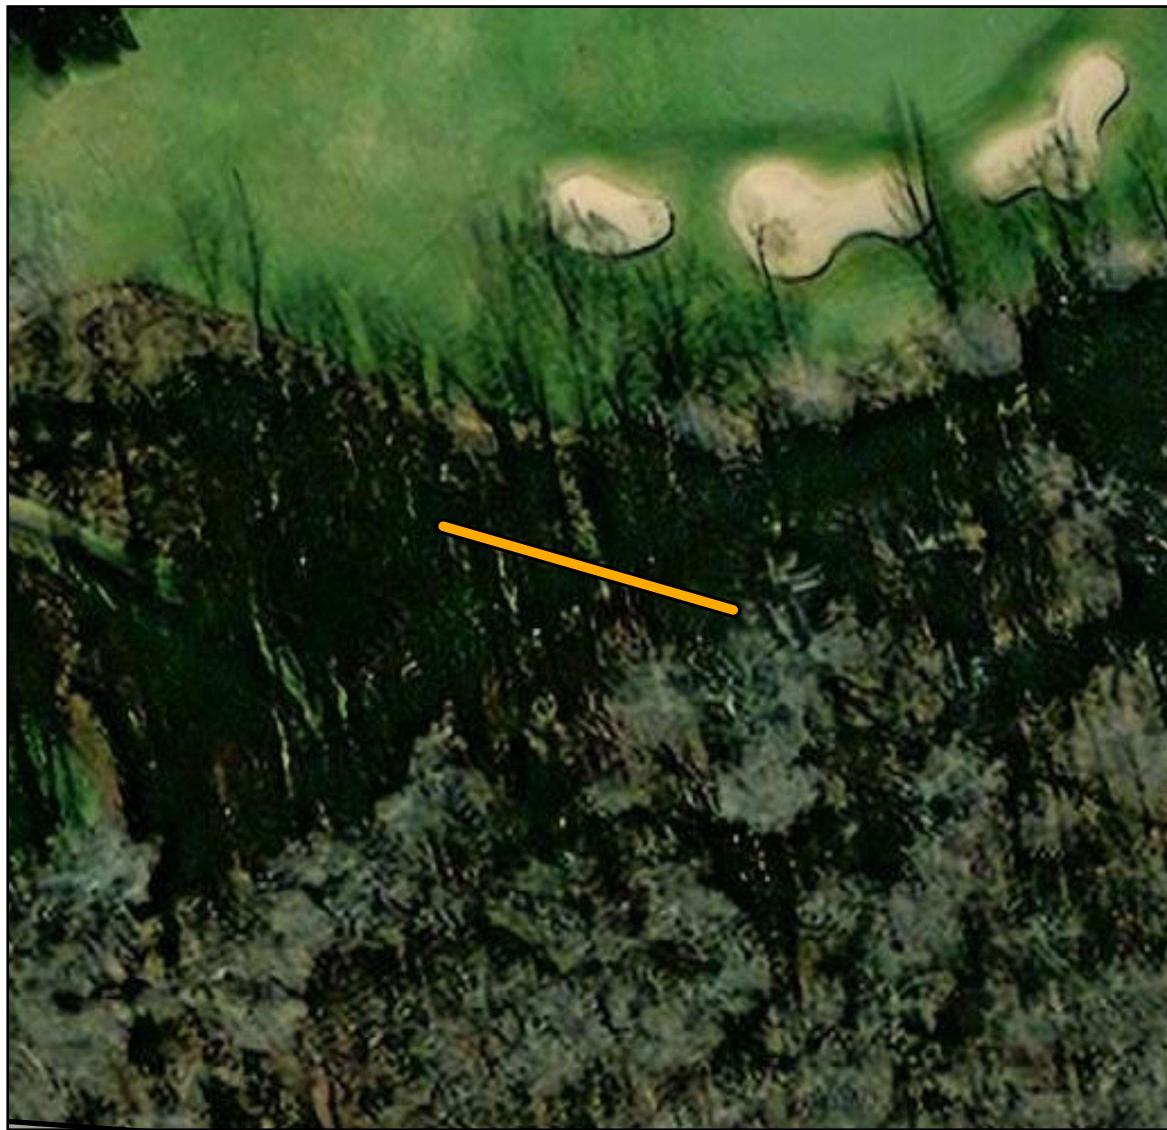
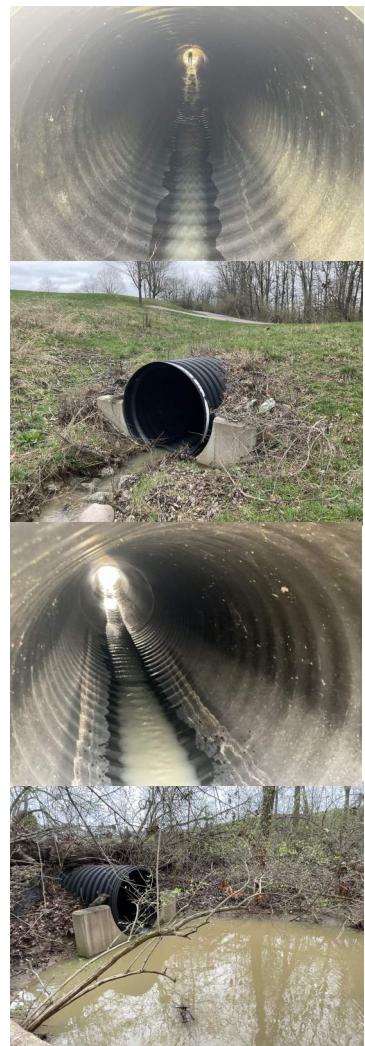
Culvert ID: A4_07

Structural Score: 2
