Project No. 10022676.00

City of Beavercreek Drainage Master Plan

City of Beavercreek

October 13, 2025

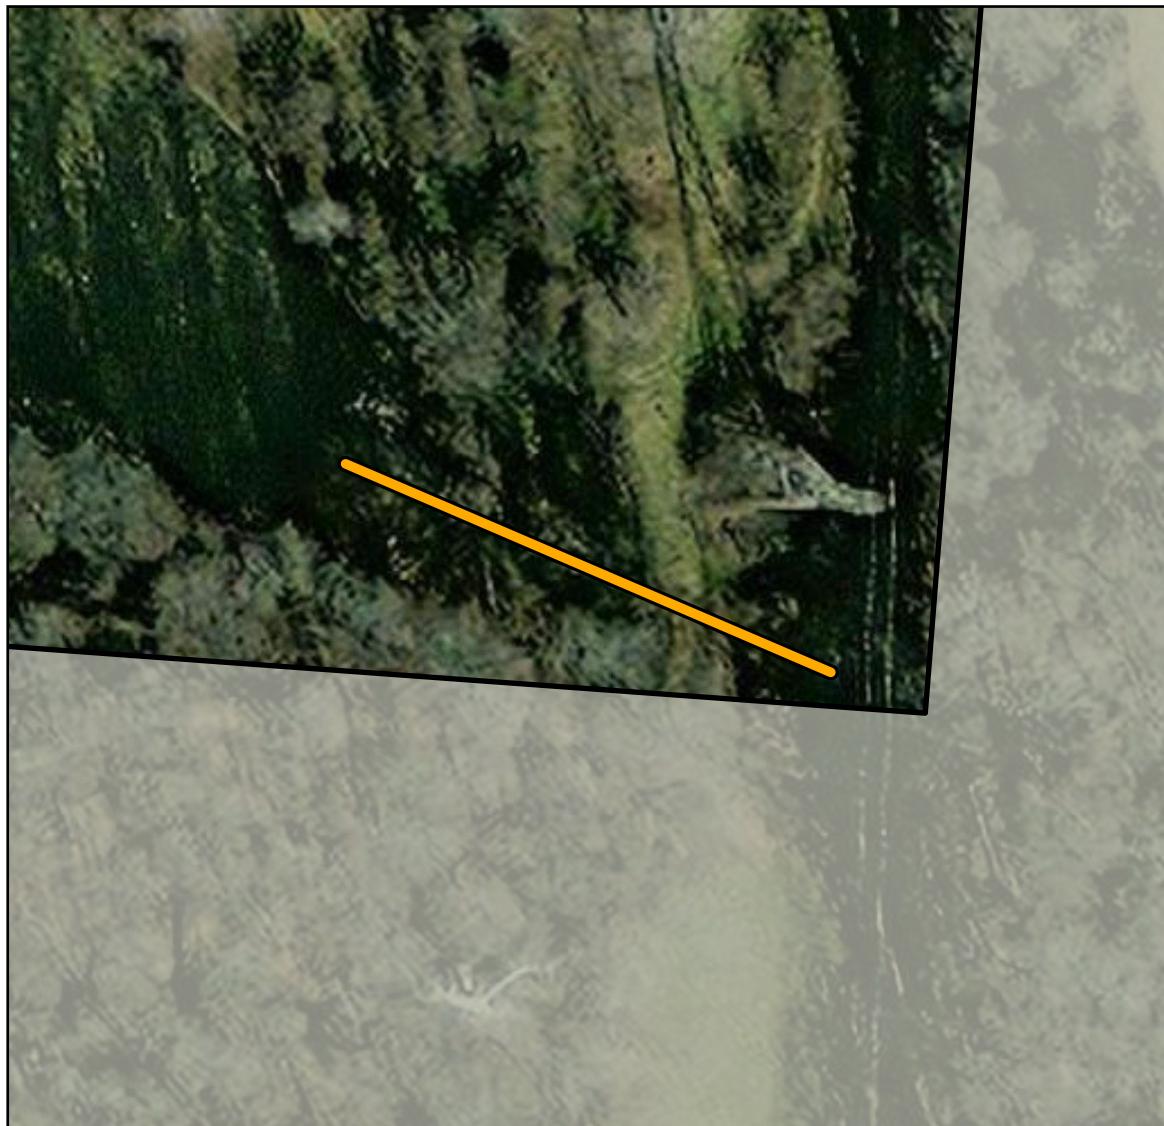
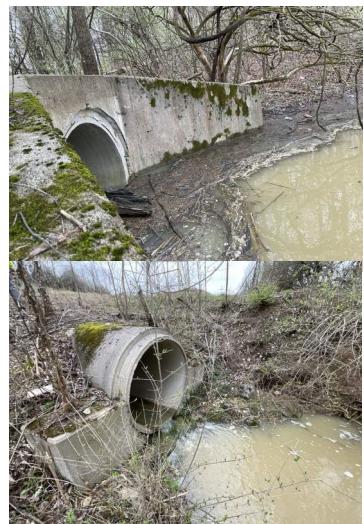
Culvert ID: A4_08

Structural Score: 2

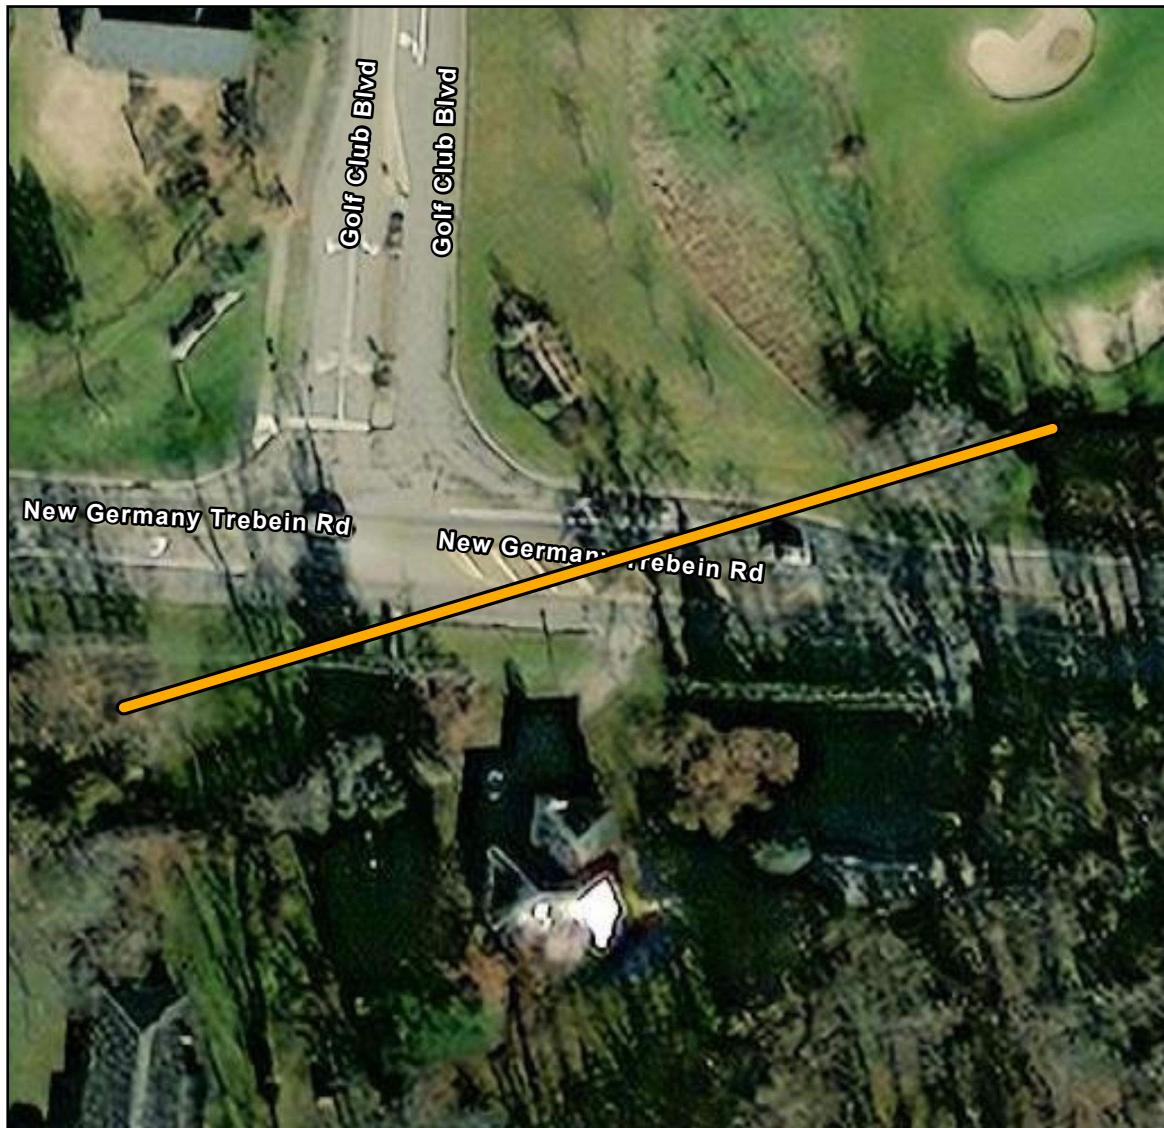
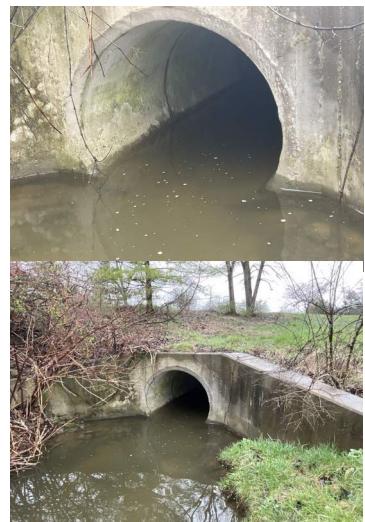
Culvert ID: A4_09

Structural Score: 2

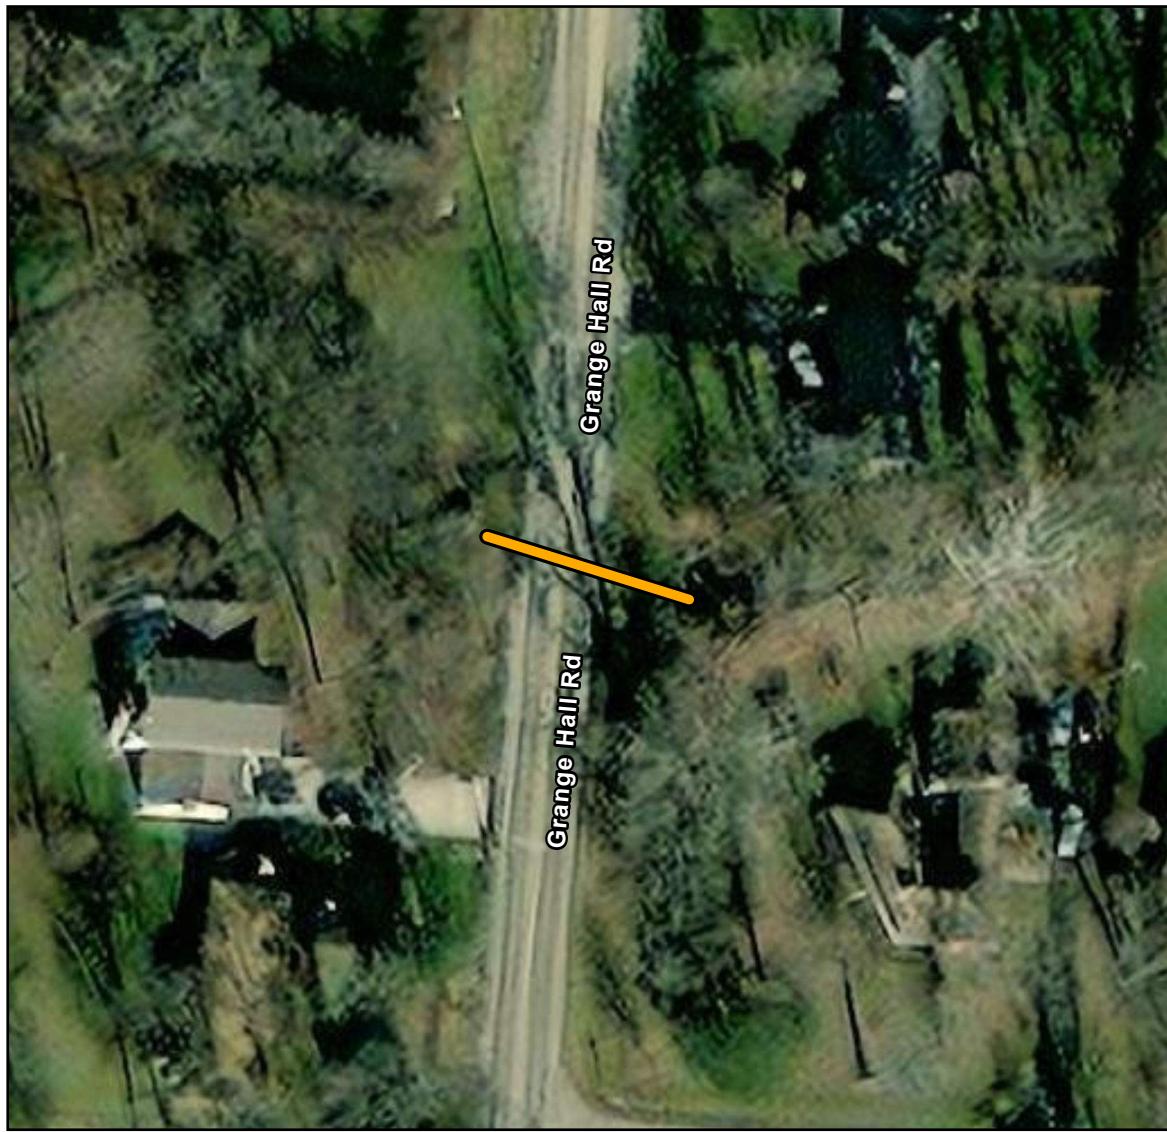
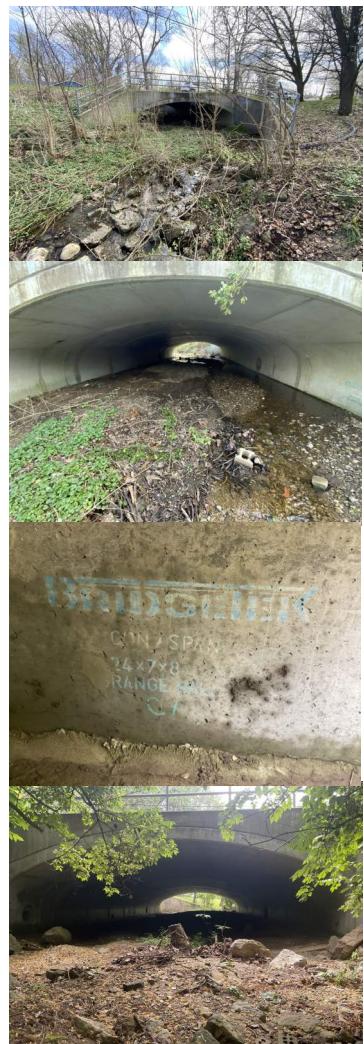
Culvert ID: A4_10

Structural Score: 1

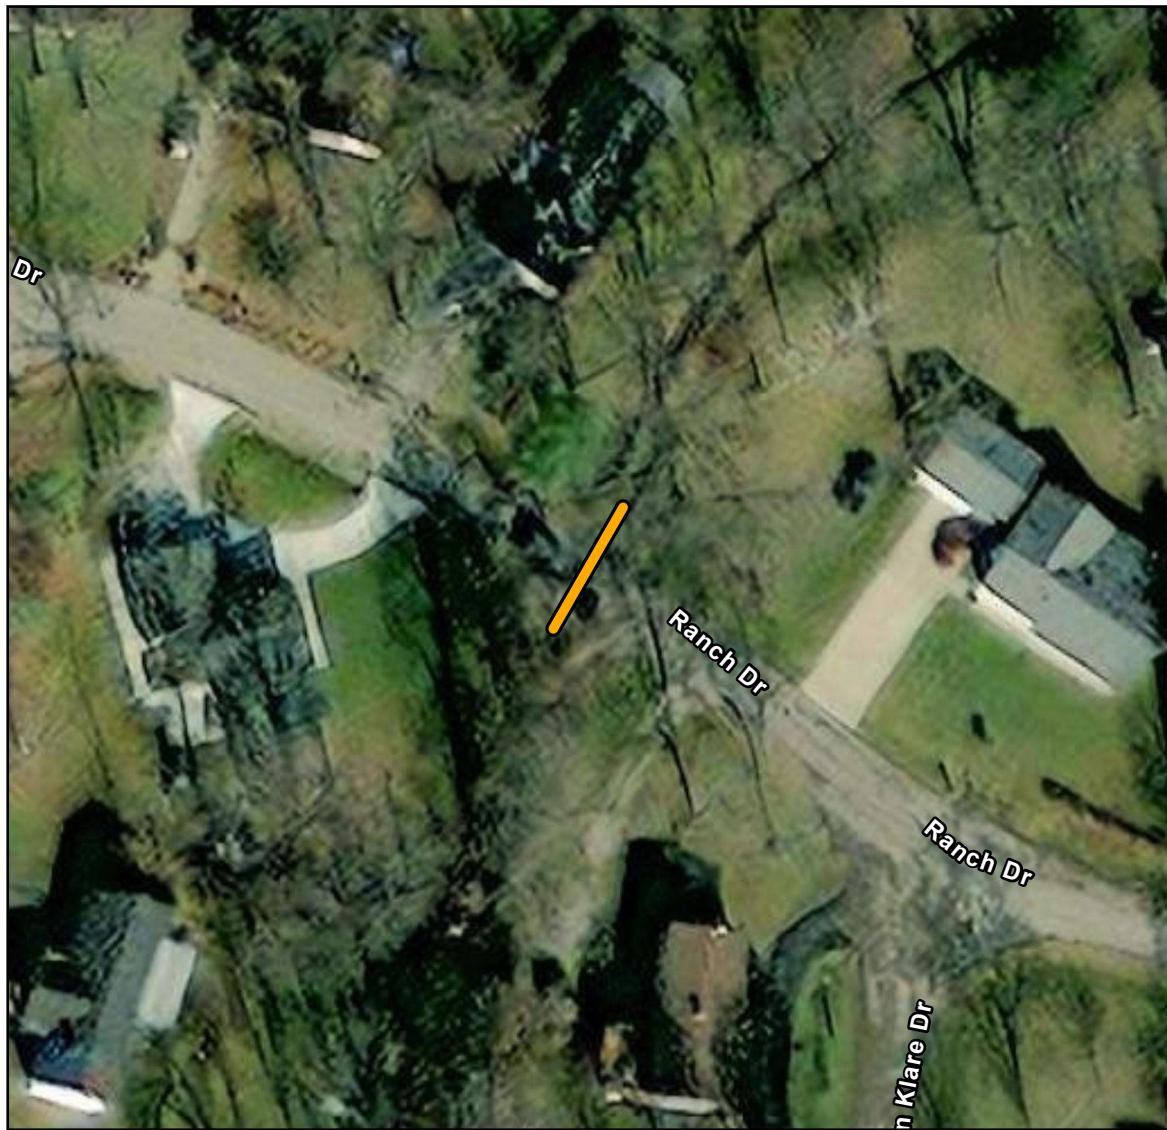
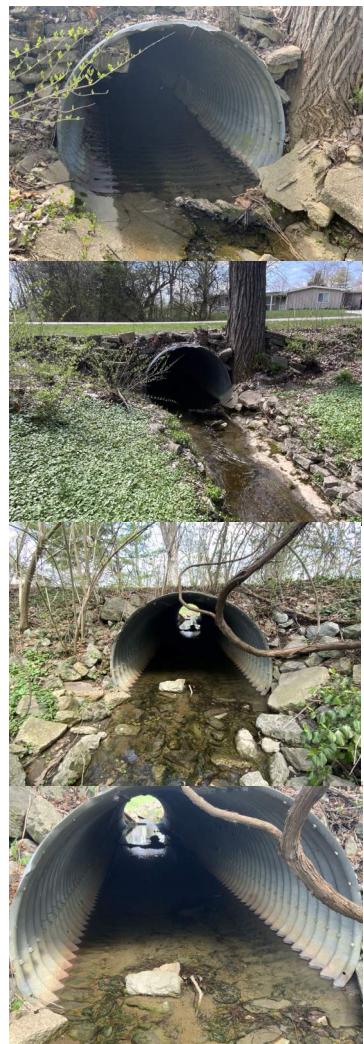
Culvert ID: B1_02

Structural Score: 1

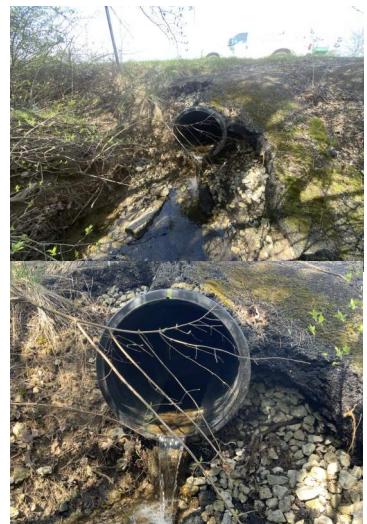
Culvert ID: B1_03

Structural Score: 2

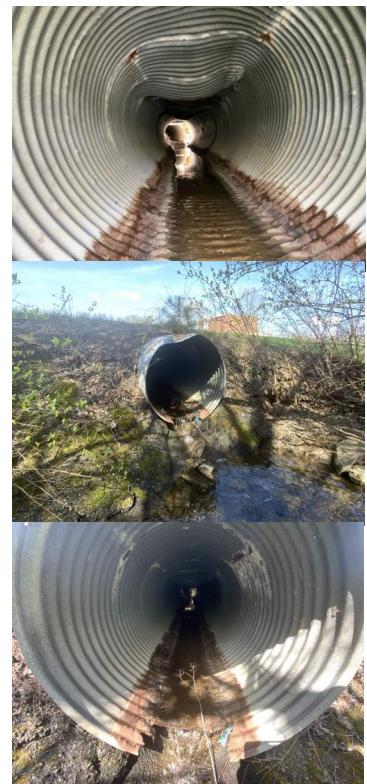
Culvert ID: B2_01

Structural Score: 2

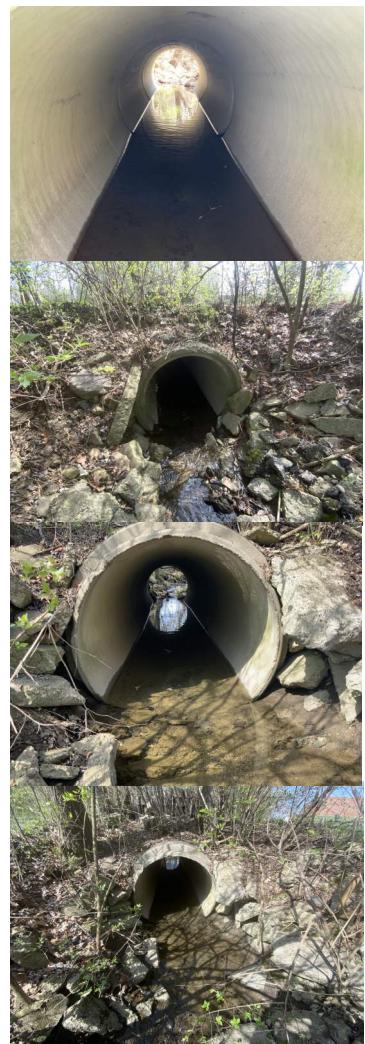
Culvert ID: B2_02

Structural Score: 3

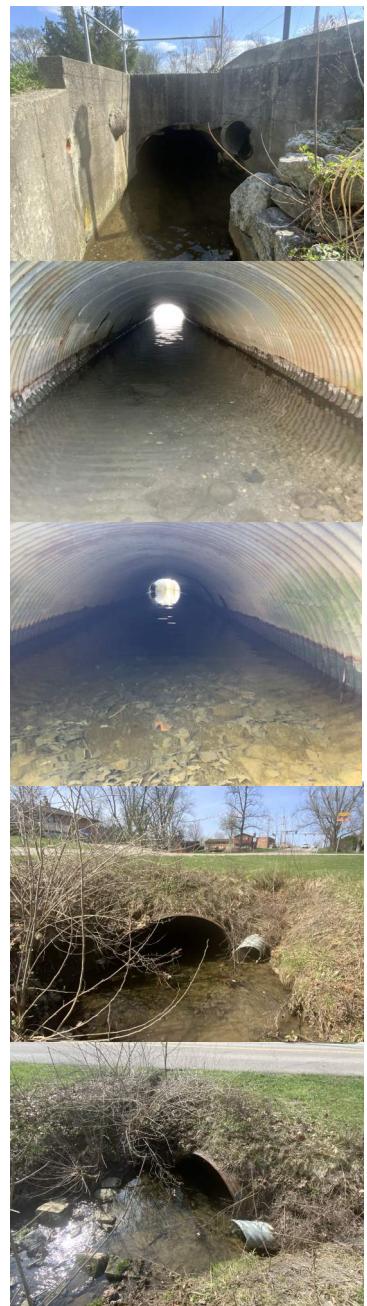
Culvert ID: B2_04

Structural Score: 2

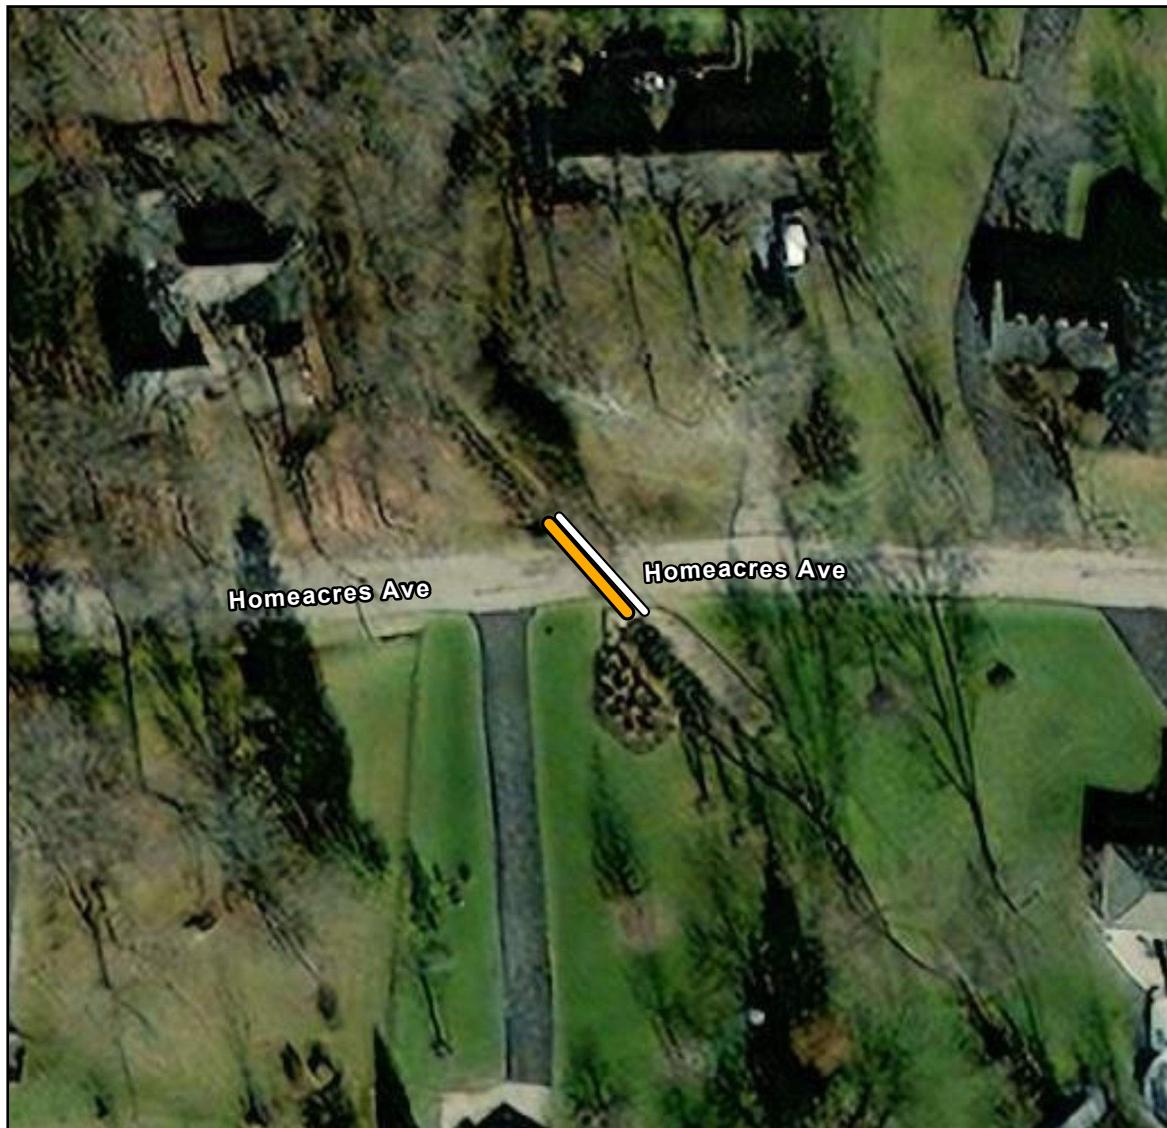
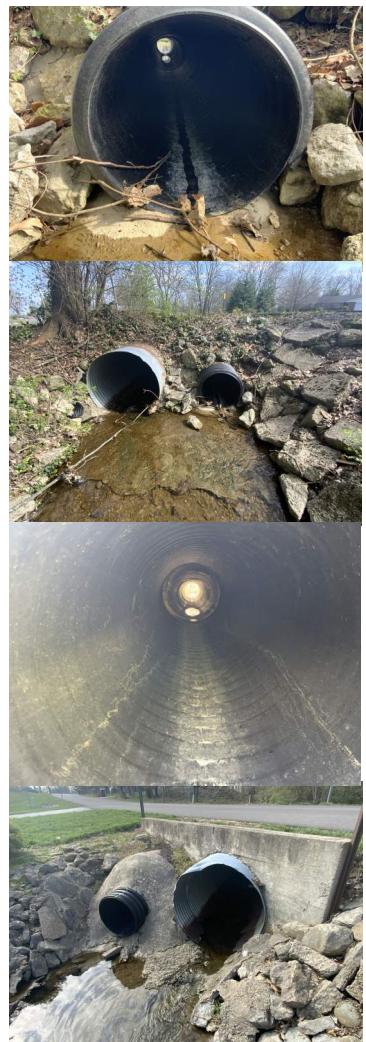
Culvert ID: B2_05

Structural Score: 1

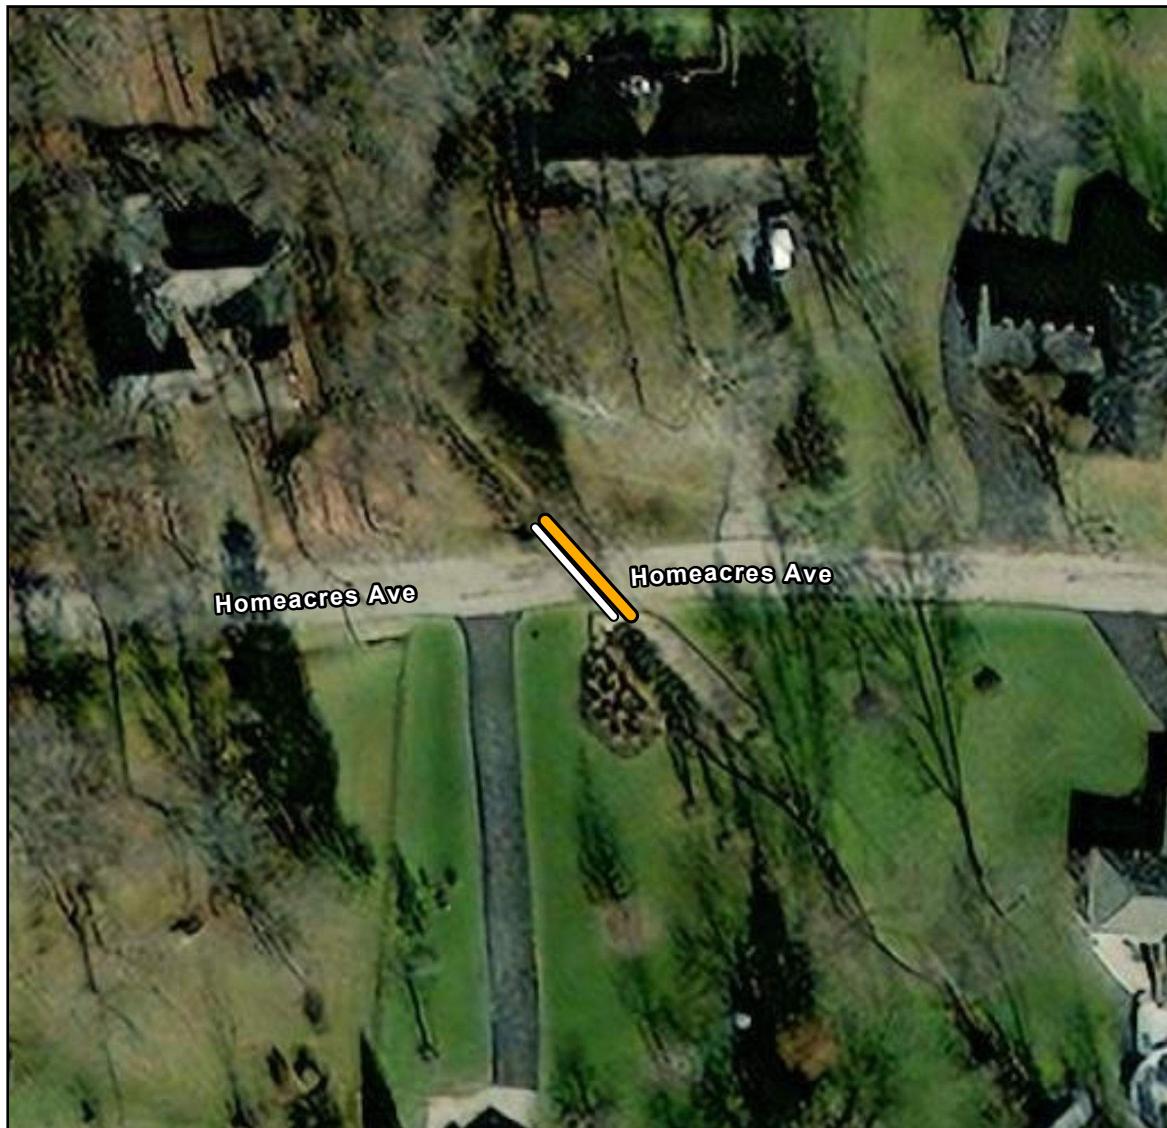
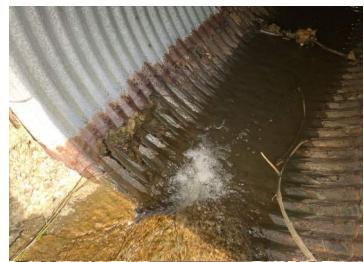
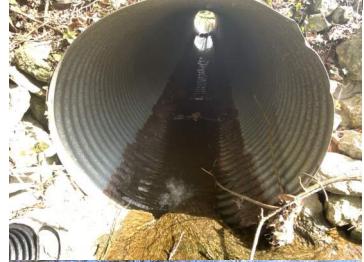
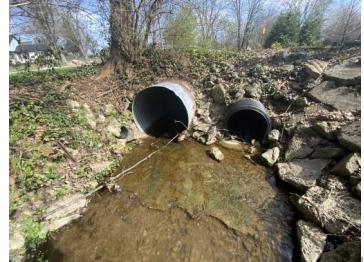
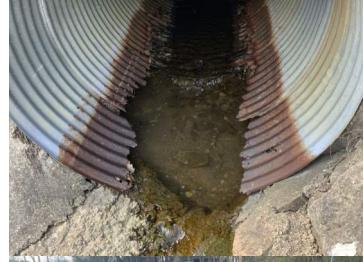
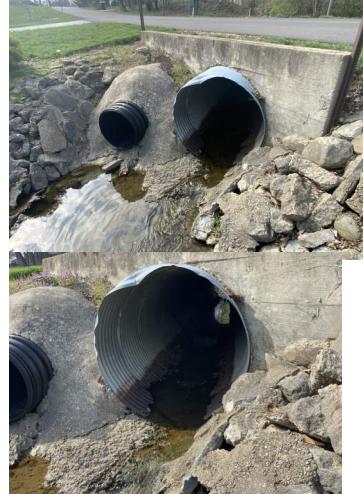
Culvert ID: B2_06

Structural Score: 3

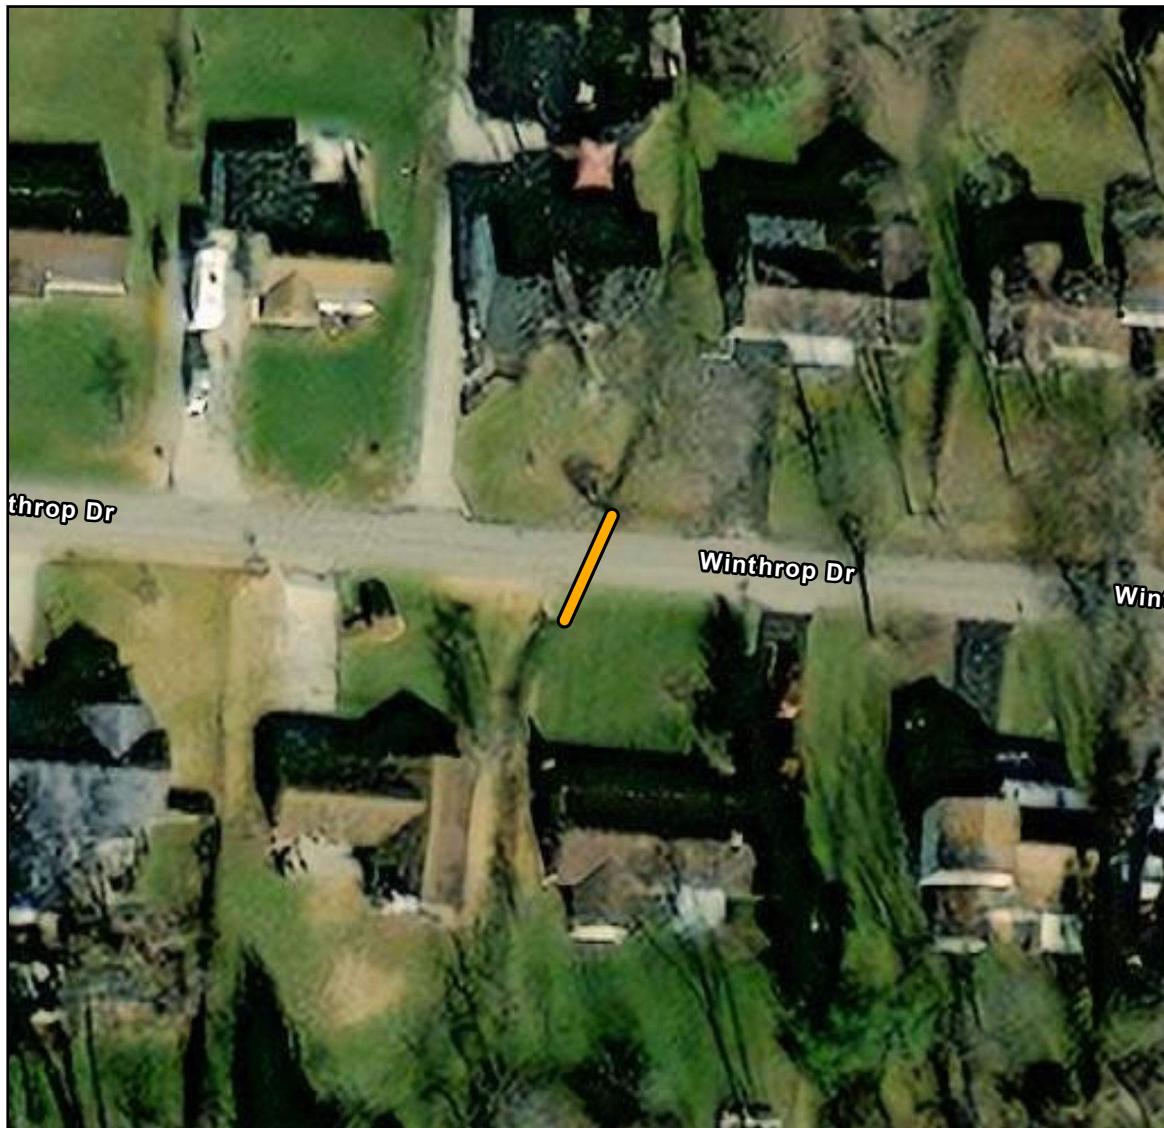
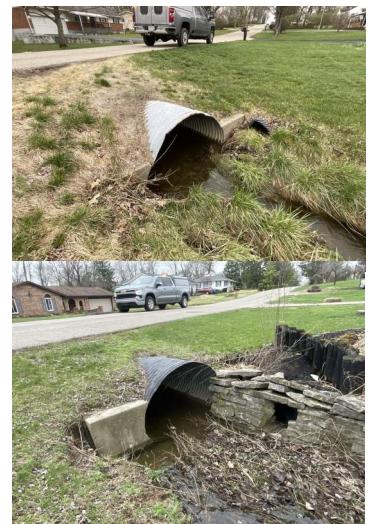
Culvert ID: B2_07

Structural Score: 2

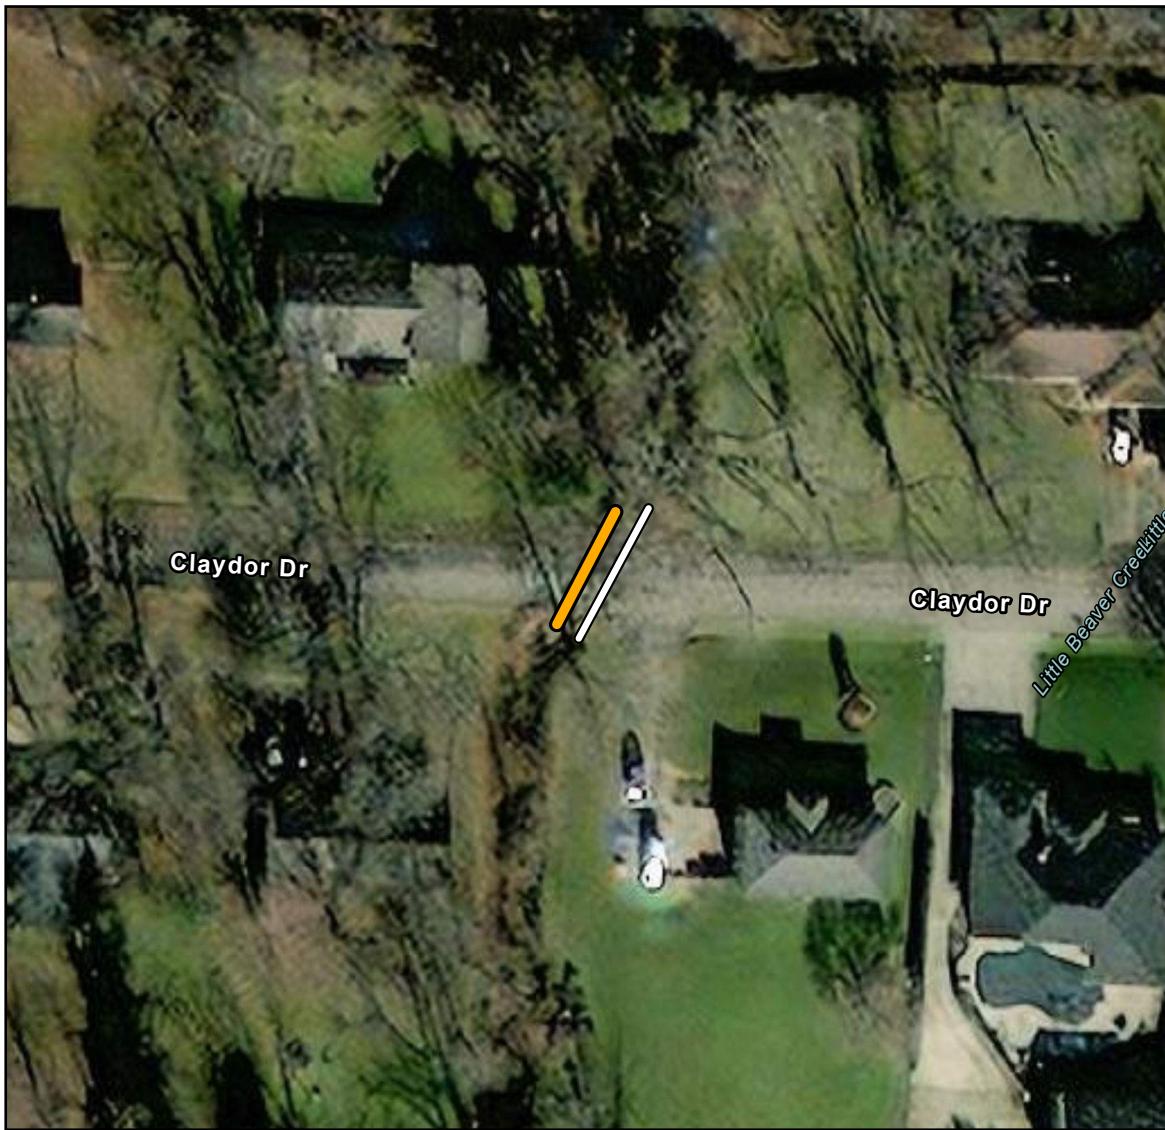
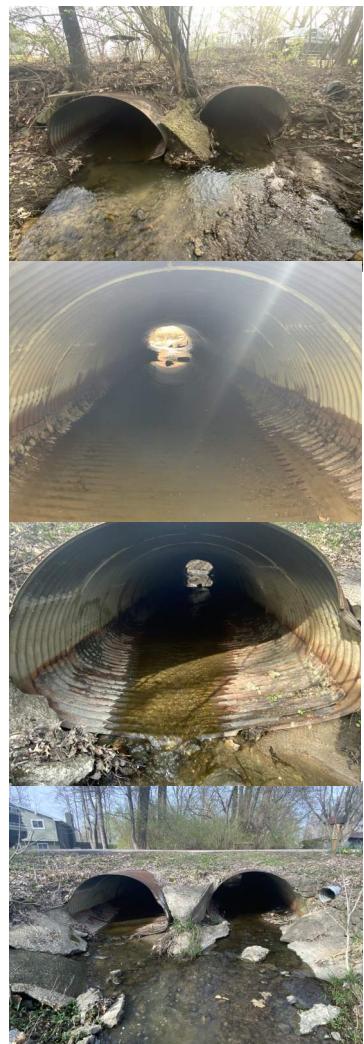
Culvert ID: B2_08

Structural Score: 1

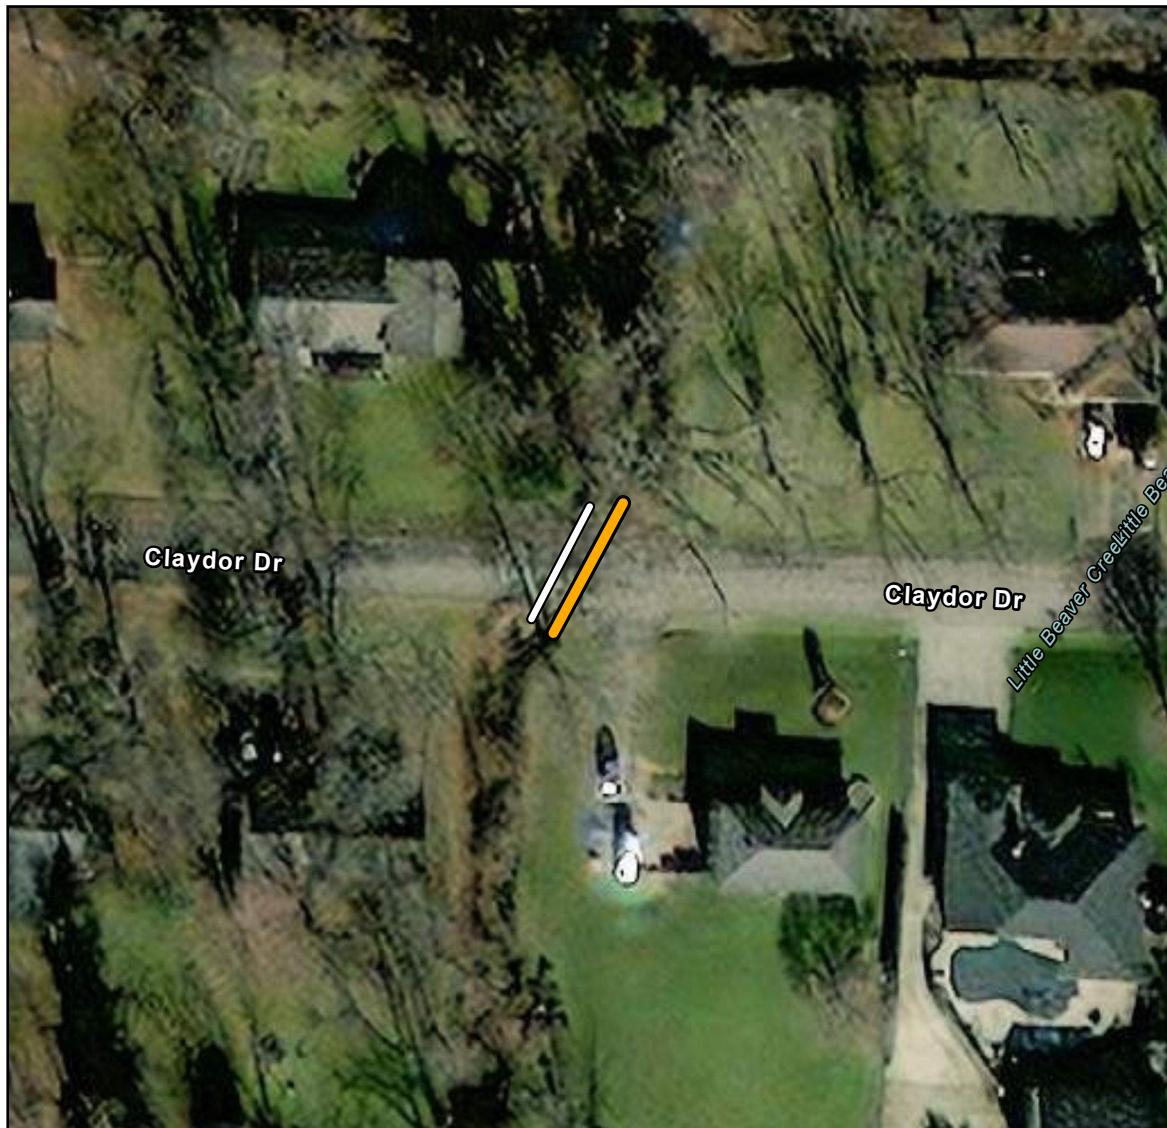
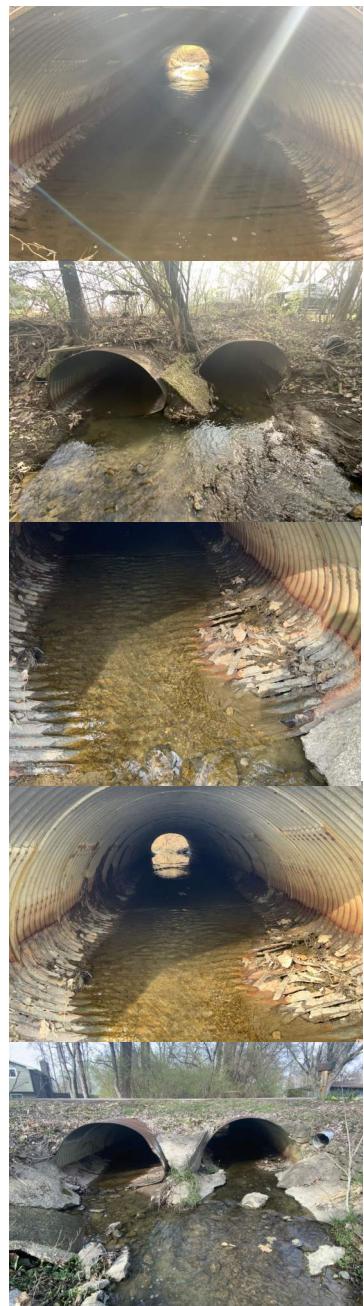
Culvert ID: B2_09

Structural Score: 2

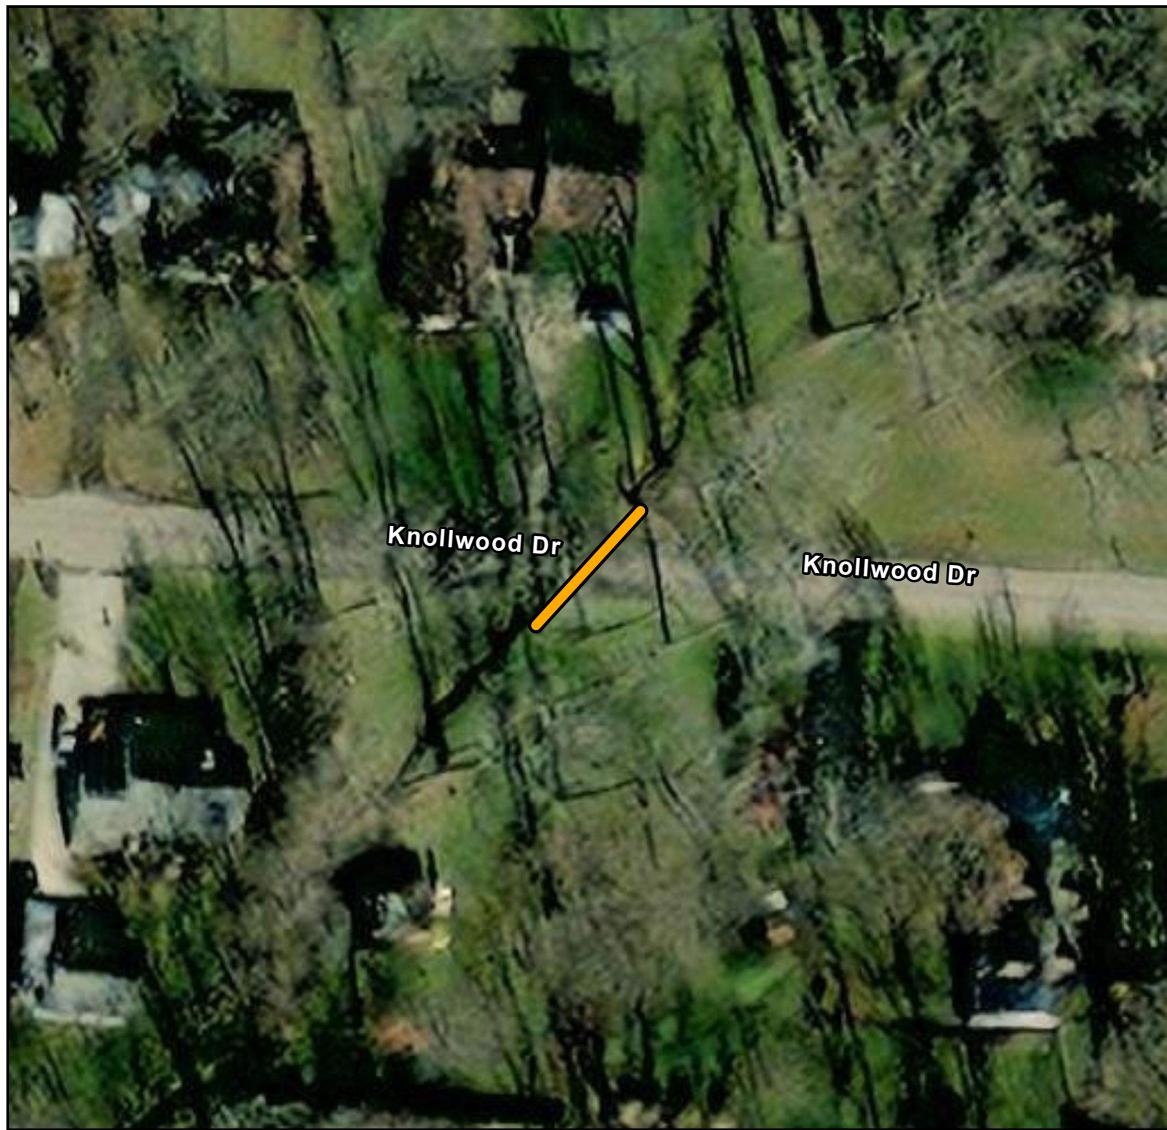
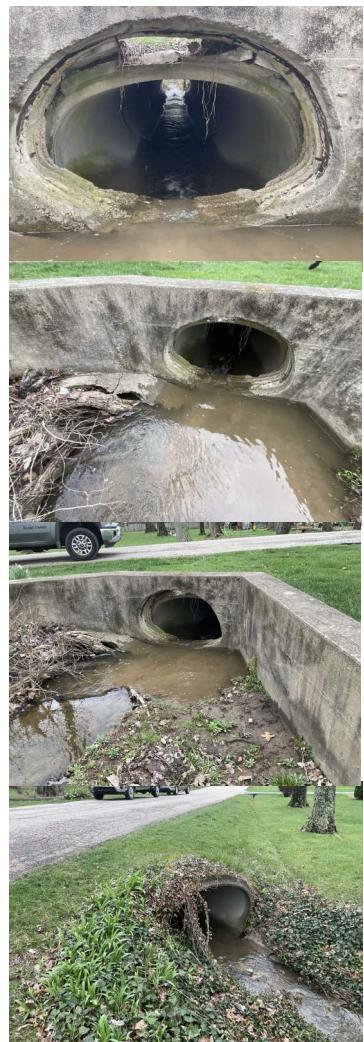
Culvert ID: B2_10

Structural Score: 3

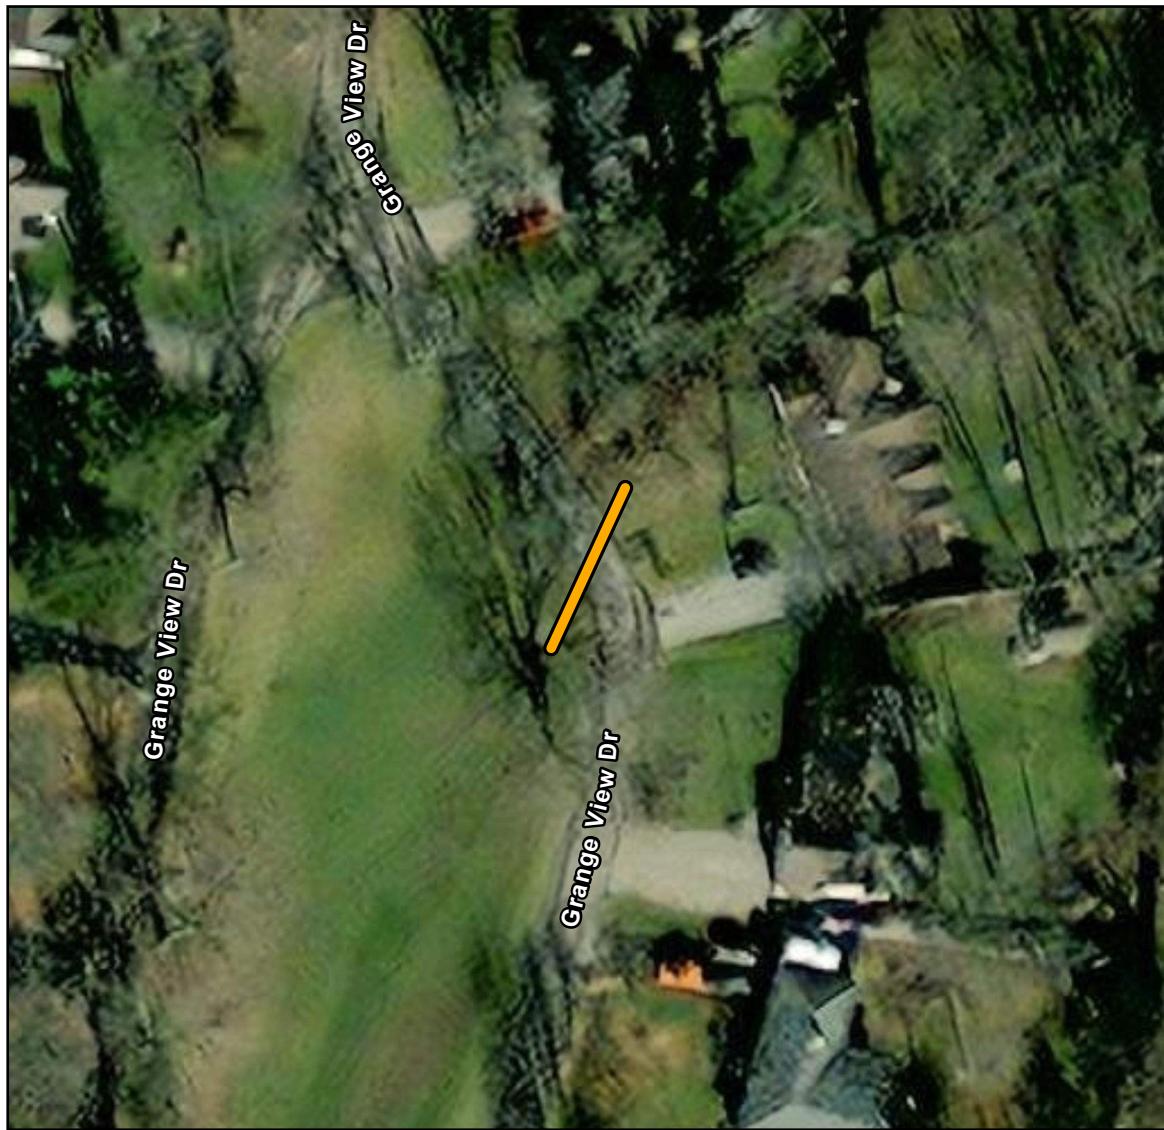
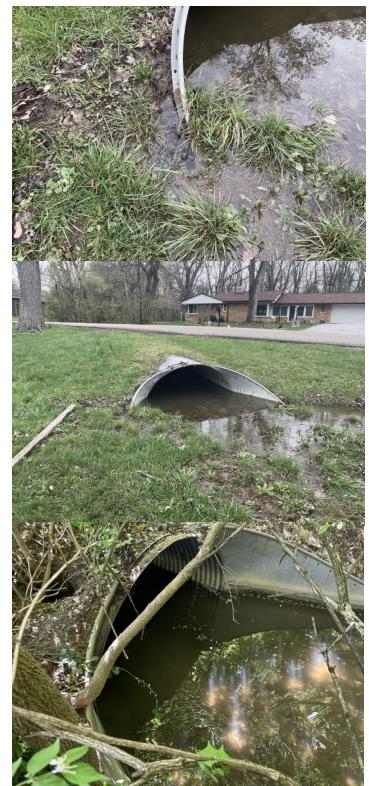
Culvert ID: B2_11

Structural Score: 2

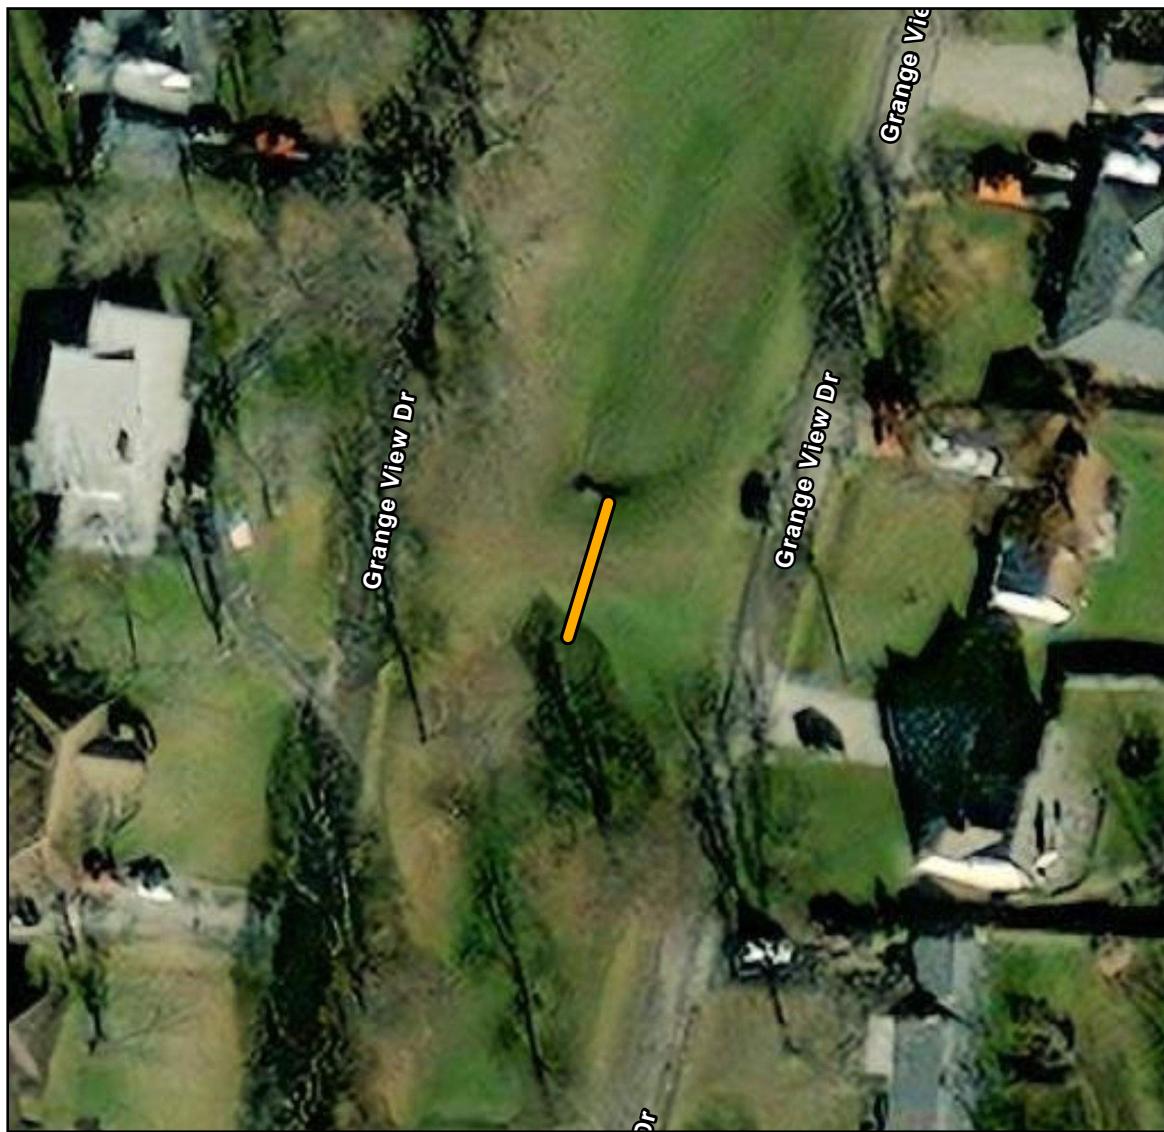
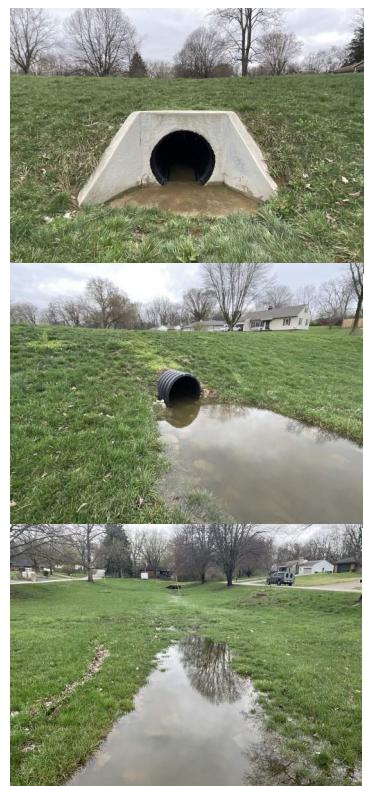
Culvert ID: B2_12

Structural Score: 1

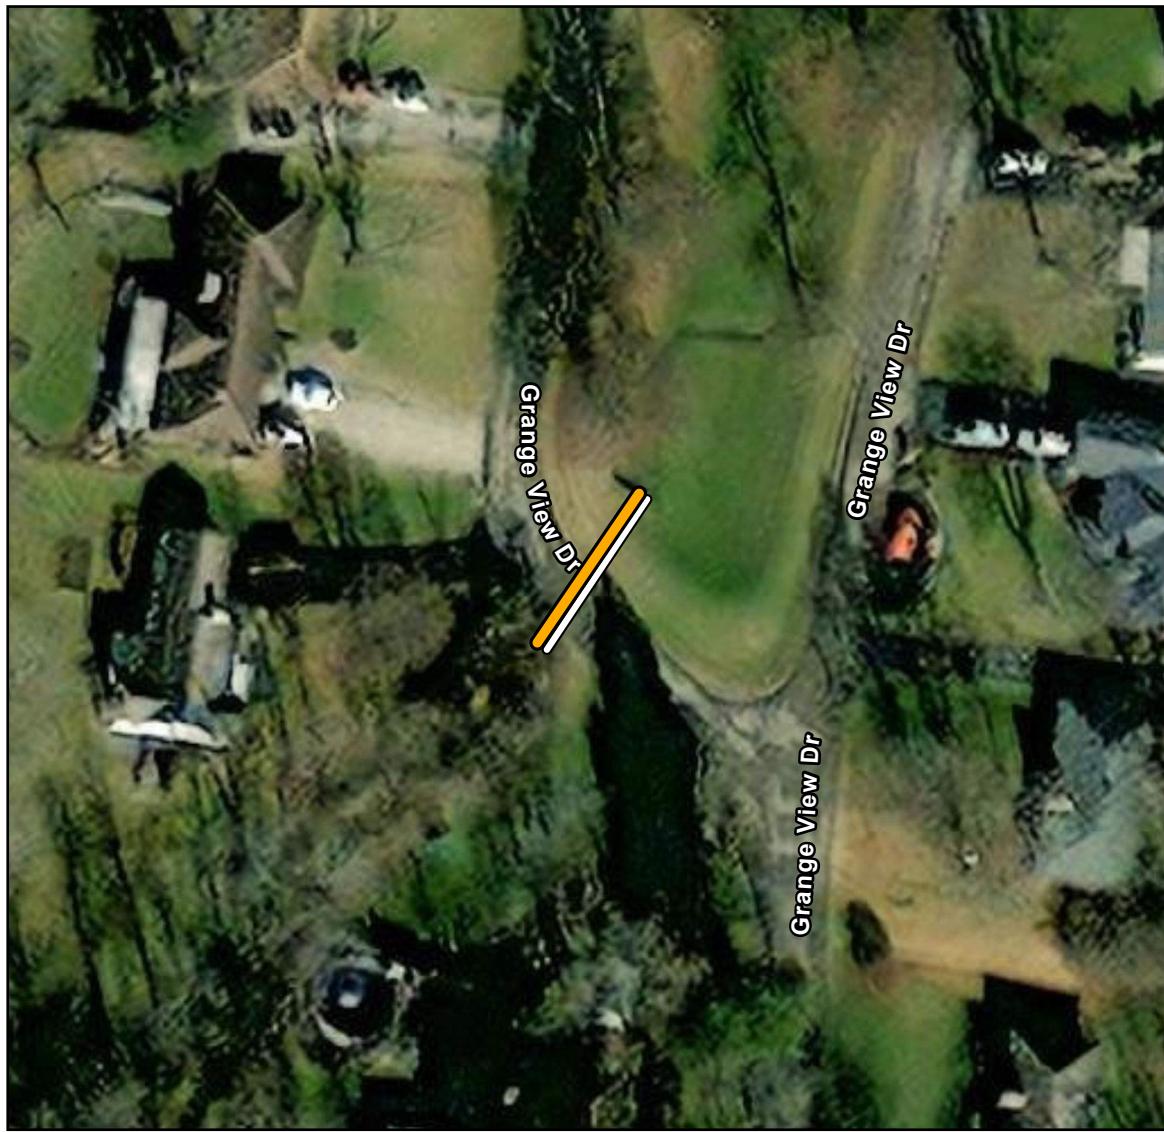
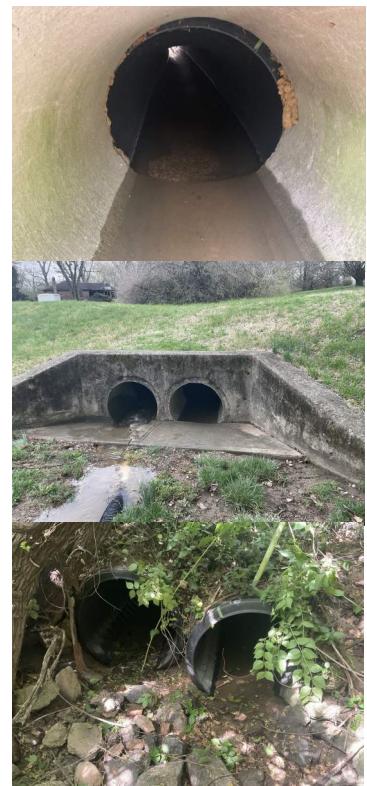
Culvert ID: B2_13

Structural Score: 2
