Project No. 10022676.00

City of Beavercreek Drainage Master Plan

City of Beavercreek

October 13, 2025

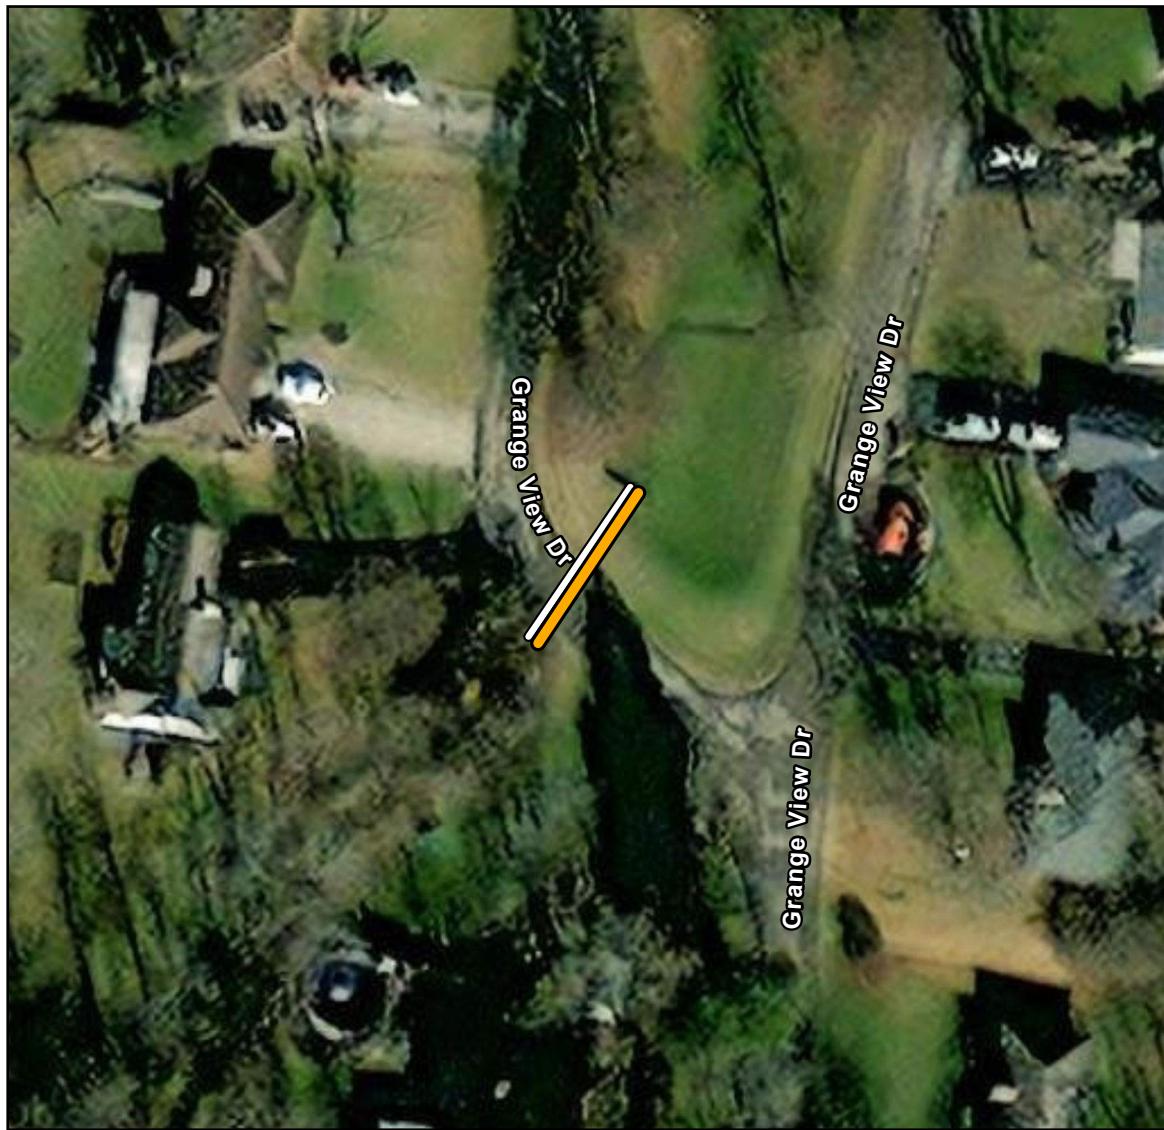
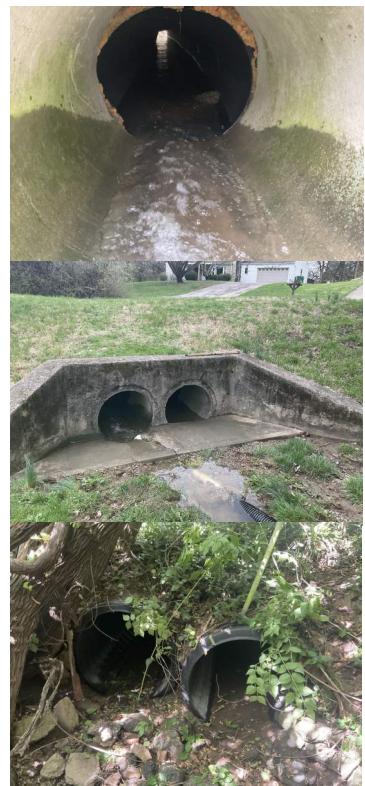
Culvert ID: B2_14

Structural Score: 2

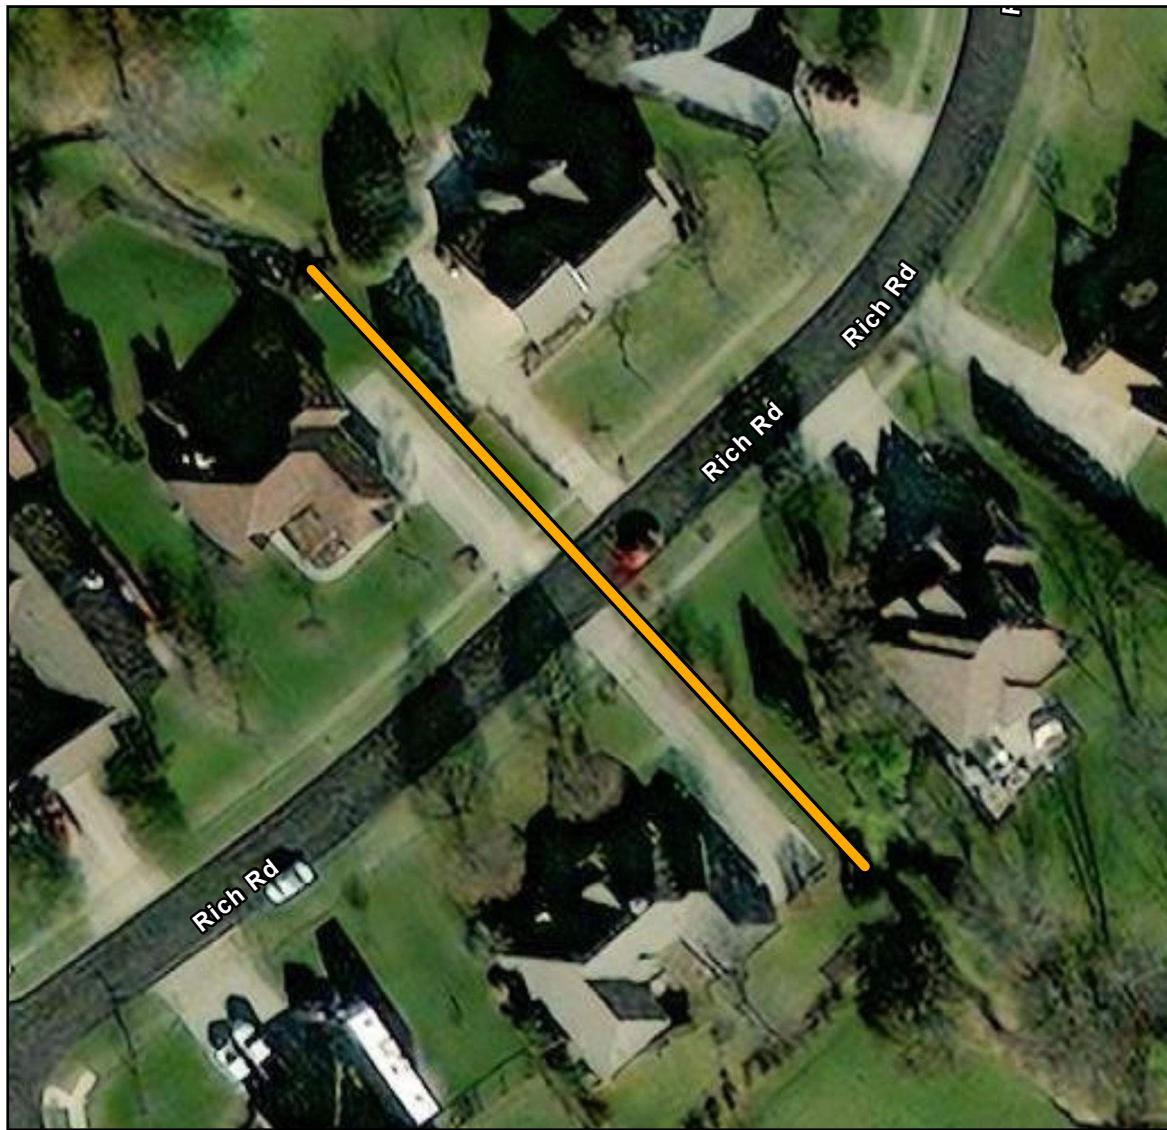
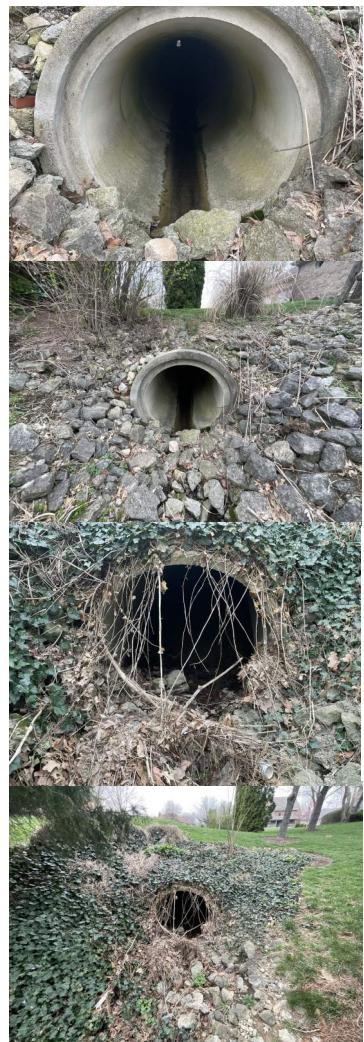
Culvert ID: B2_15

Structural Score: 1

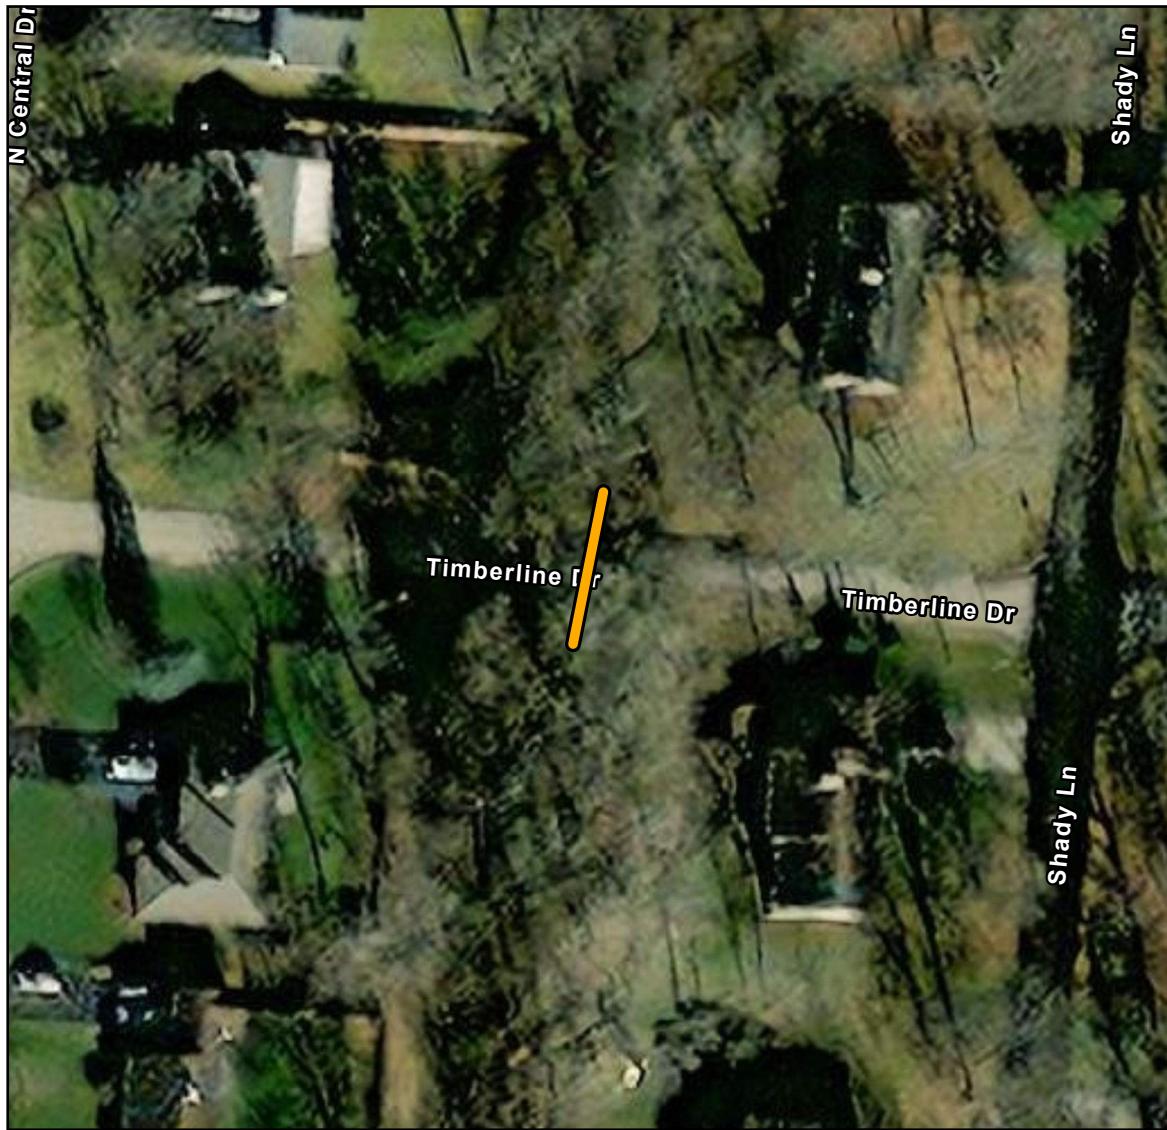
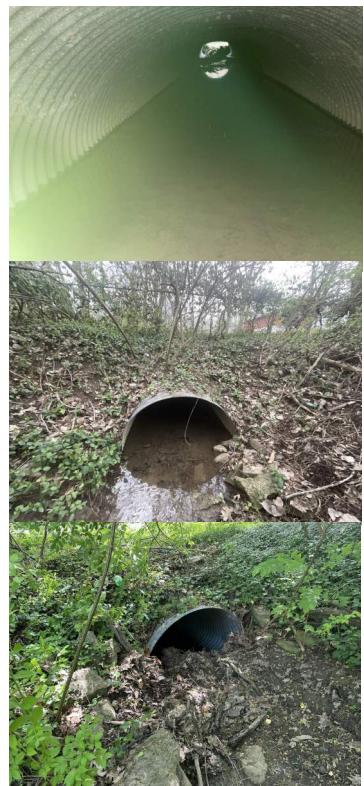
Culvert ID: B2_16

Structural Score: 2

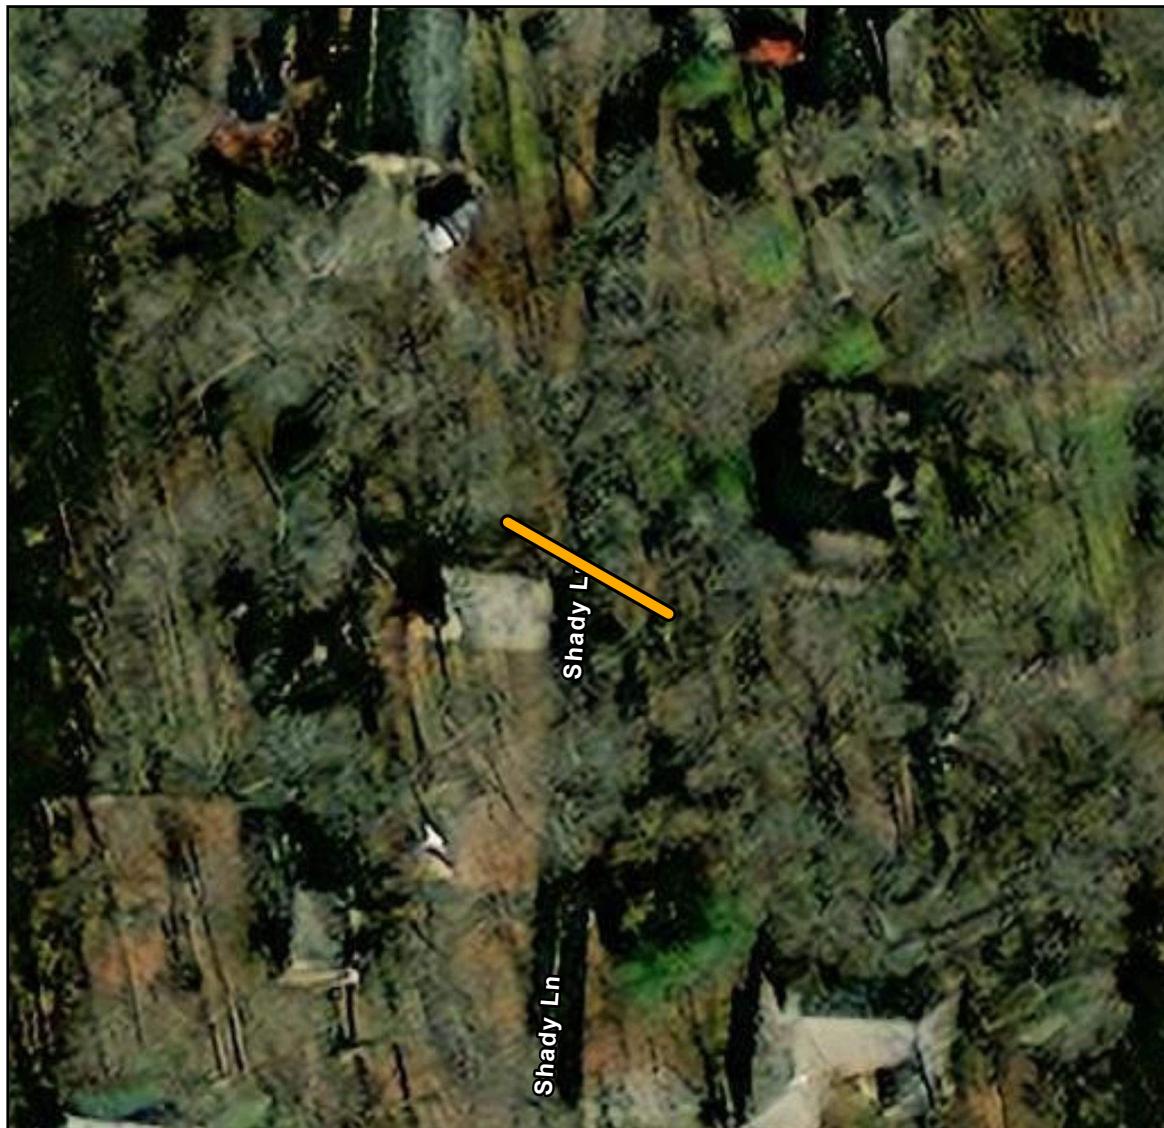
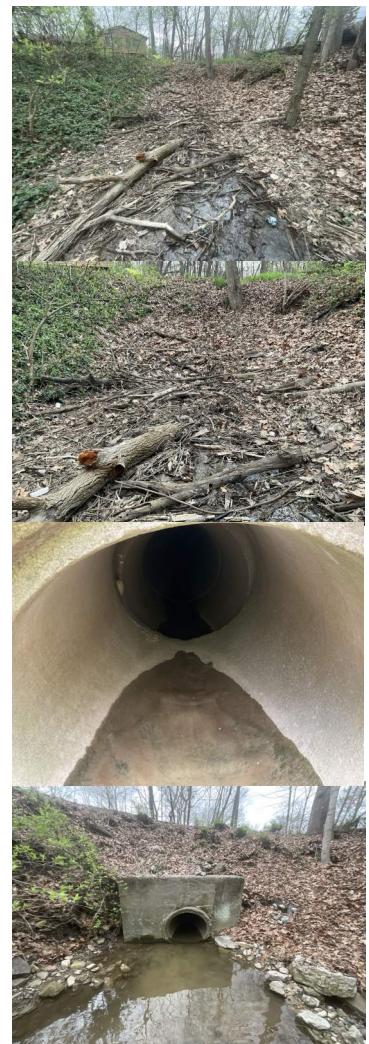
Culvert ID: B2_17

Structural Score: 3

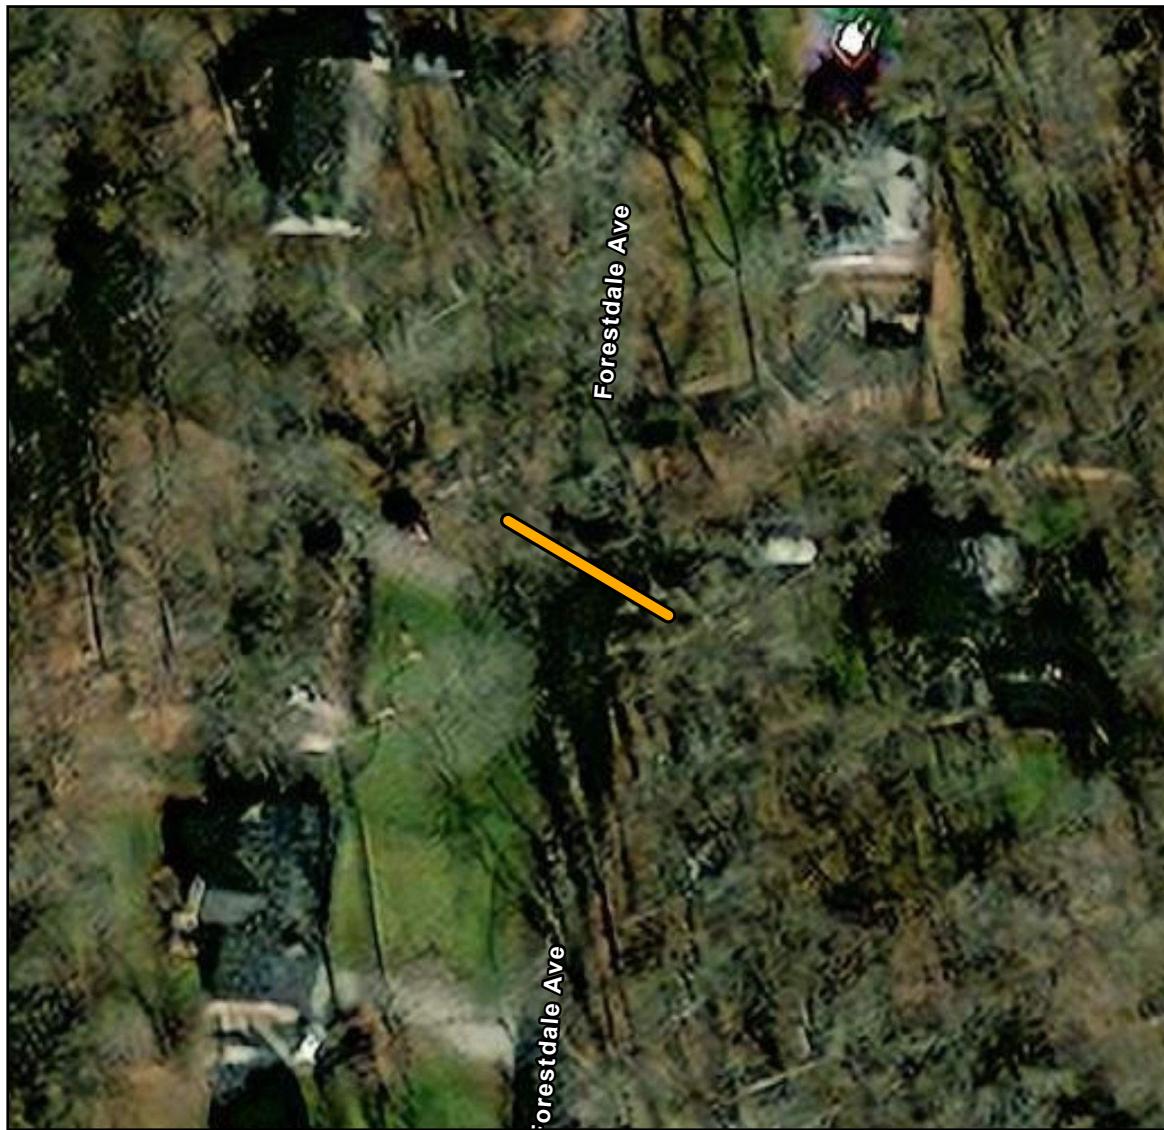
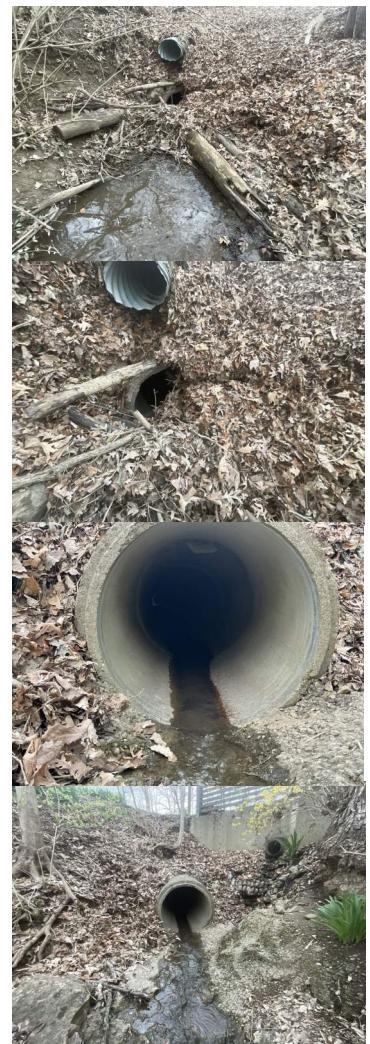
Culvert ID: B2_18

Structural Score: 2

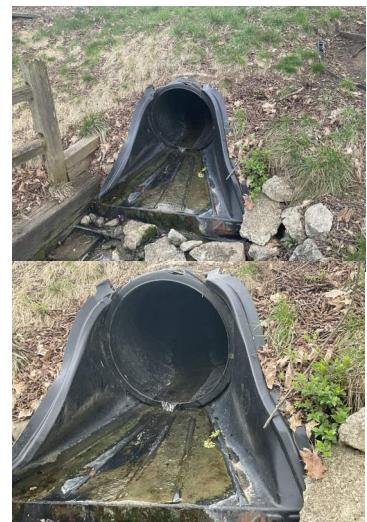
Culvert ID: B2_19

Structural Score: 2

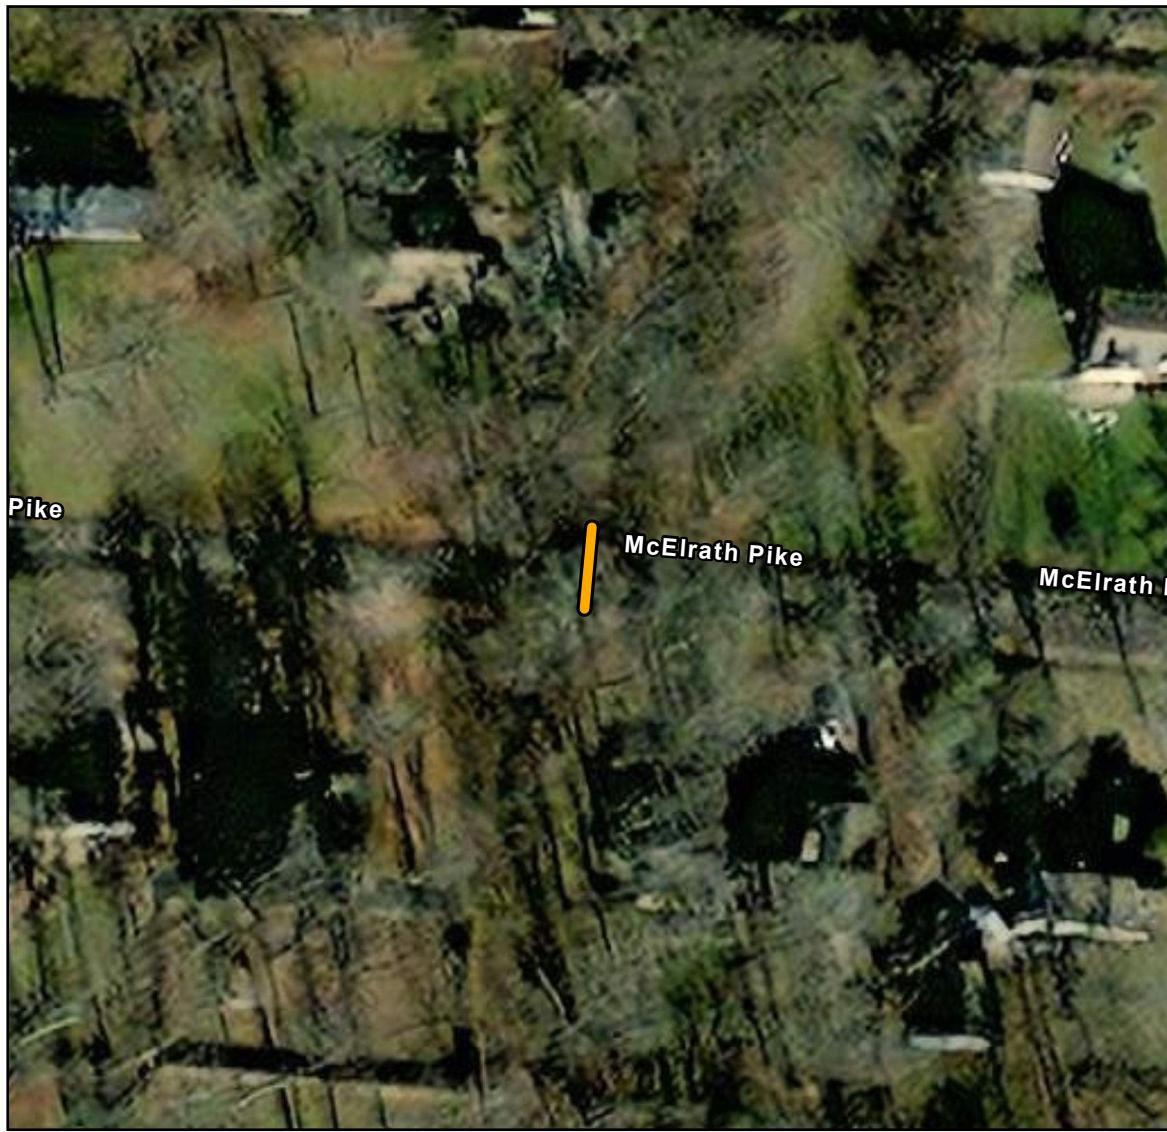
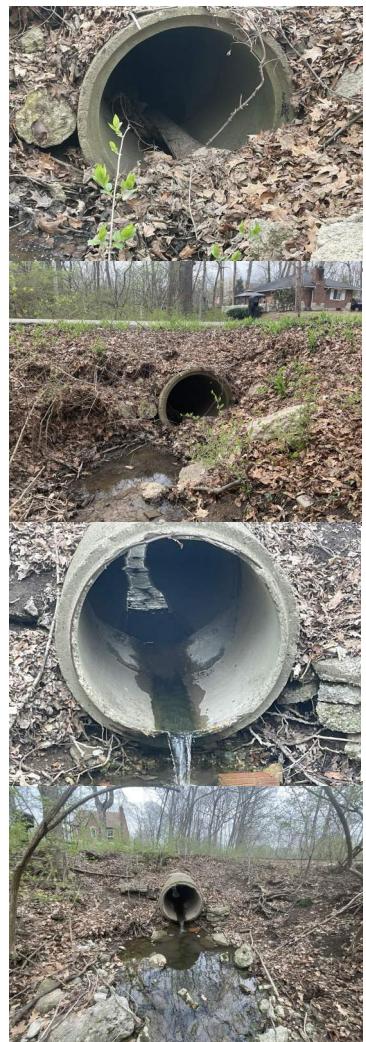
Culvert ID: B2_20

Structural Score: 2

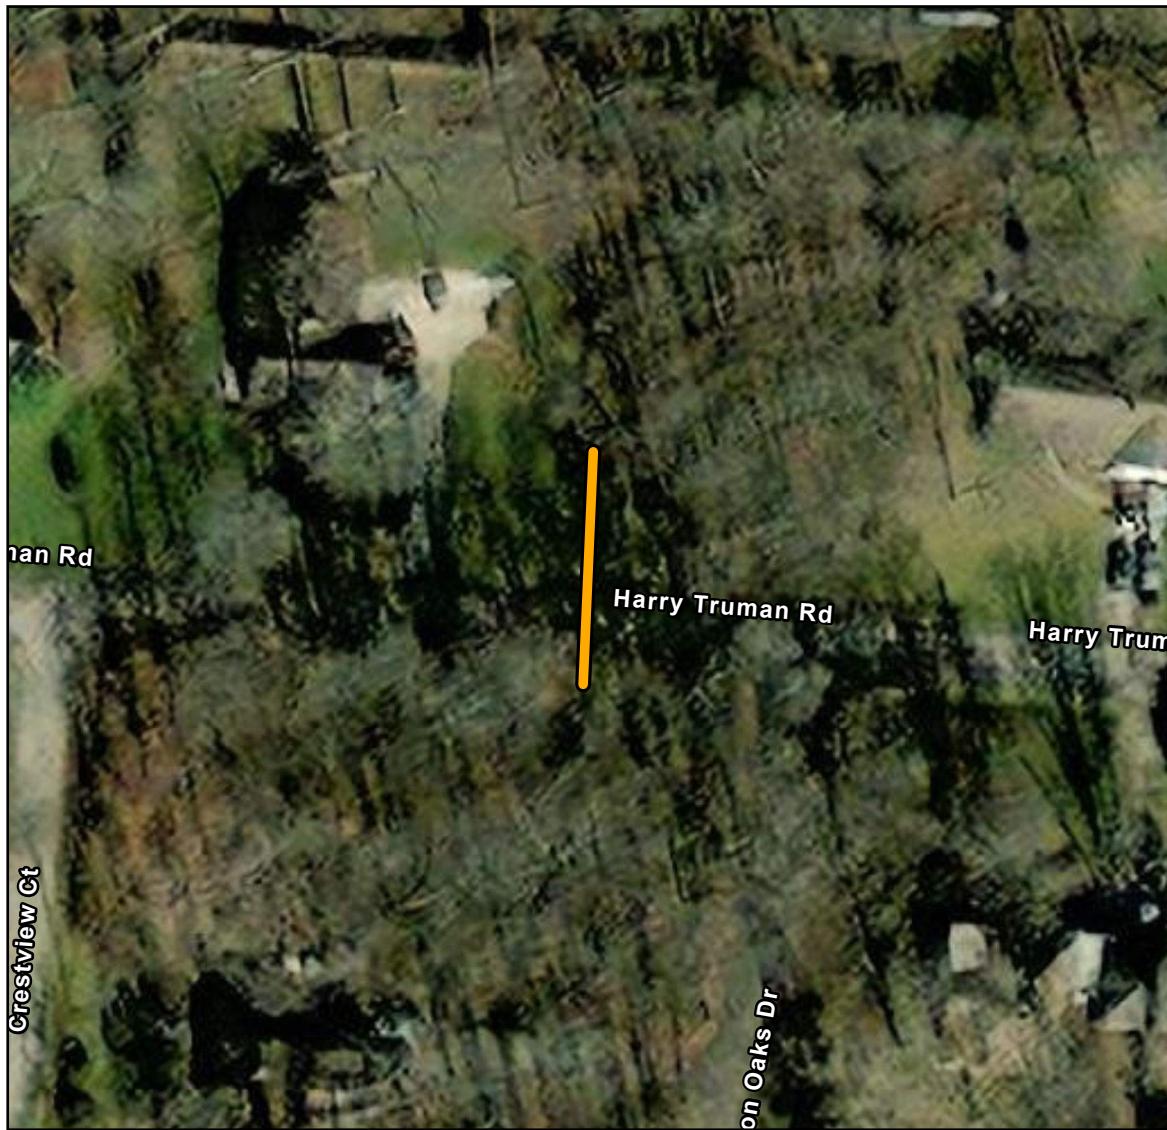
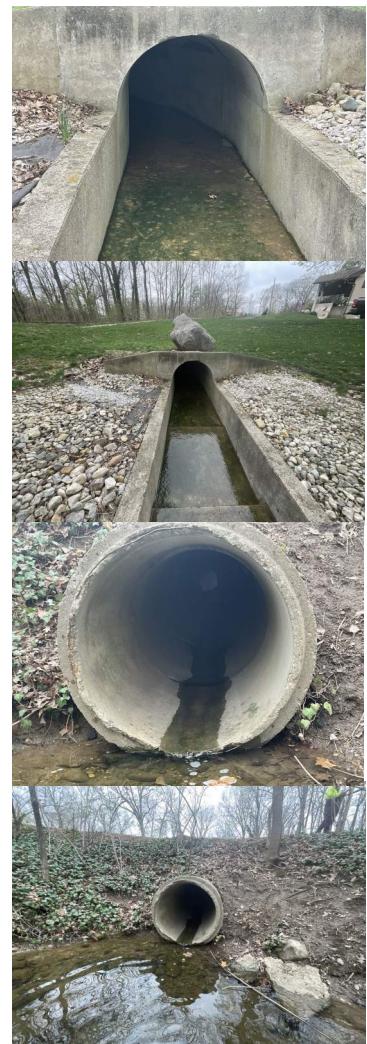
Culvert ID: B2_21

Structural Score: 2

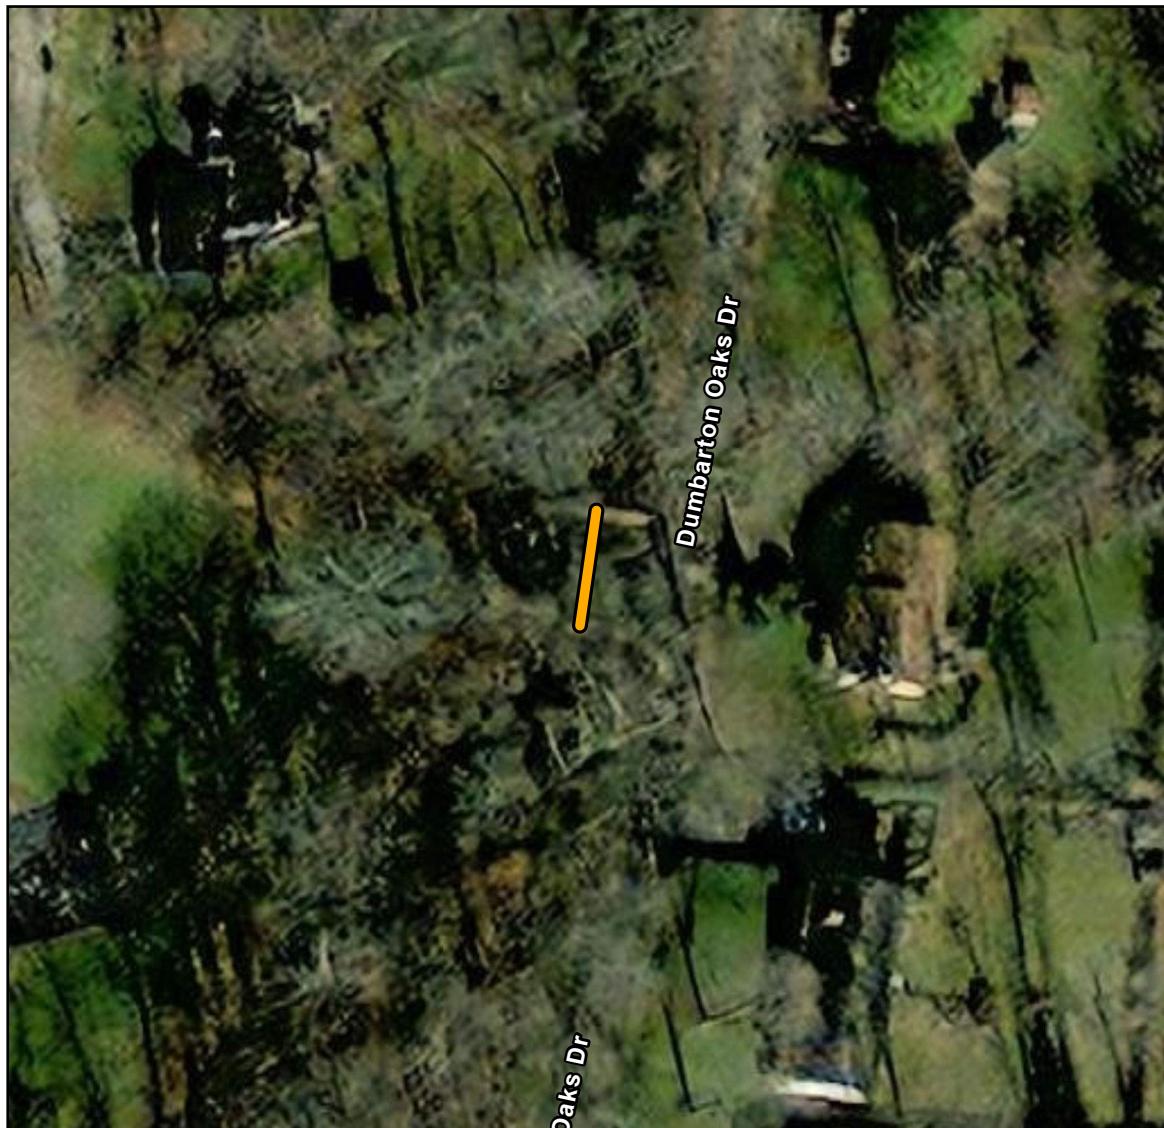
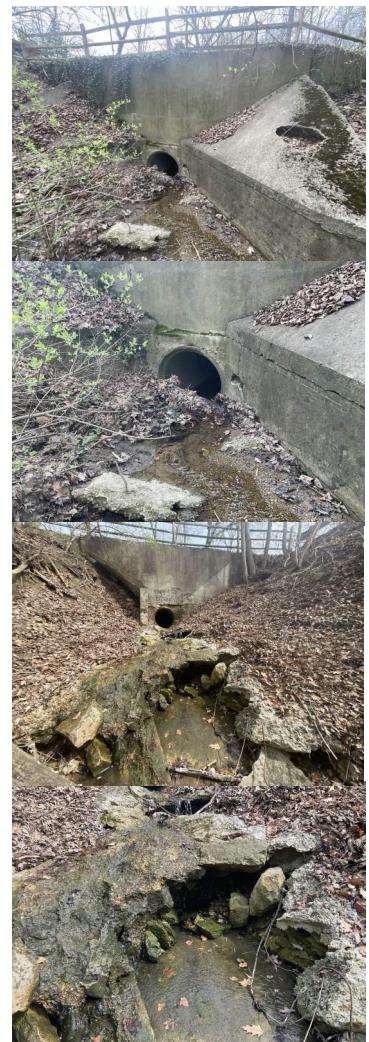
Culvert ID: B2_22

Structural Score: 2

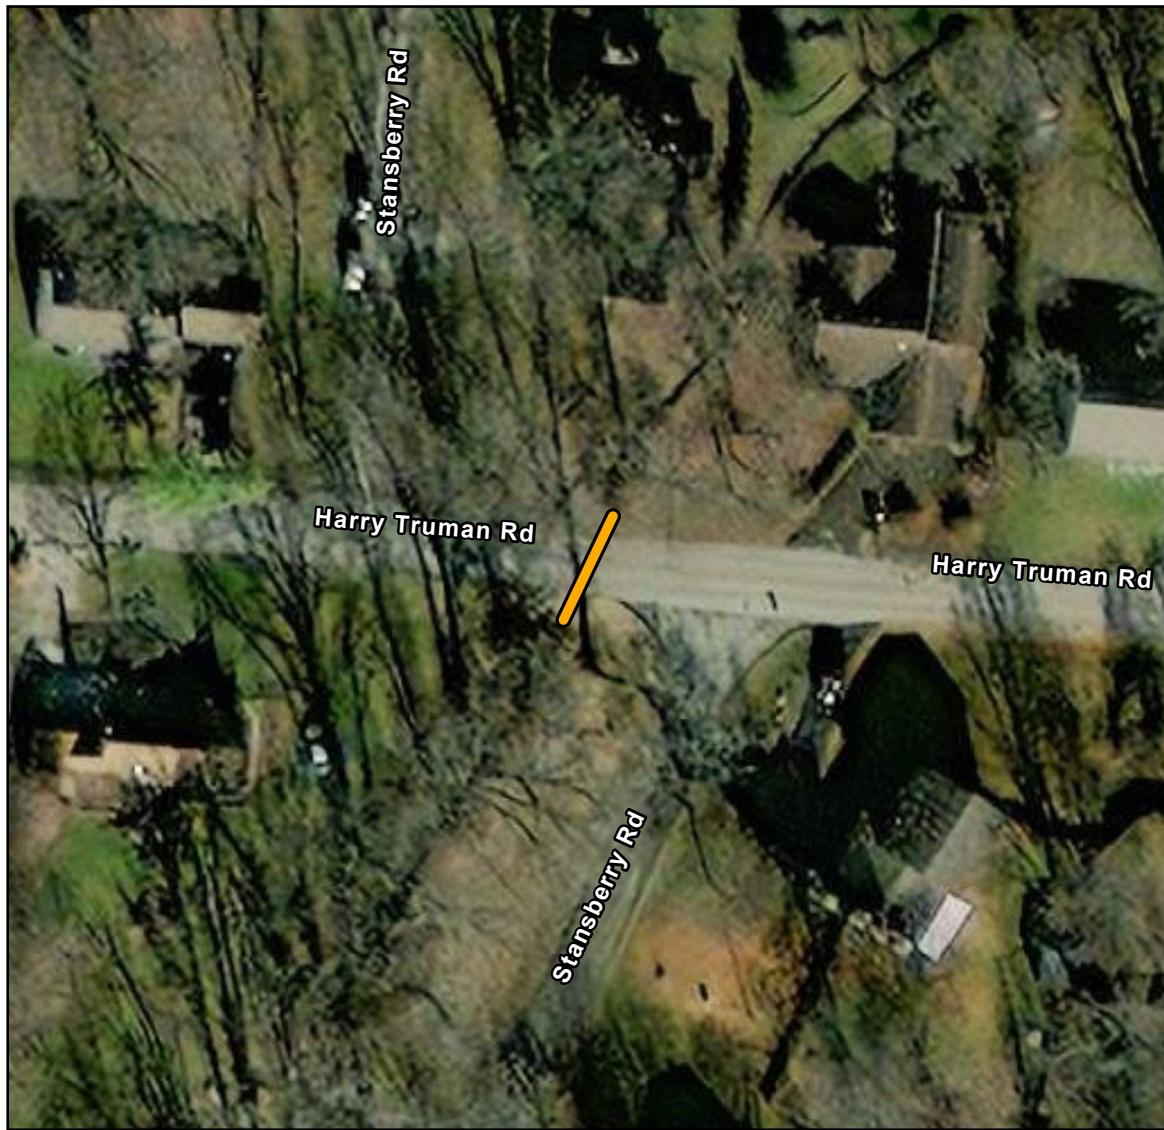
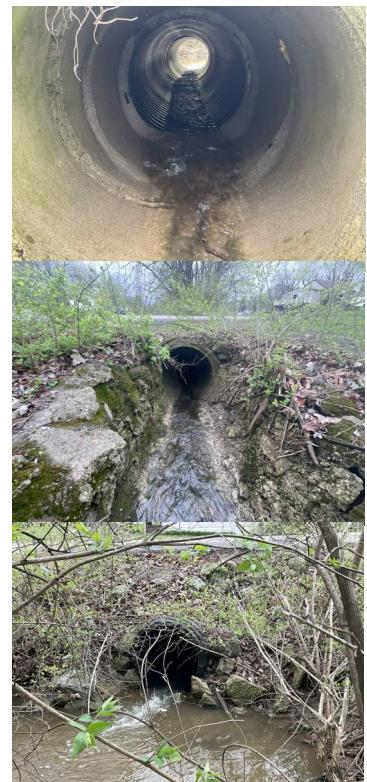
Culvert ID: B2_23

Structural Score: 1

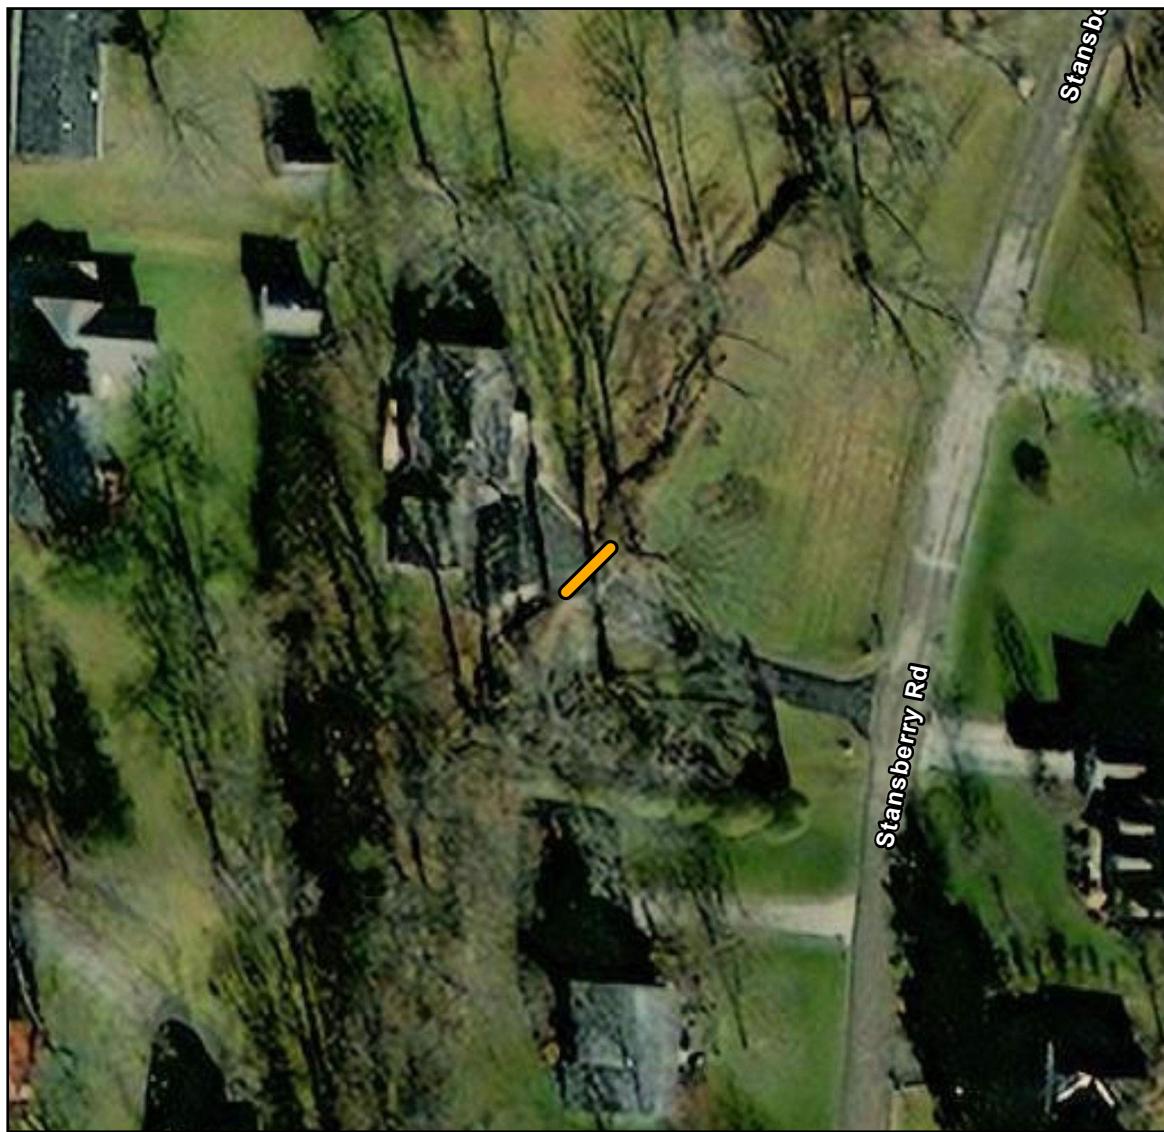
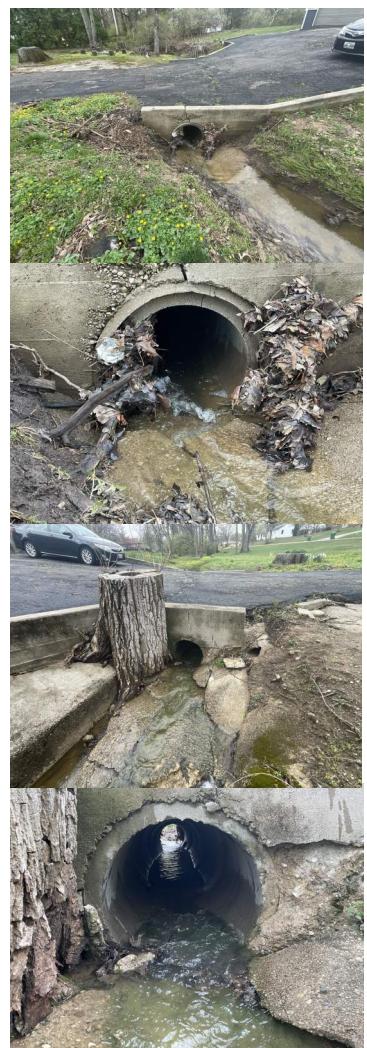
Culvert ID: B2_24

Structural Score: 2

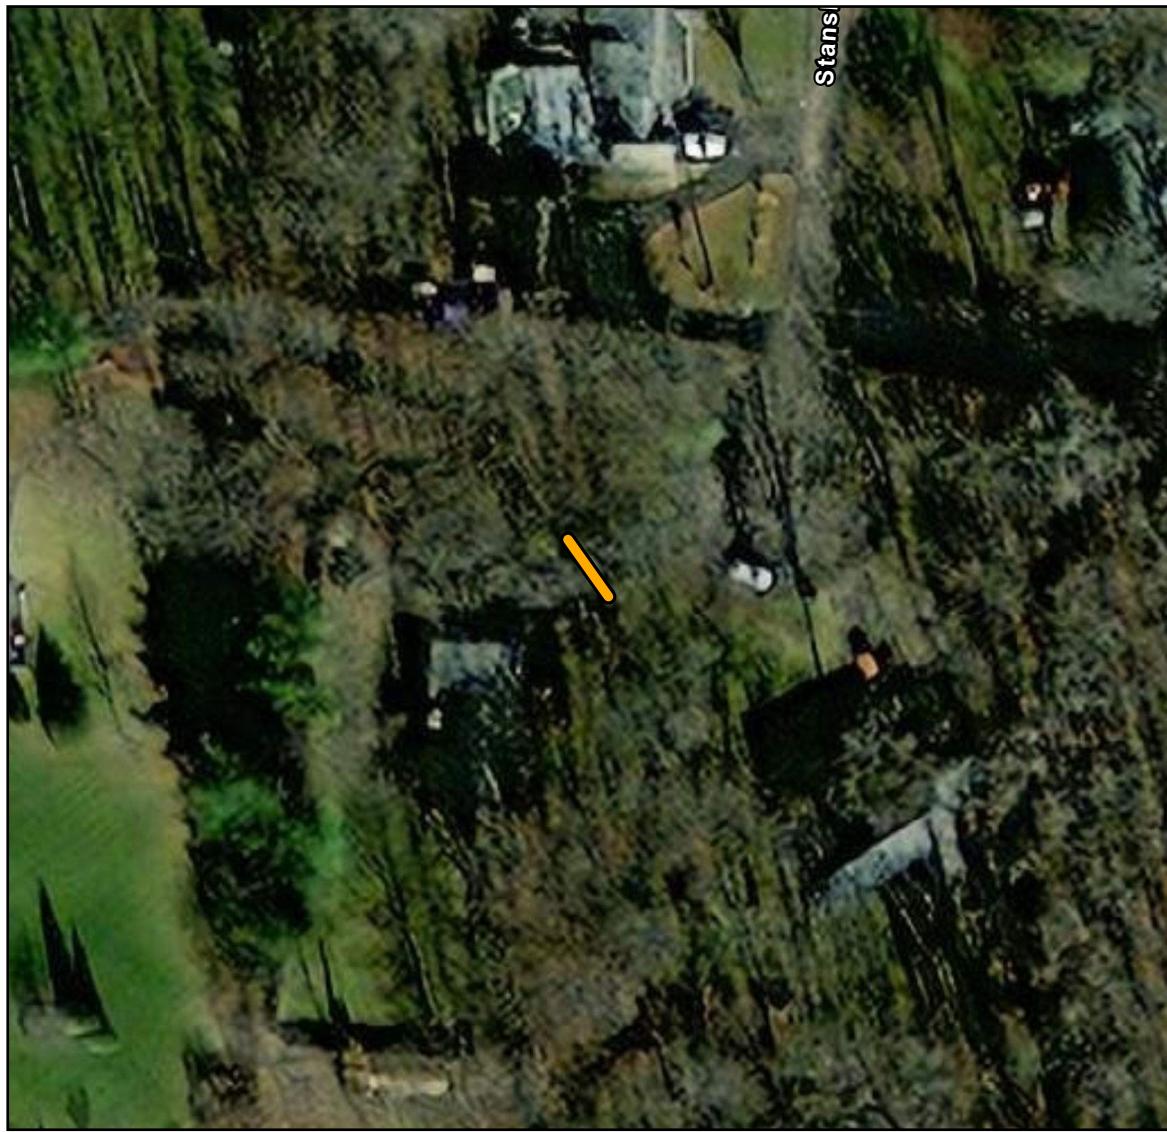
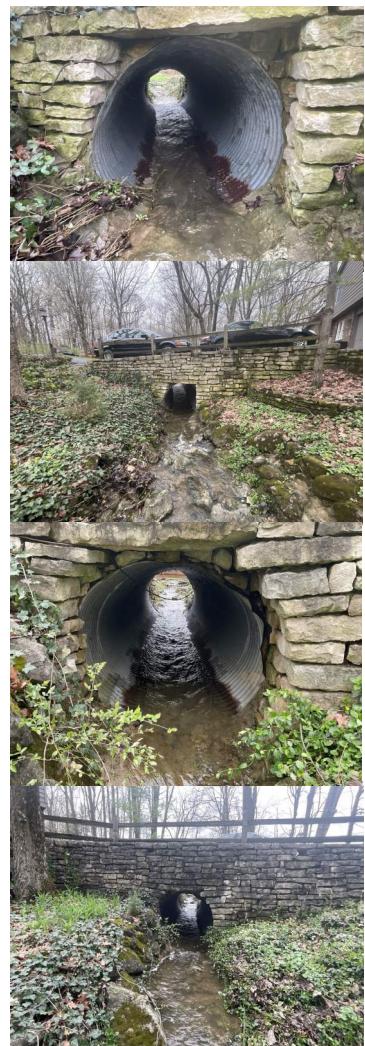
Culvert ID: B2_25

Structural Score: 1

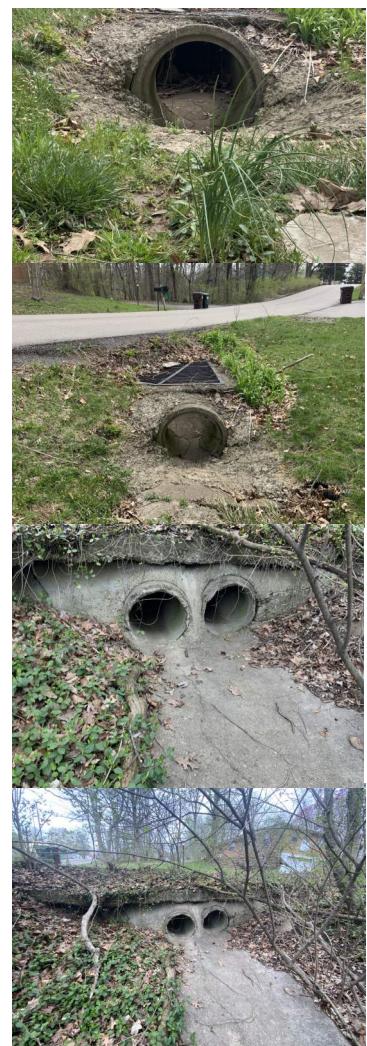
Culvert ID: B2_26

Structural Score: 2

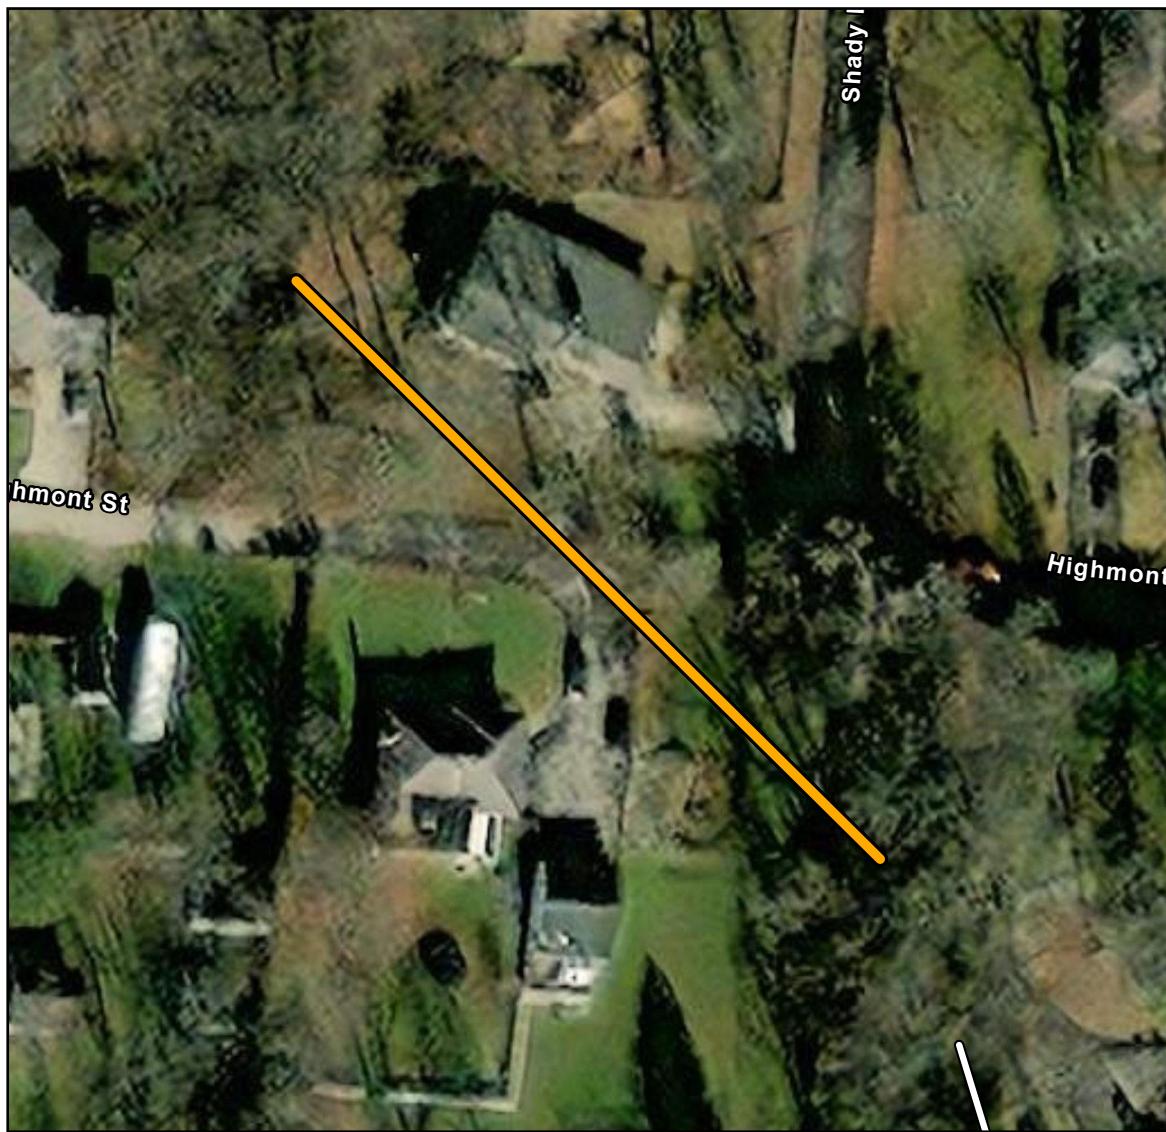
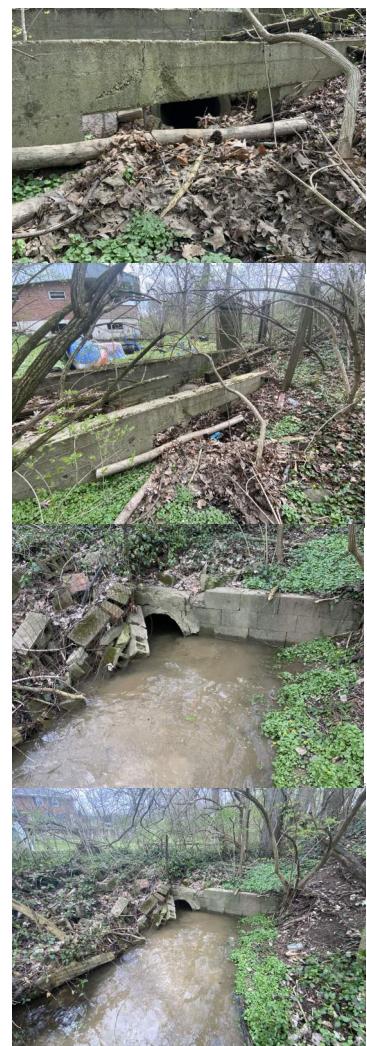
Culvert ID: B2_27

Structural Score: 3

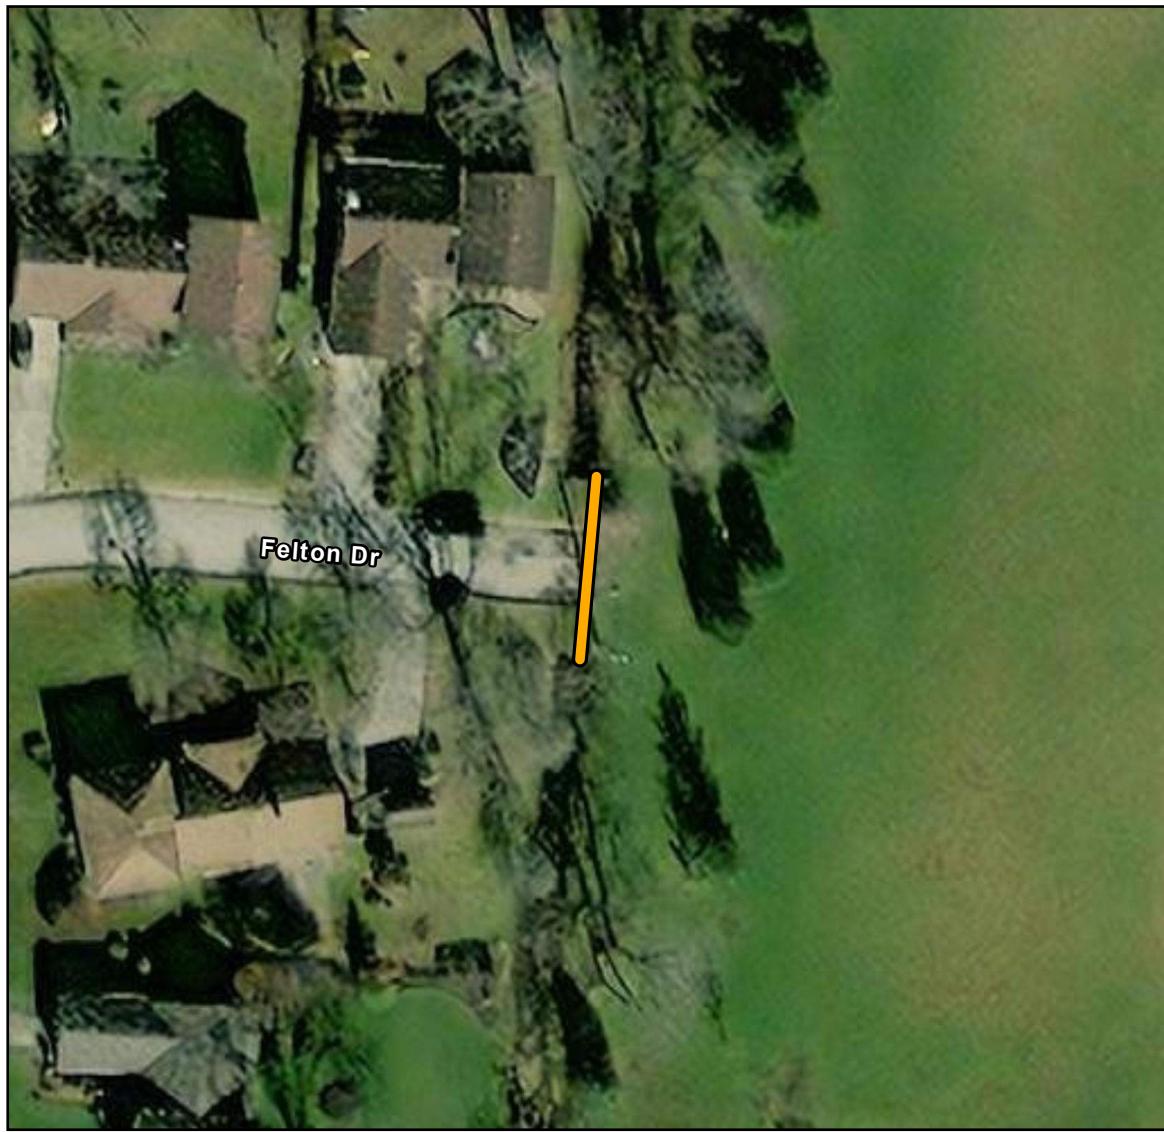
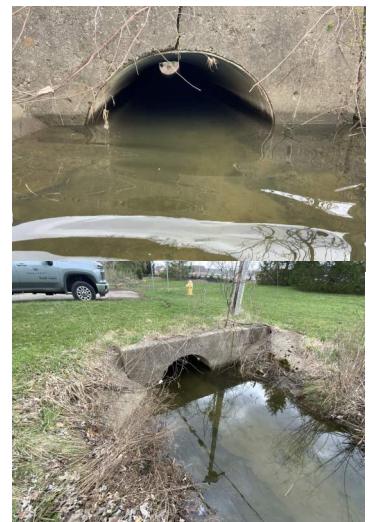
Culvert ID: B3_01

Structural Score: 1
