Project No. 10022676.00

City of Beavercreek Drainage Master Plan

City of Beavercreek

October 13, 2025

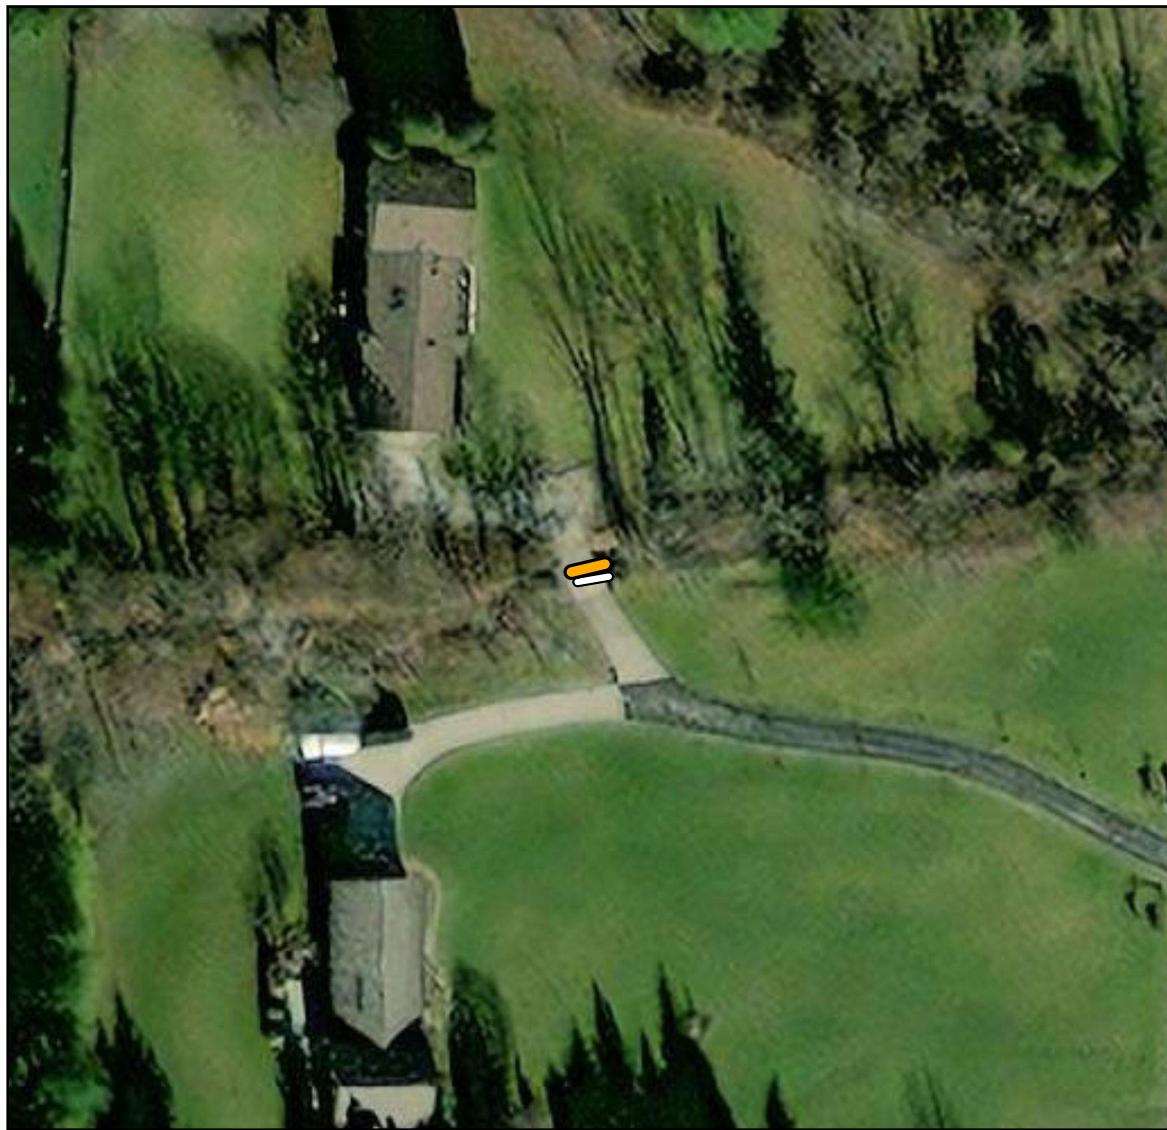
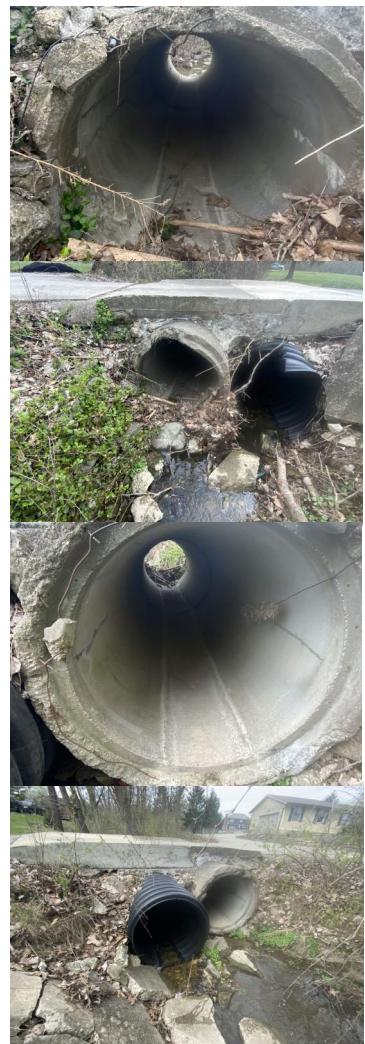
Culvert ID: B3_02

Structural Score: 2

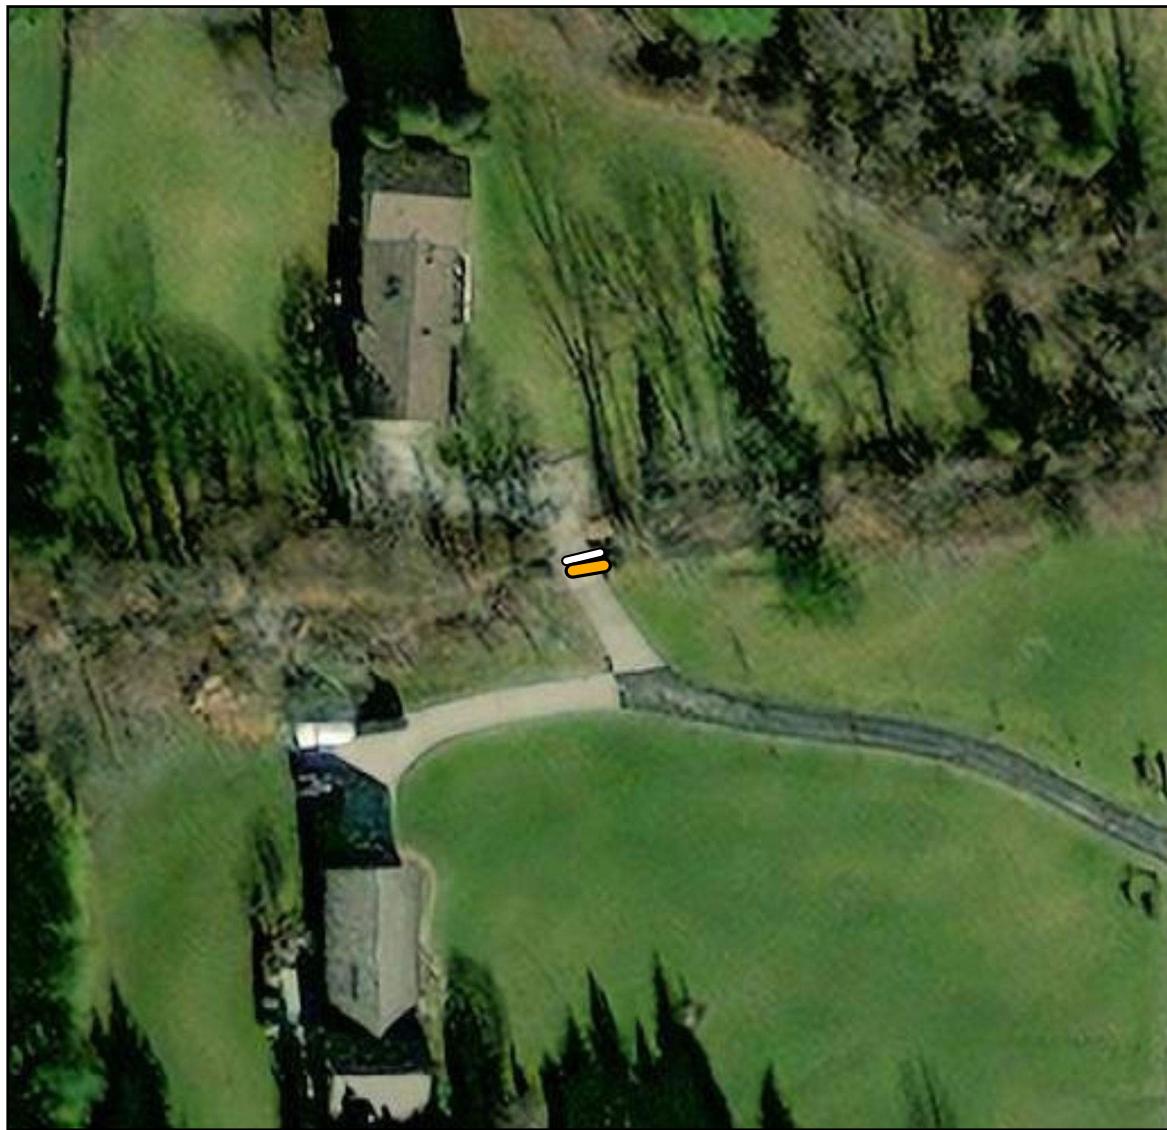
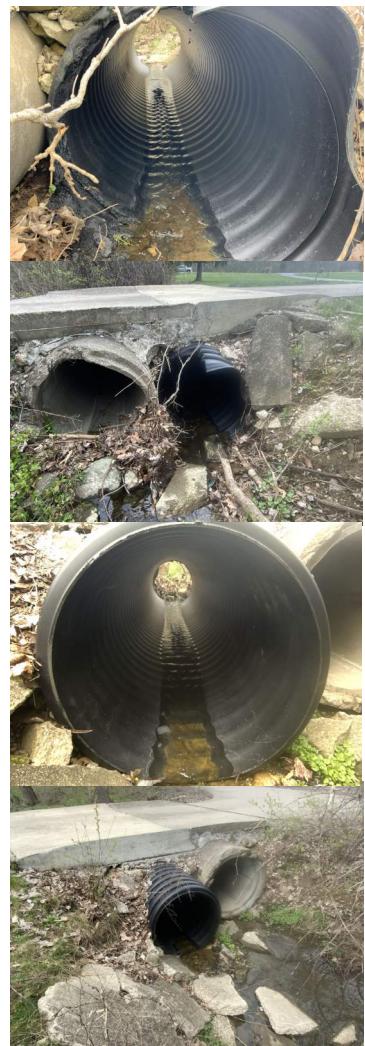
Culvert ID: B3_03

Structural Score: 2

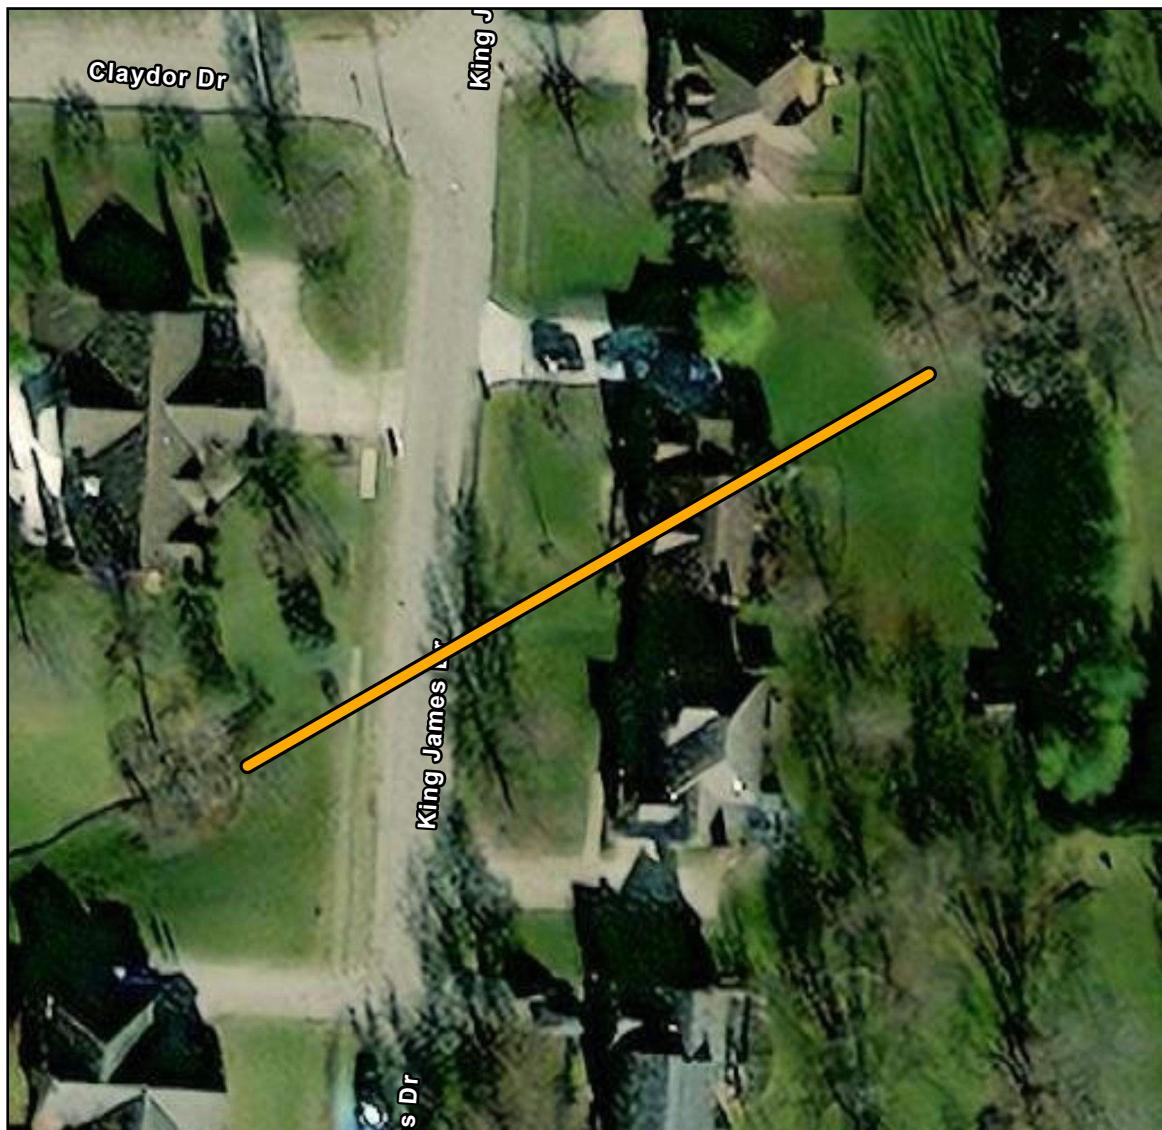
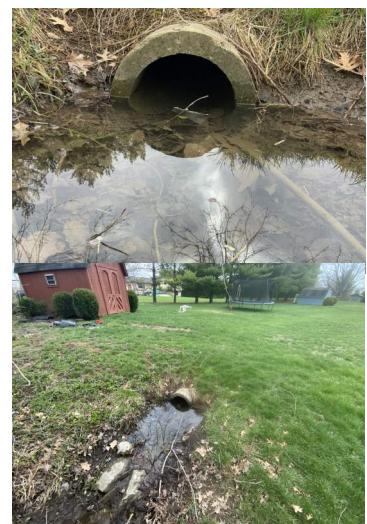
Culvert ID: B3_04

Structural Score: 1

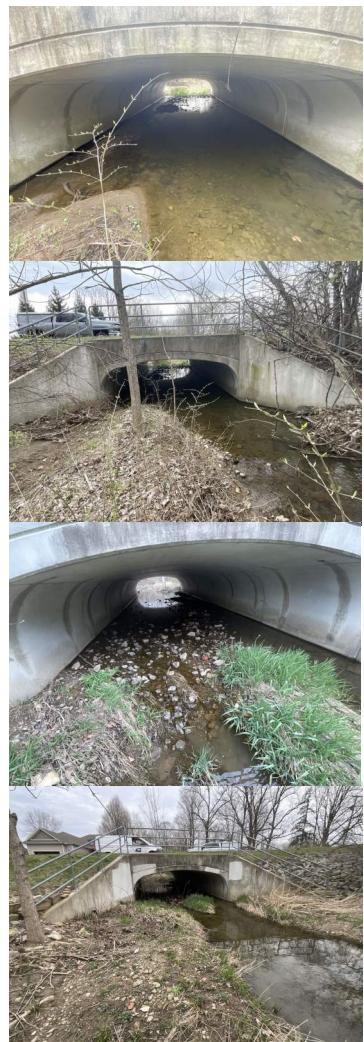
Culvert ID: B3_05

Structural Score: 1

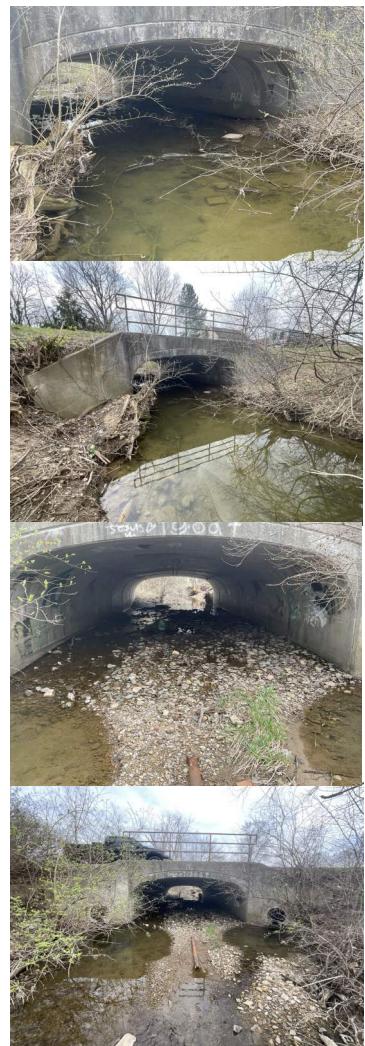
Culvert ID: B3_06

Structural Score: 1

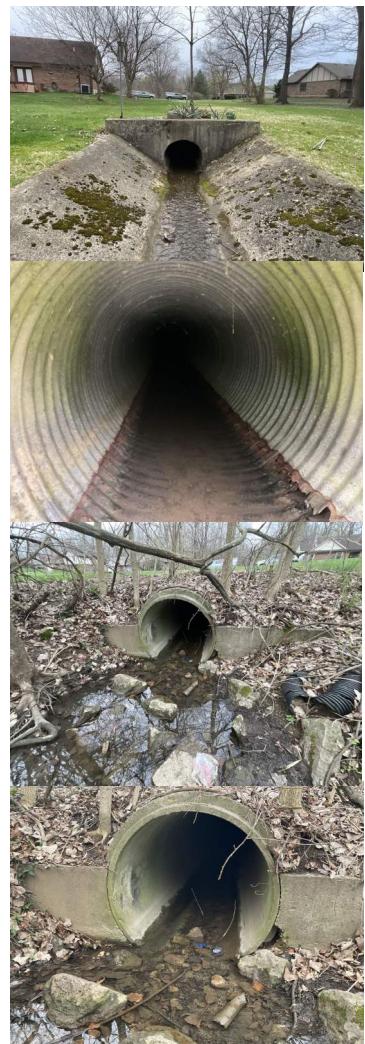
Culvert ID: B3_07

Structural Score: 2

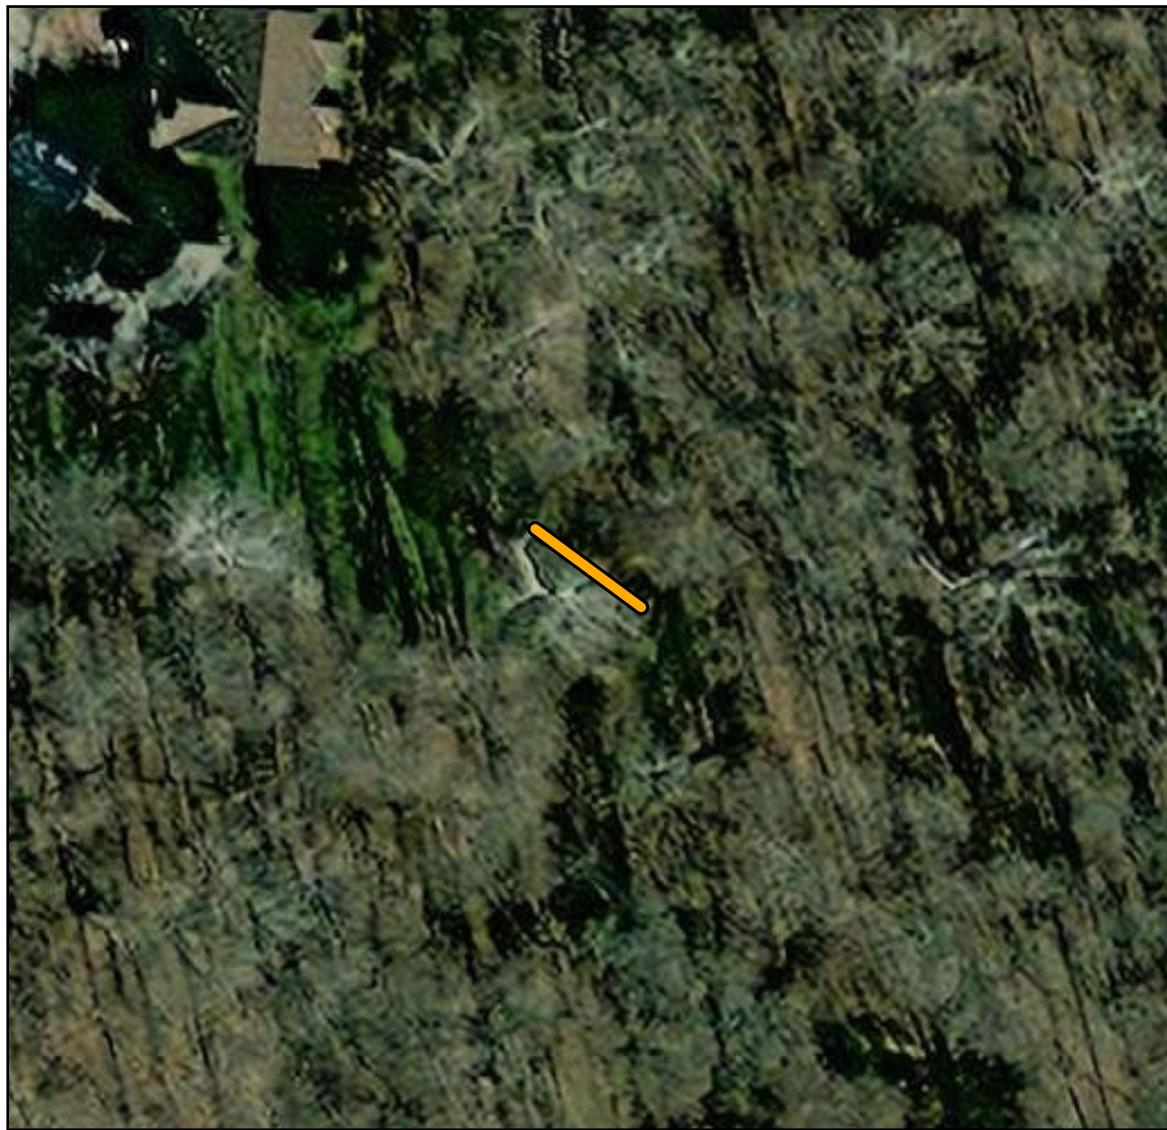
Culvert ID: B4_01

Structural Score: 2

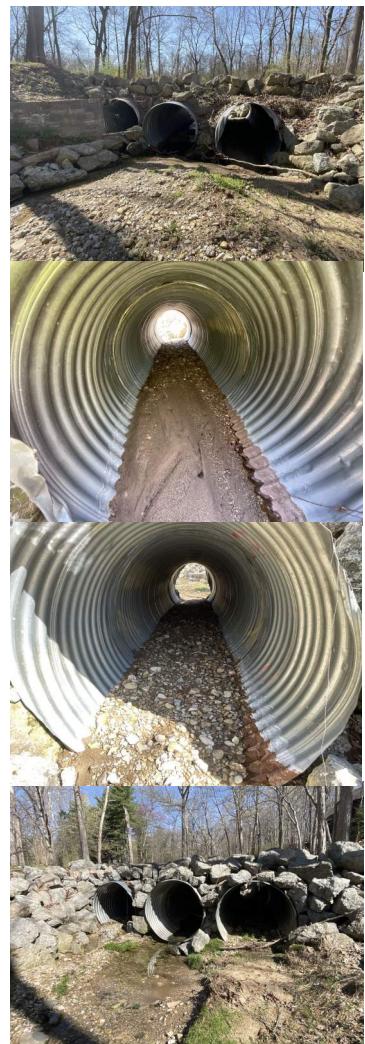
Culvert ID: B4_02

Structural Score: 2

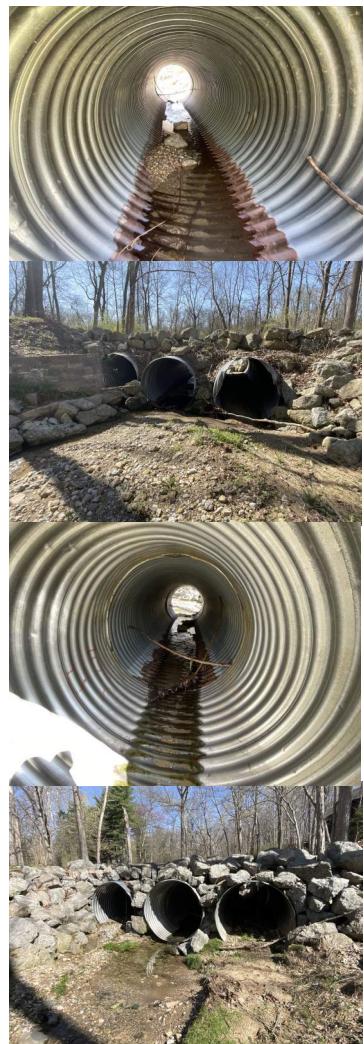
Culvert ID: B4_03

Structural Score: 1

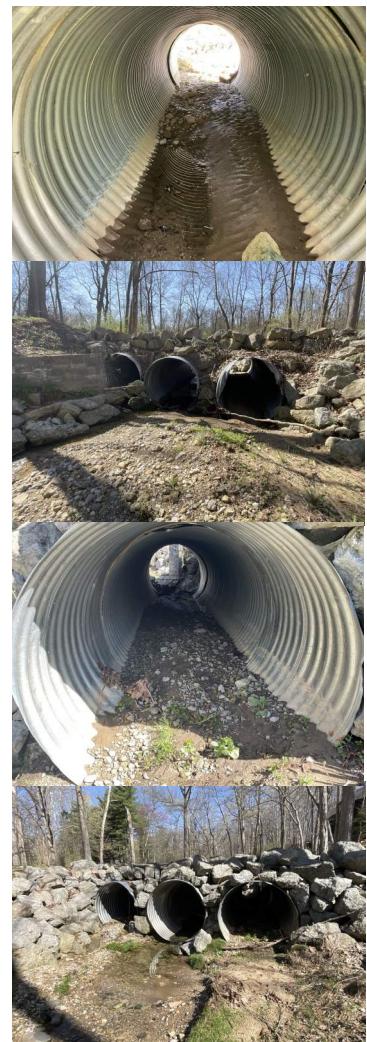
Culvert ID: B4_04

Structural Score: 1

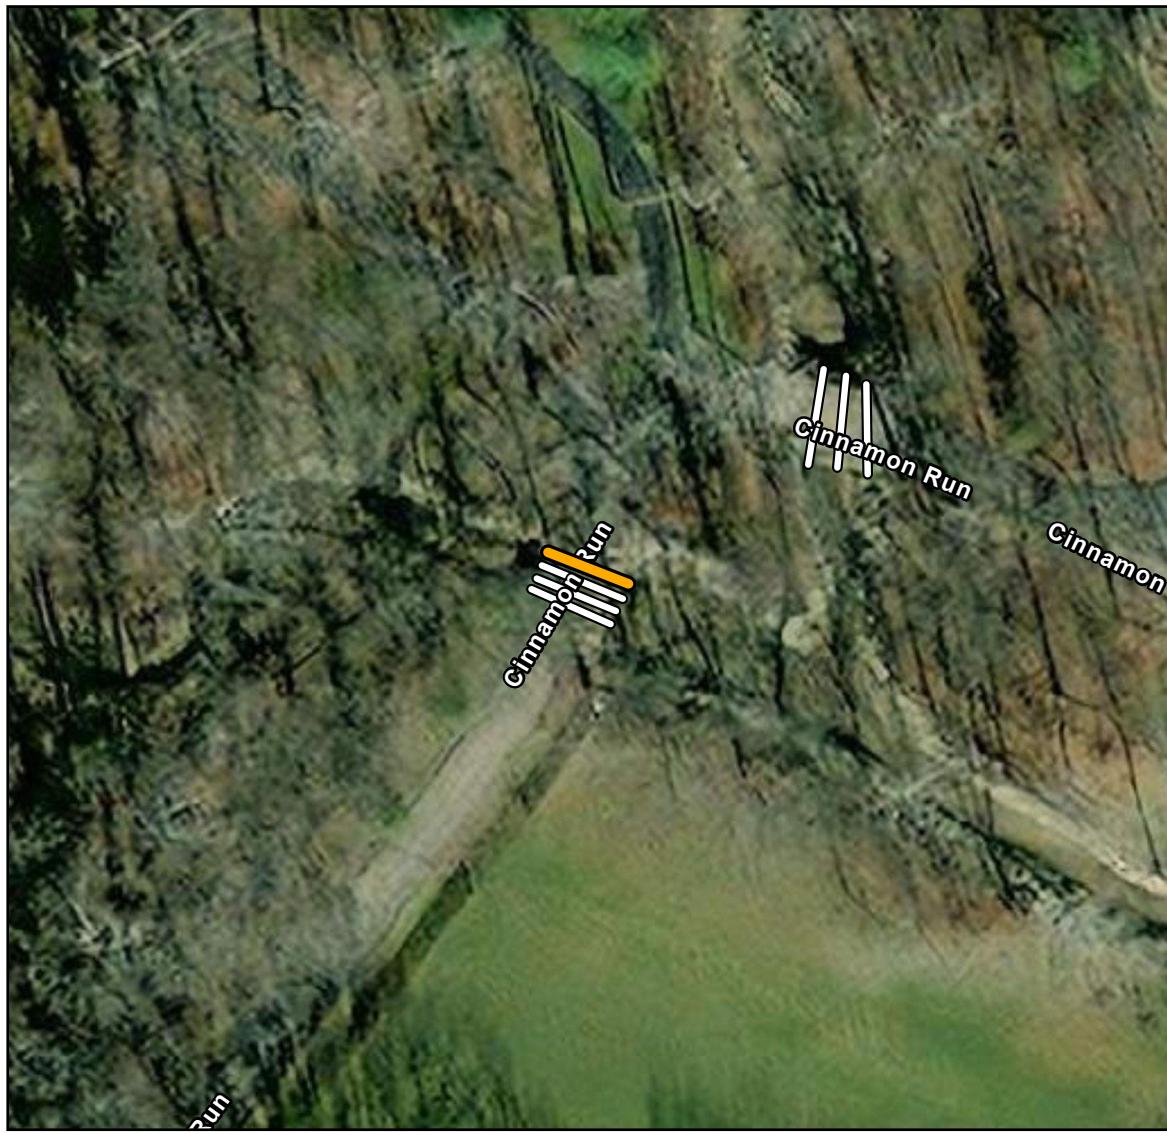
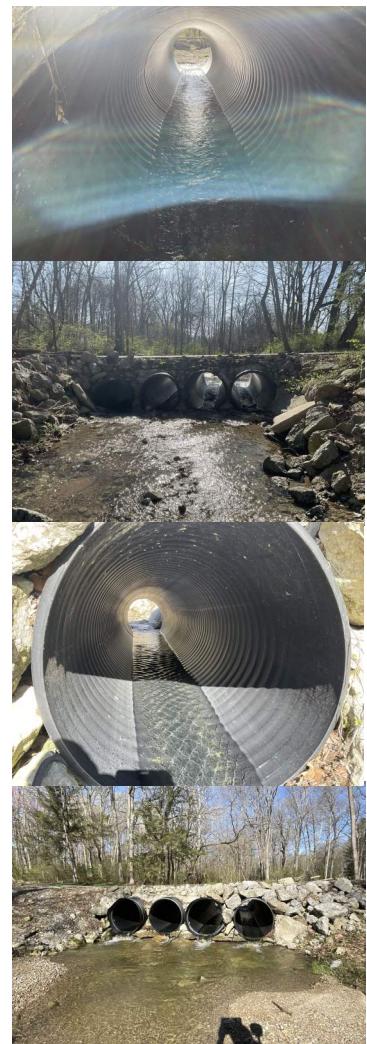
Culvert ID: B4_05

Structural Score: 1

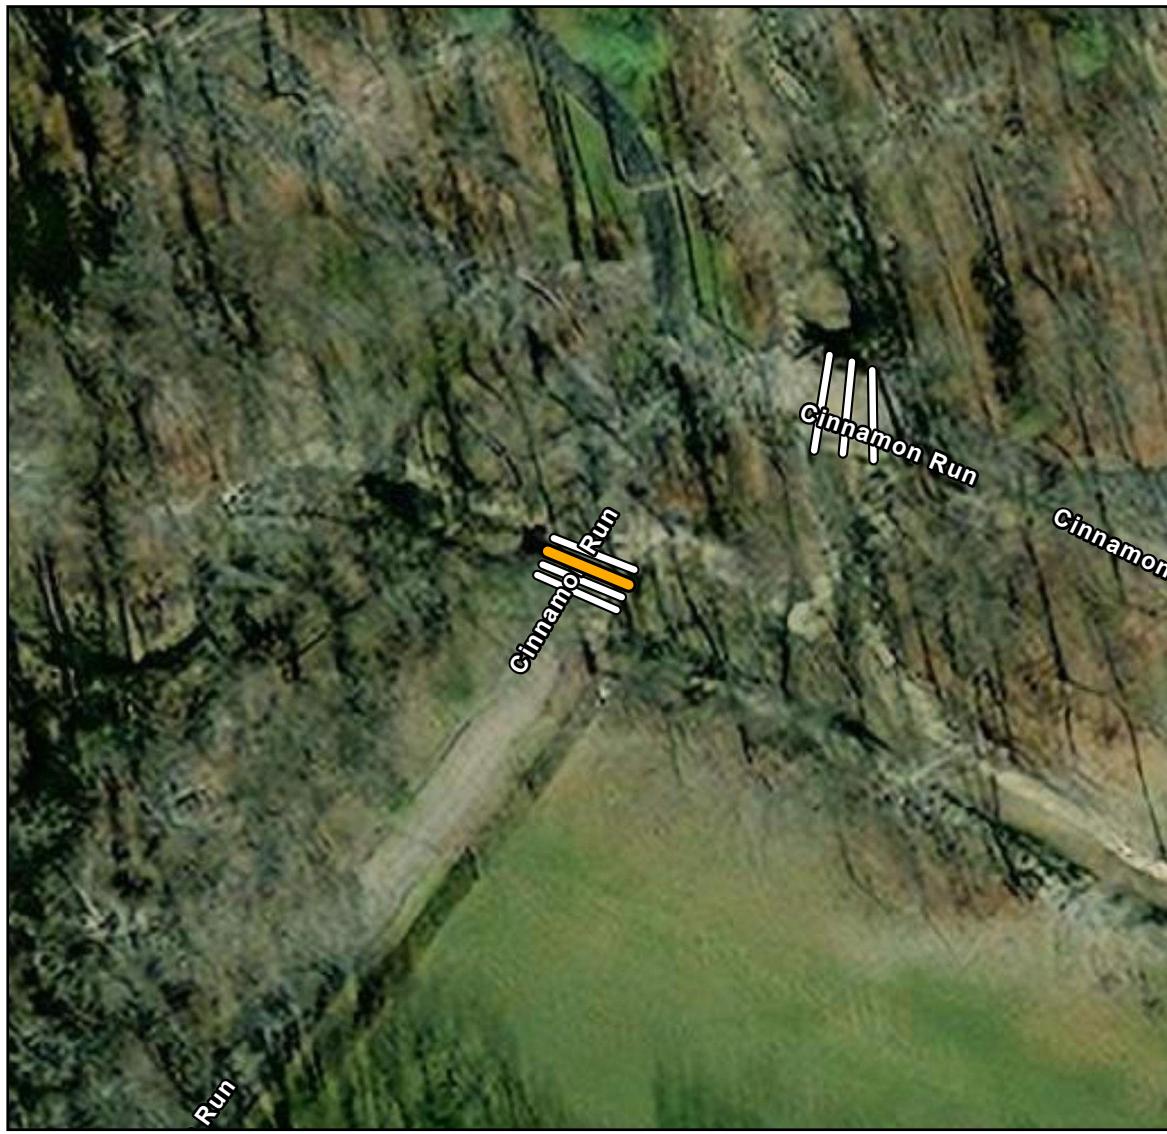
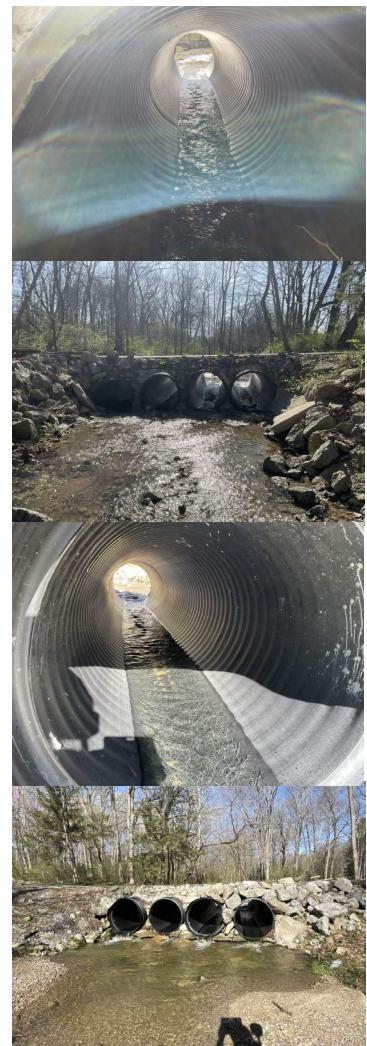
Culvert ID: B4_06

Structural Score: 1

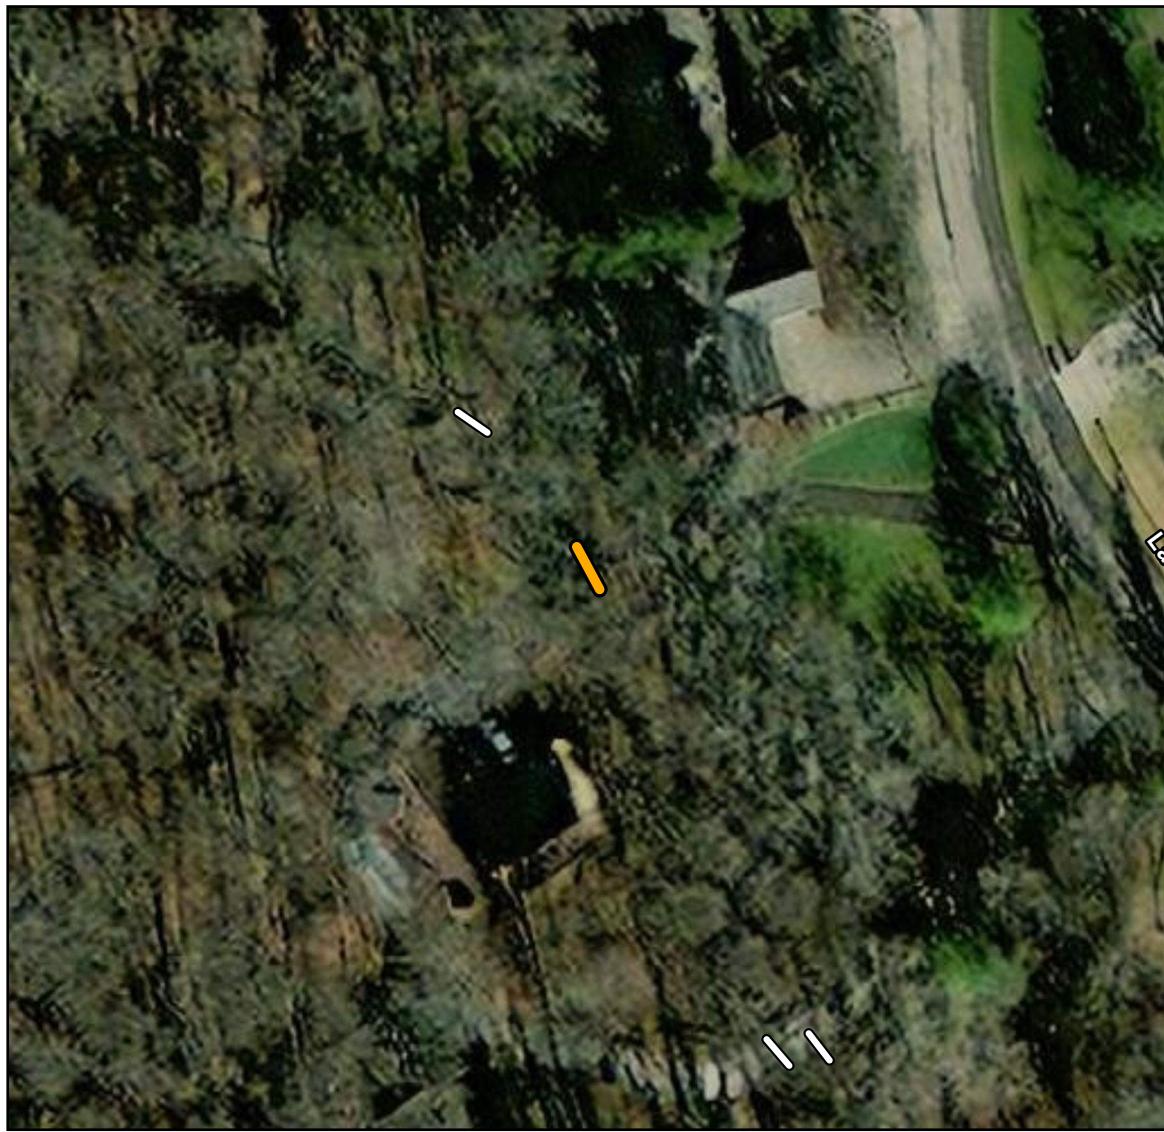
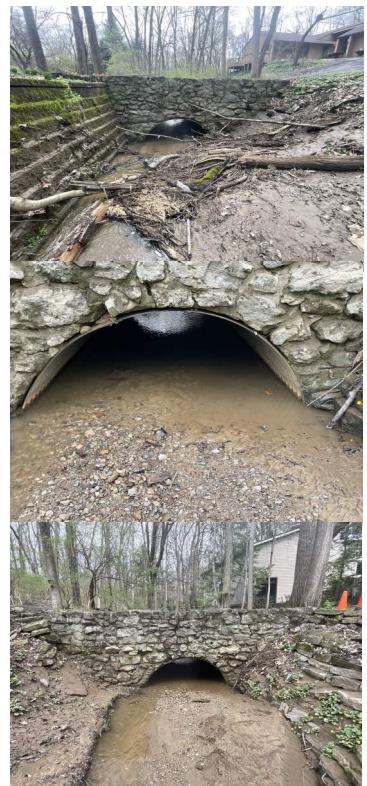
Culvert ID: C2_11

Structural Score: 2

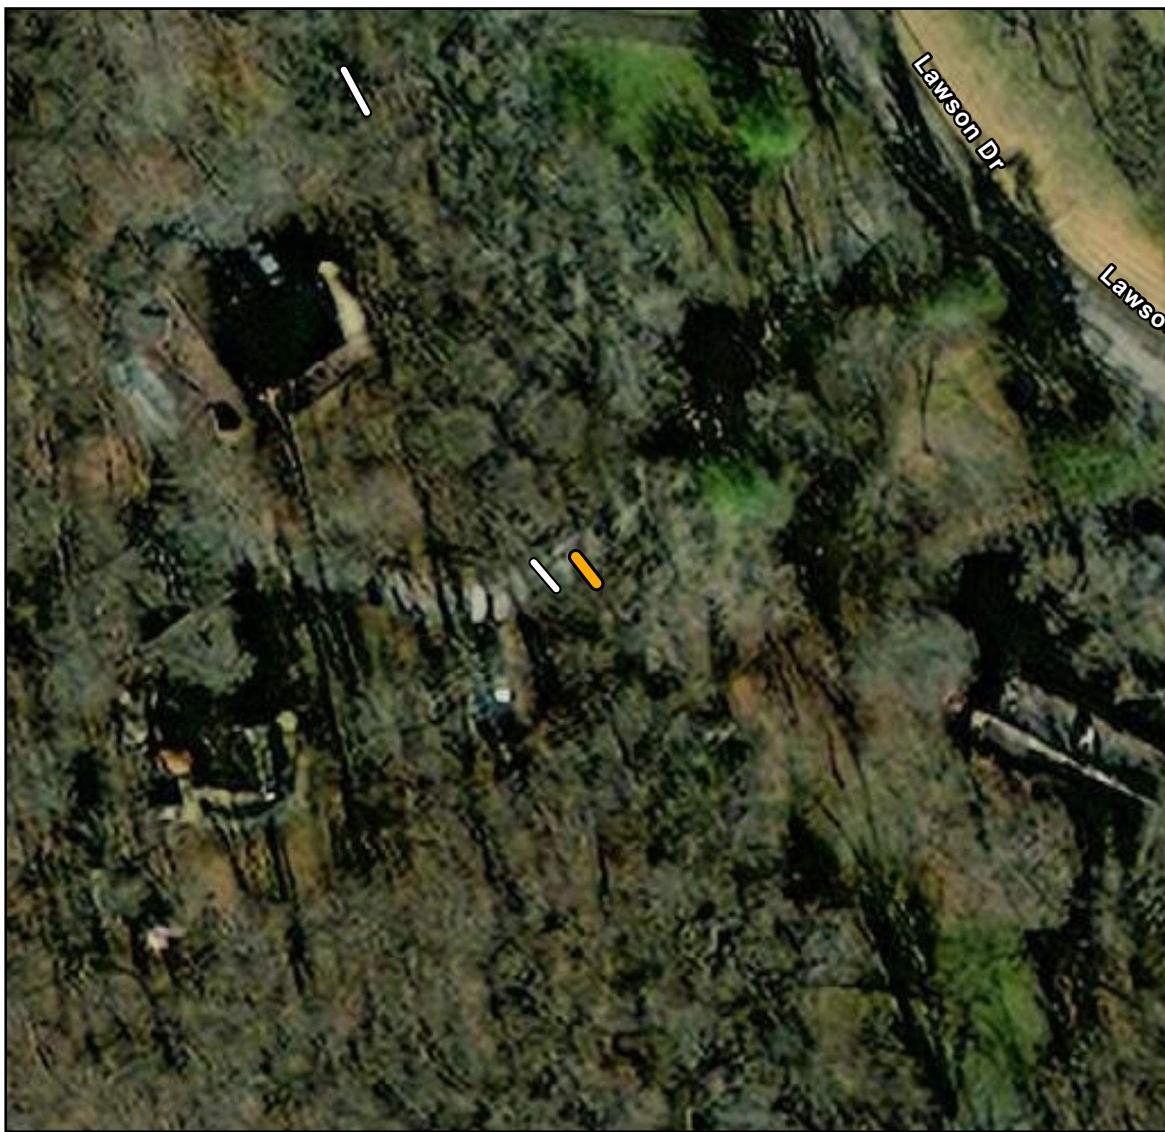
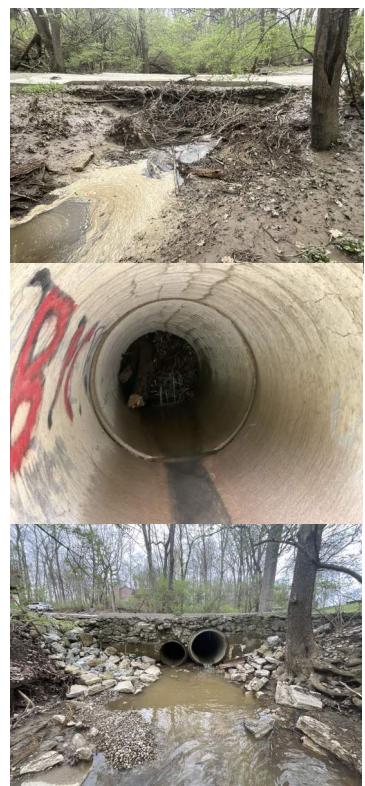
Culvert ID: C2_12

Structural Score: 2

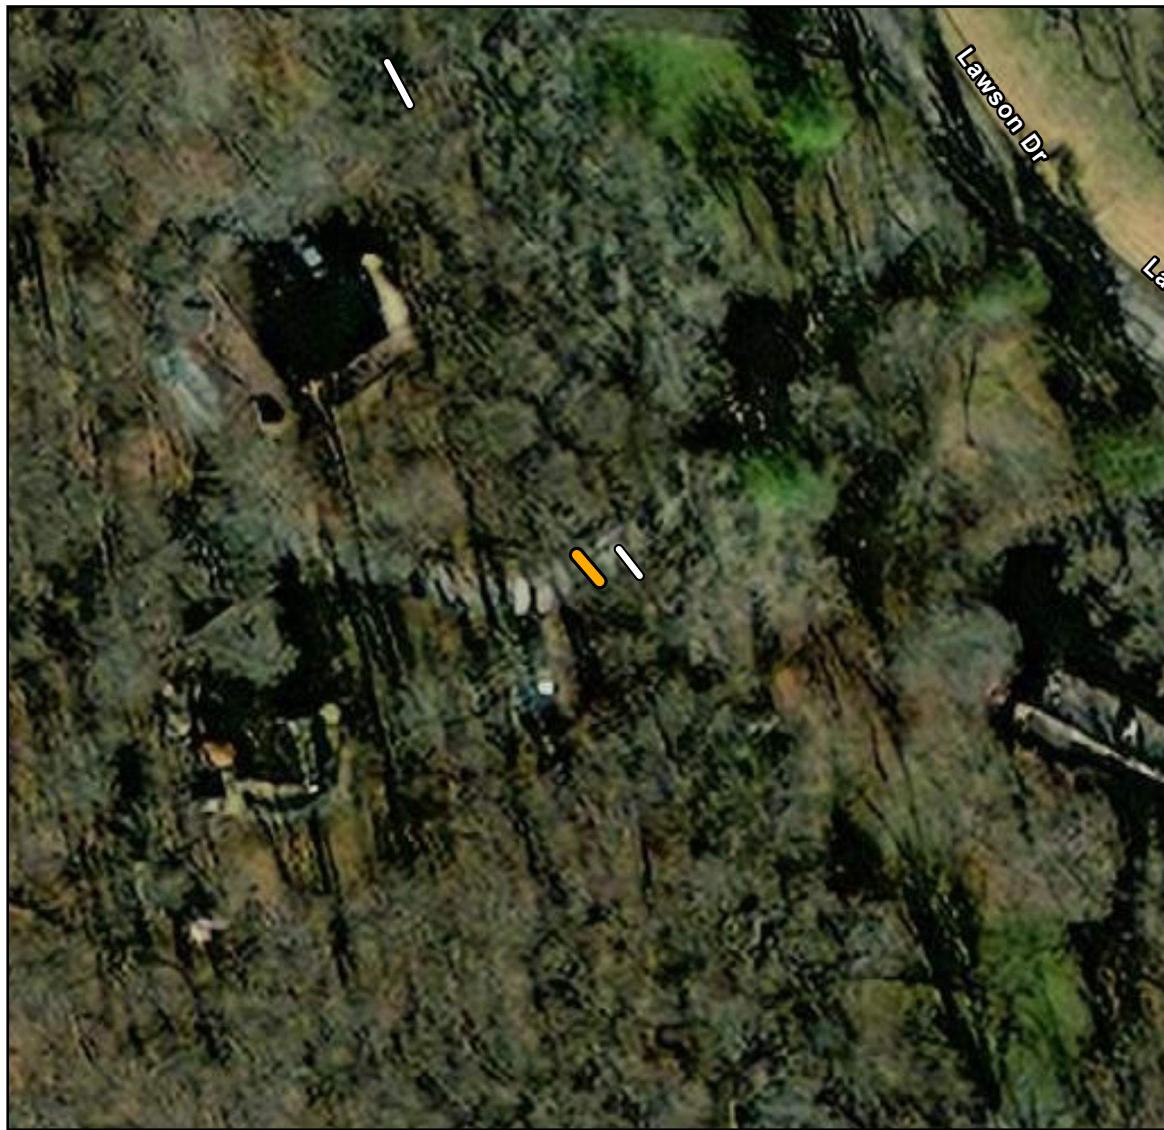
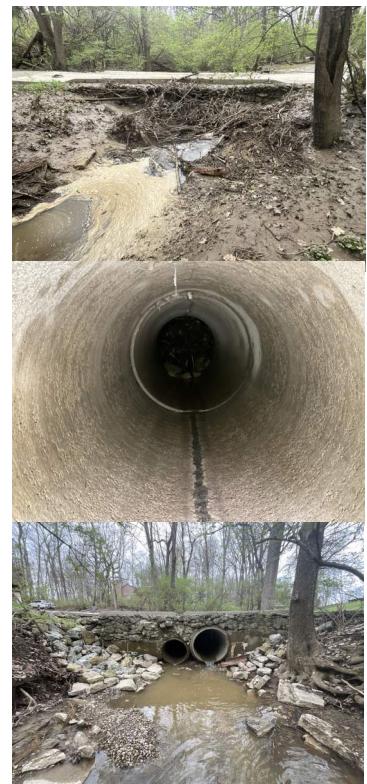
Culvert ID: C2_13

Structural Score: 2

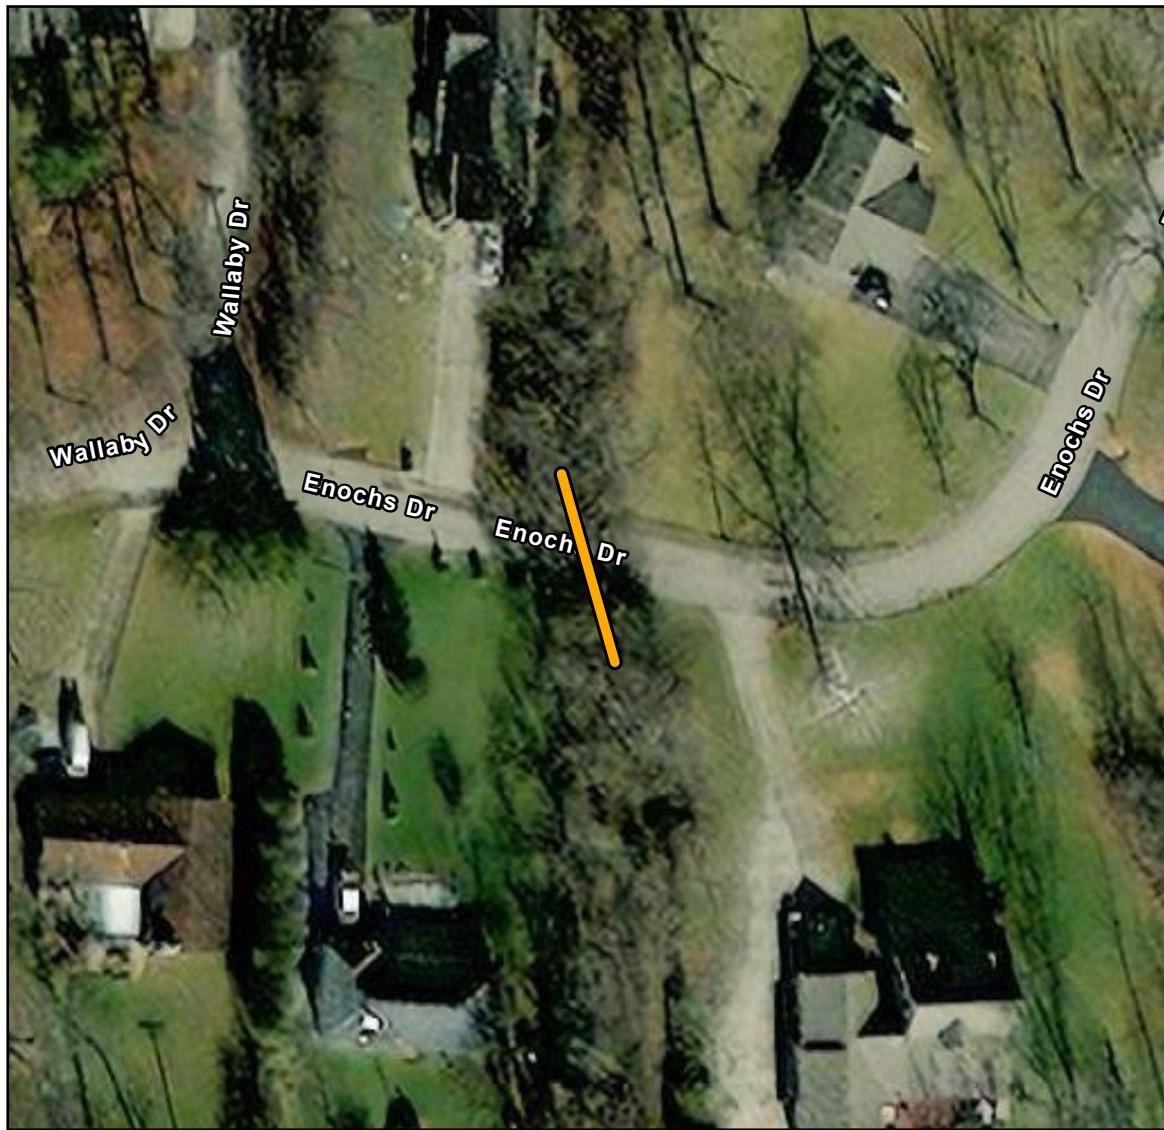
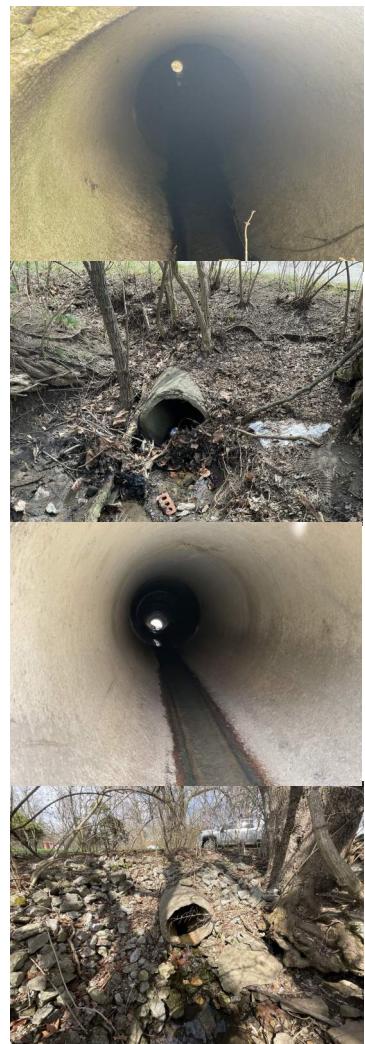
Culvert ID: C2_14

Structural Score: 2

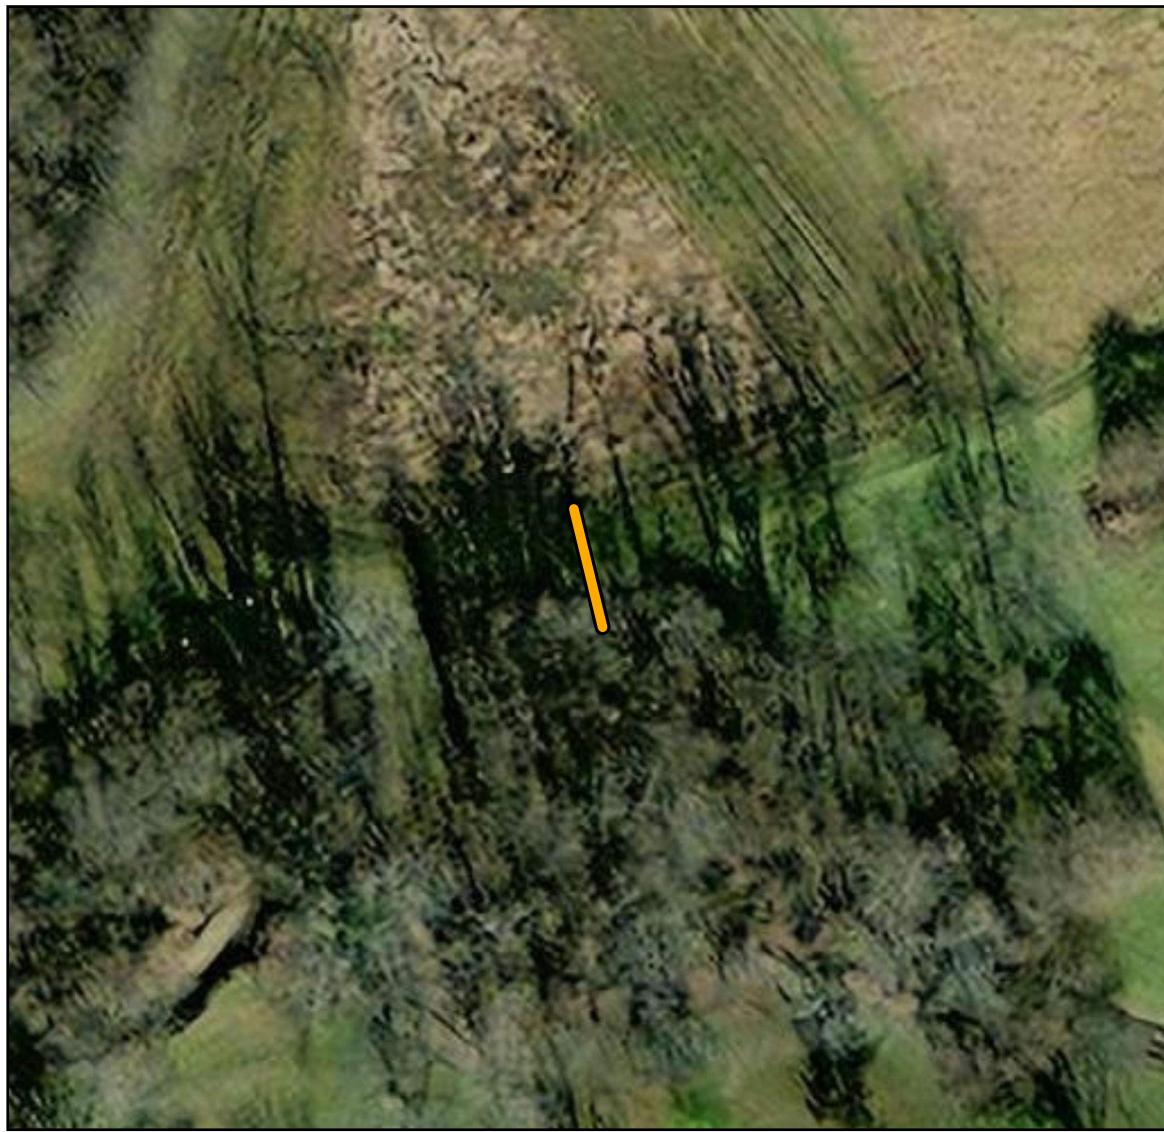
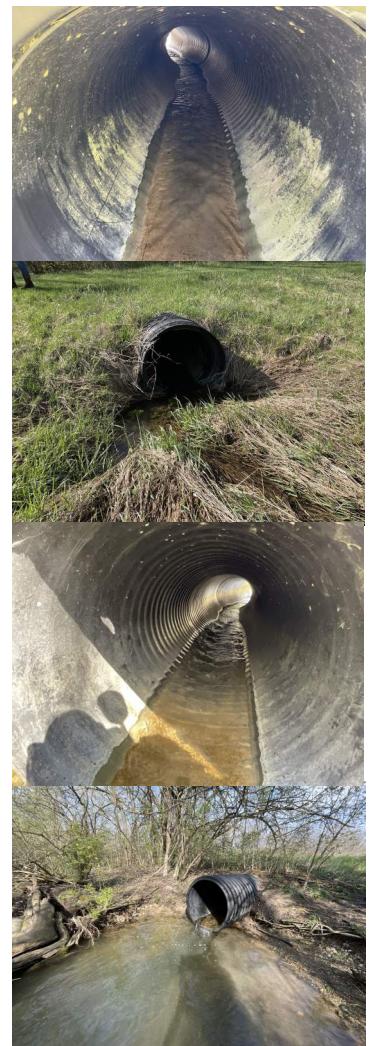
Culvert ID: C3_01

Structural Score: 1

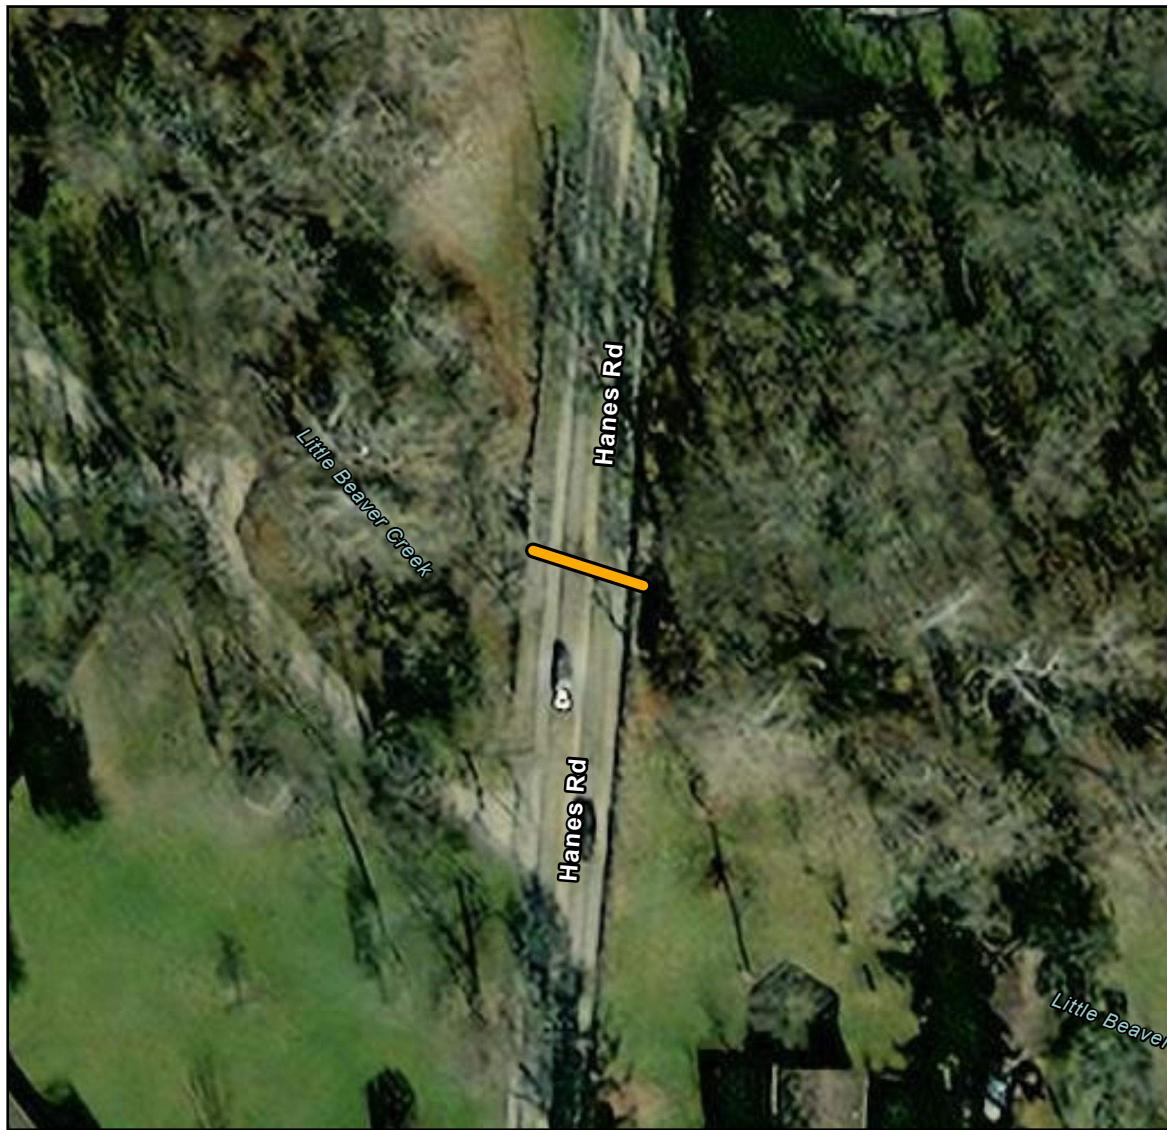
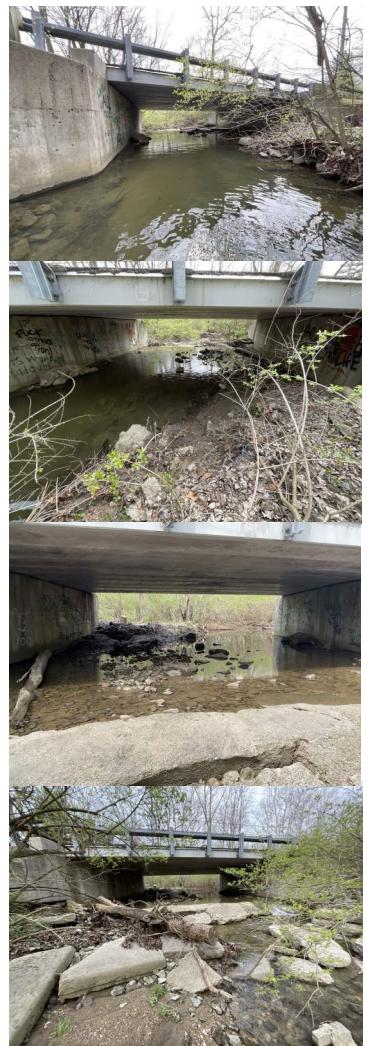
Culvert ID: C3_02

Structural Score: 2
