Project No. 10022676.00

City of Beavercreek Drainage Master Plan

City of Beavercreek

October 13, 2025

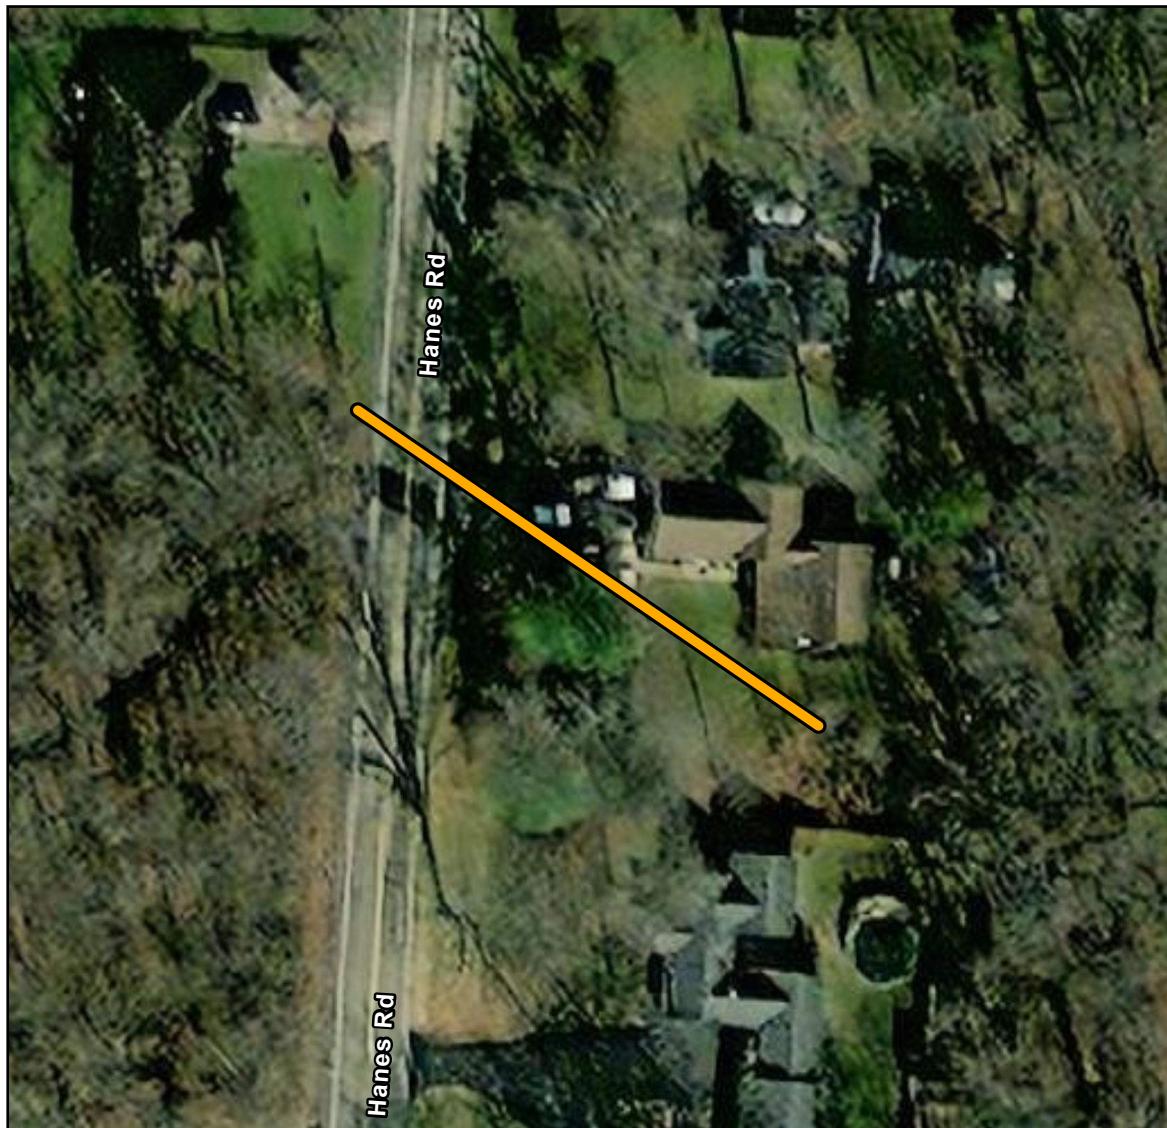
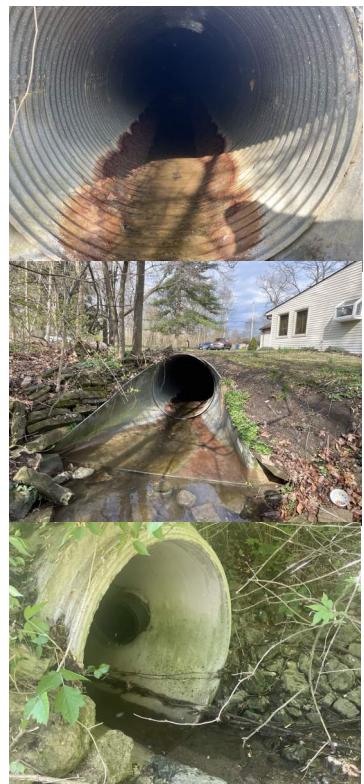
Culvert ID: C3_03

Structural Score: 1

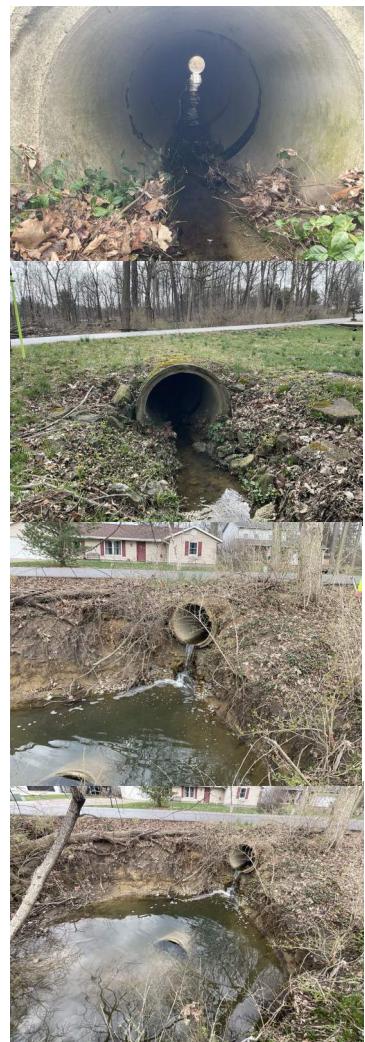
Culvert ID: C3_04

Structural Score: 3

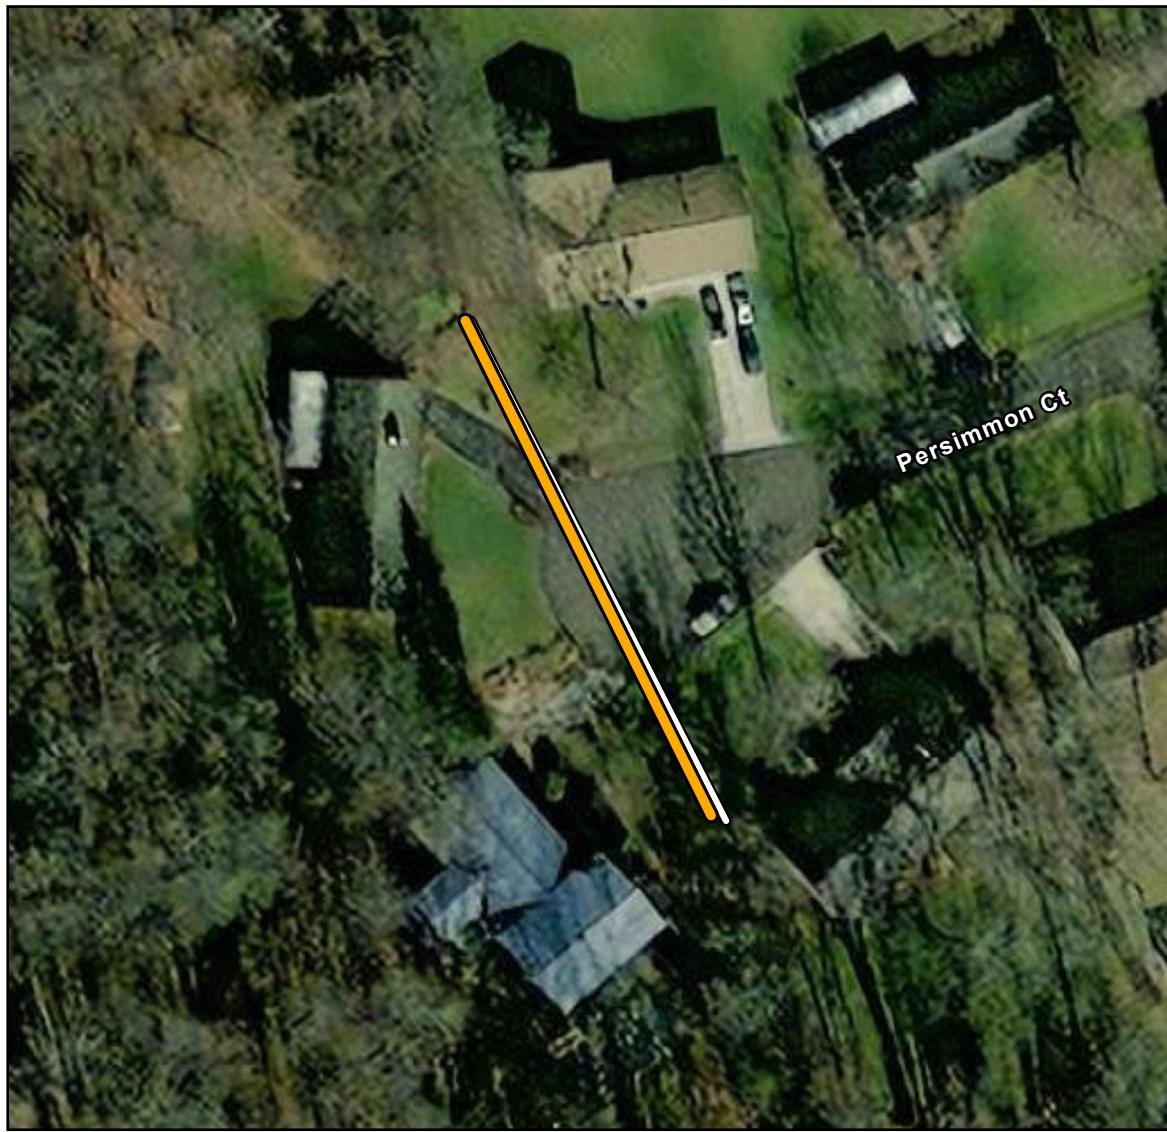
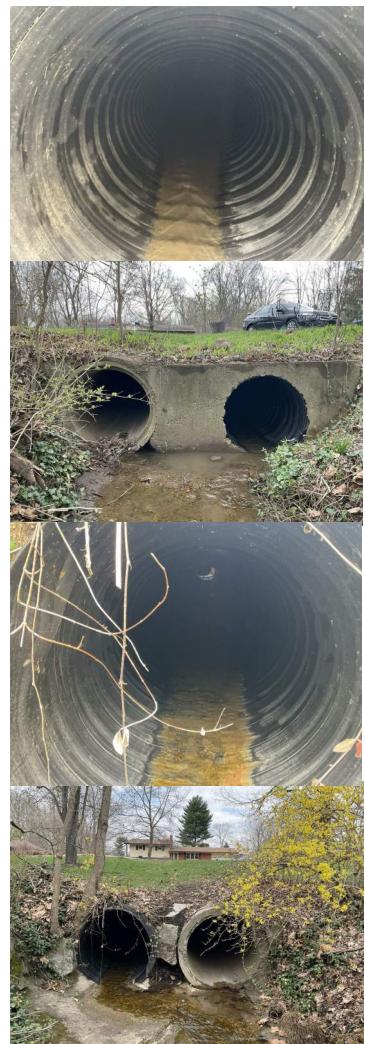
Culvert ID: C3_05

Structural Score: 2

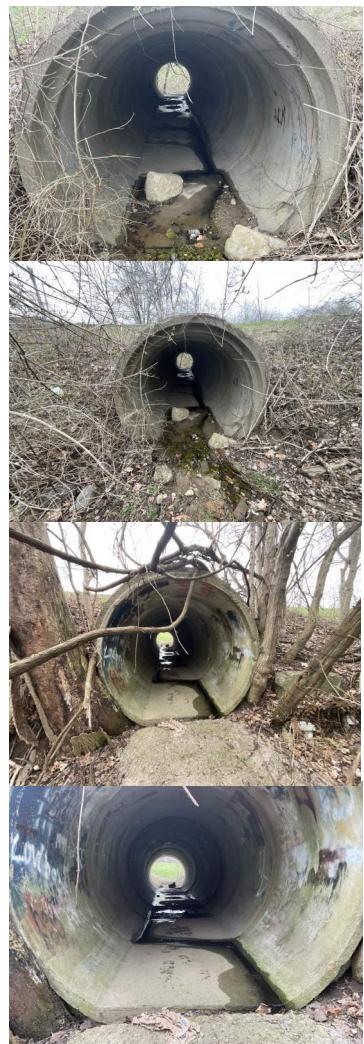
Culvert ID: C4_01

Structural Score: 1

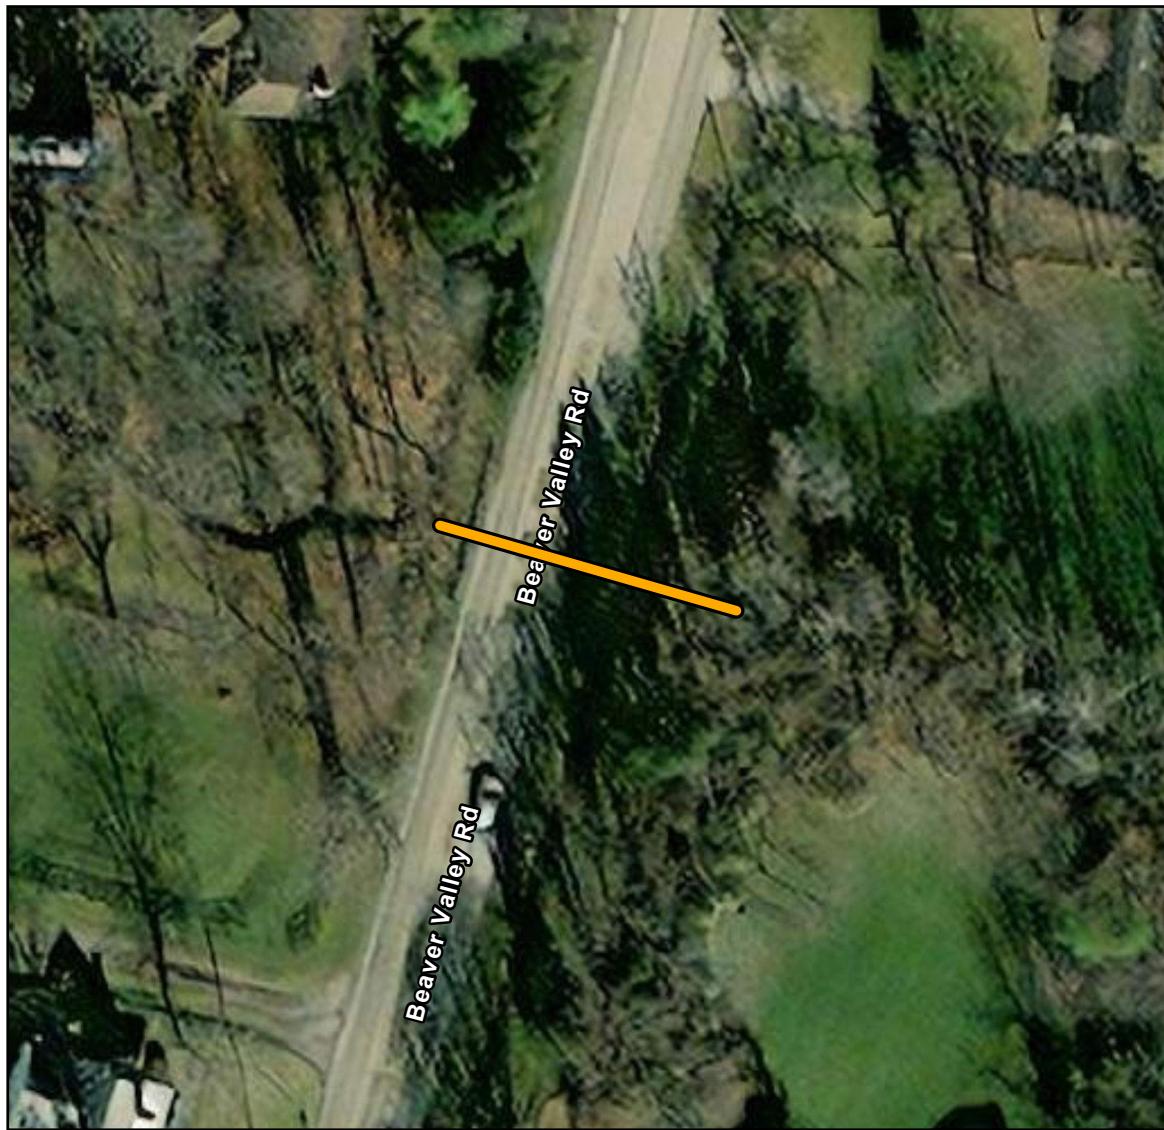
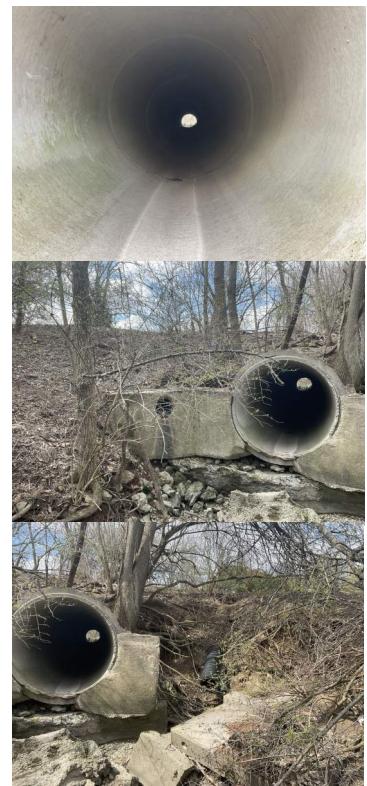
Culvert ID: C4_02

Structural Score: 3

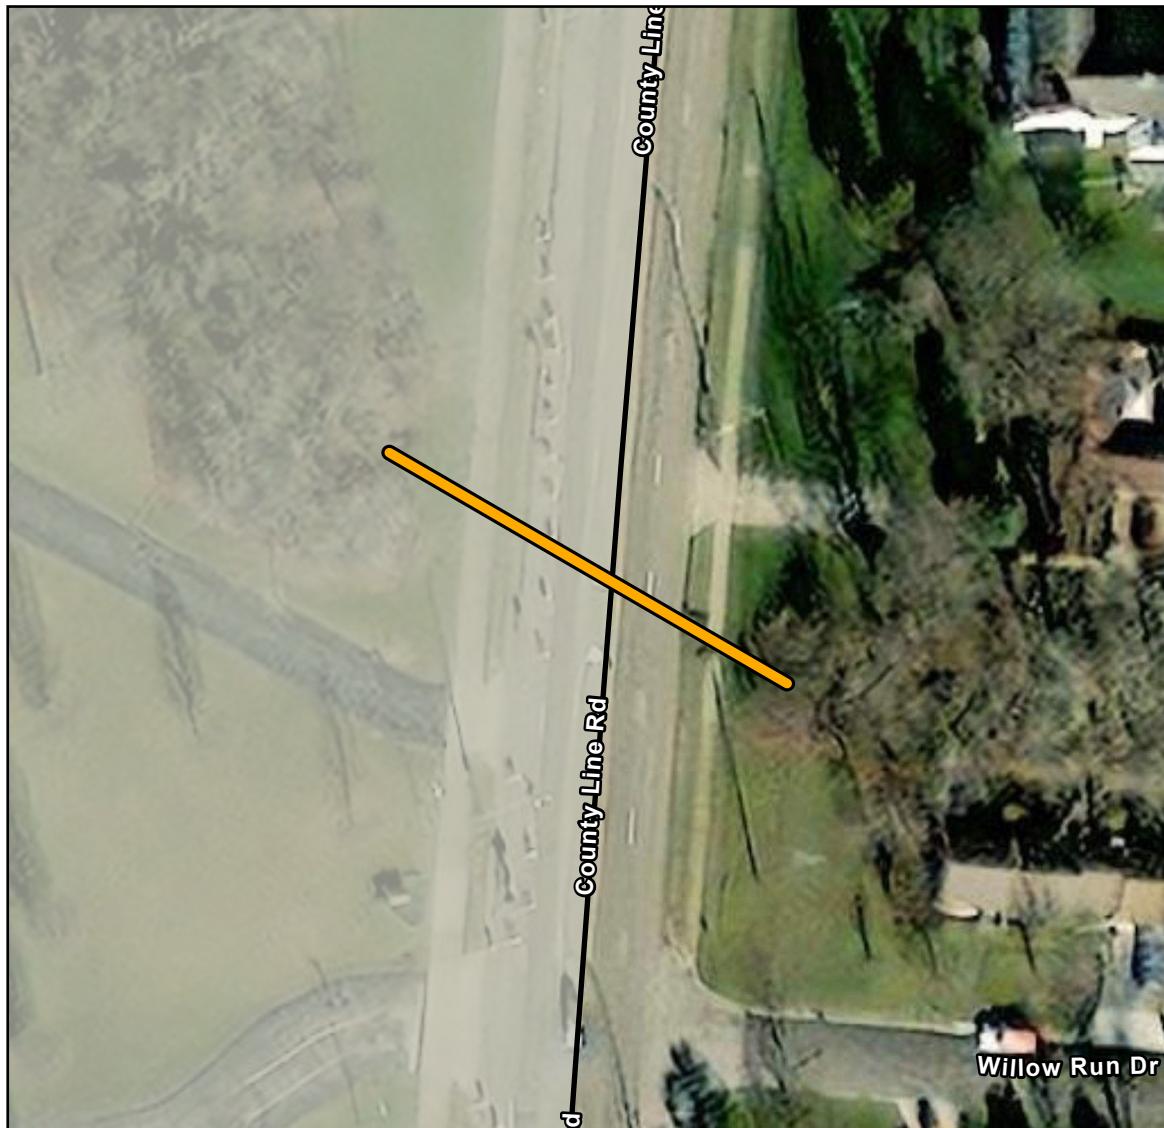
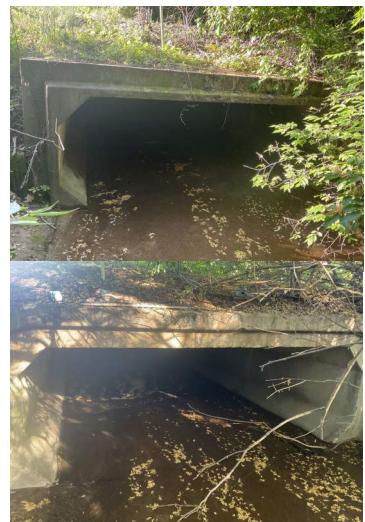
Culvert ID: D1_01

Structural Score: 1

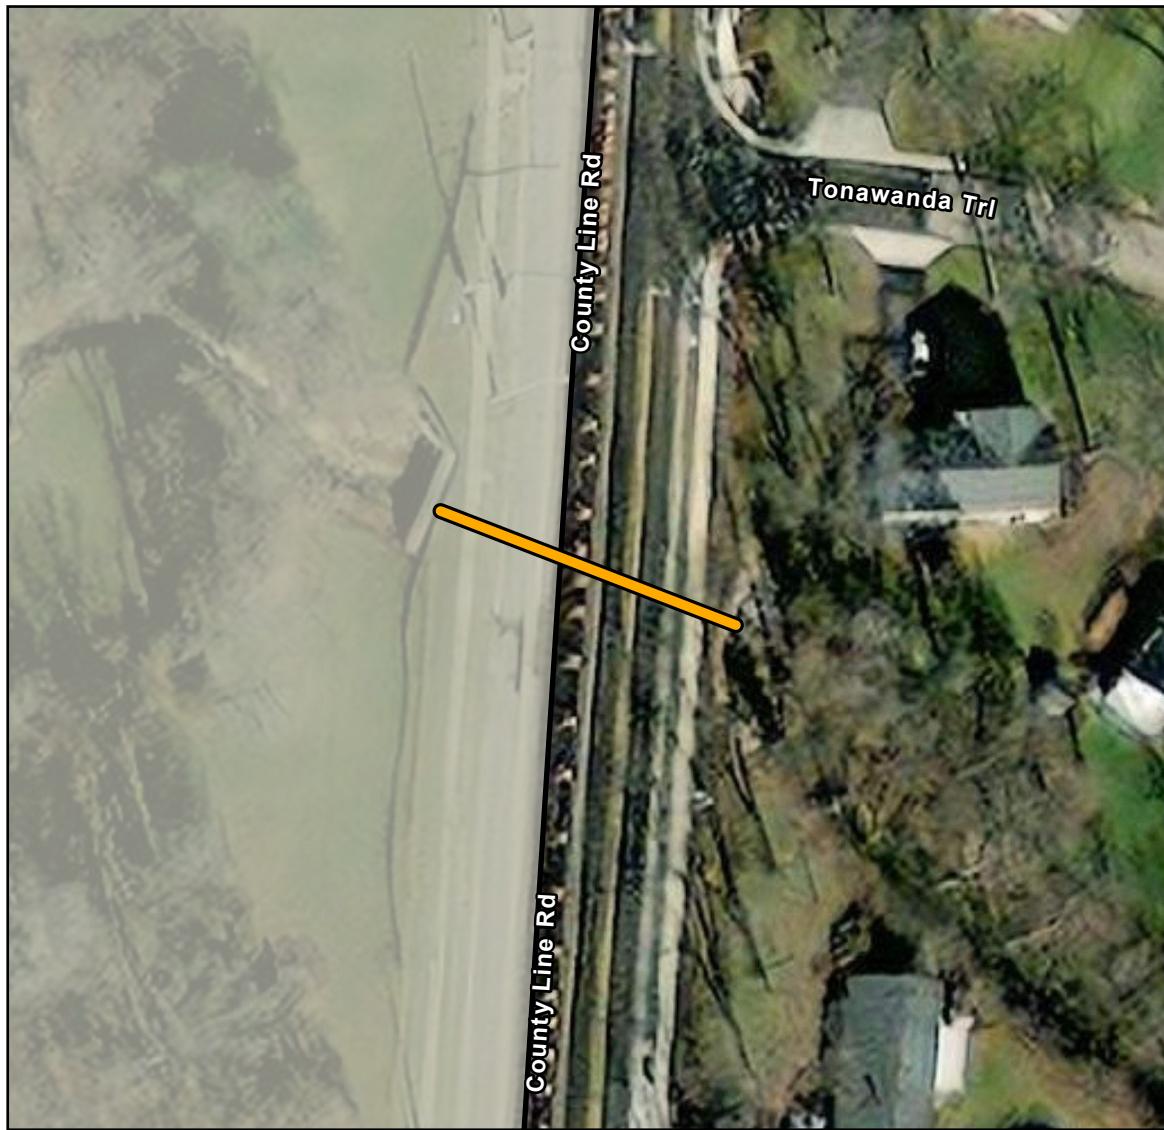
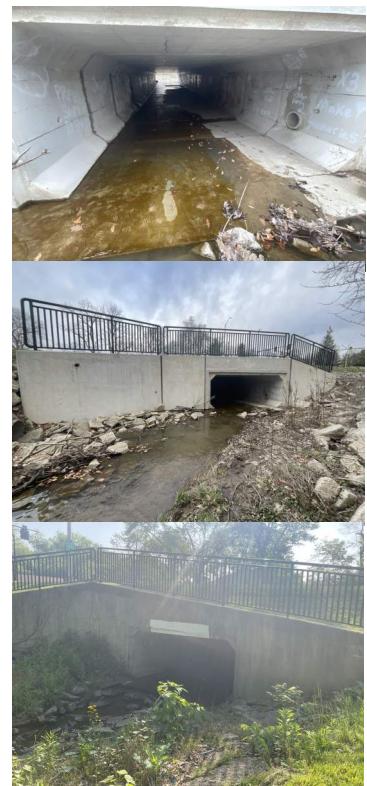
Culvert ID: D1_04

Structural Score: 1

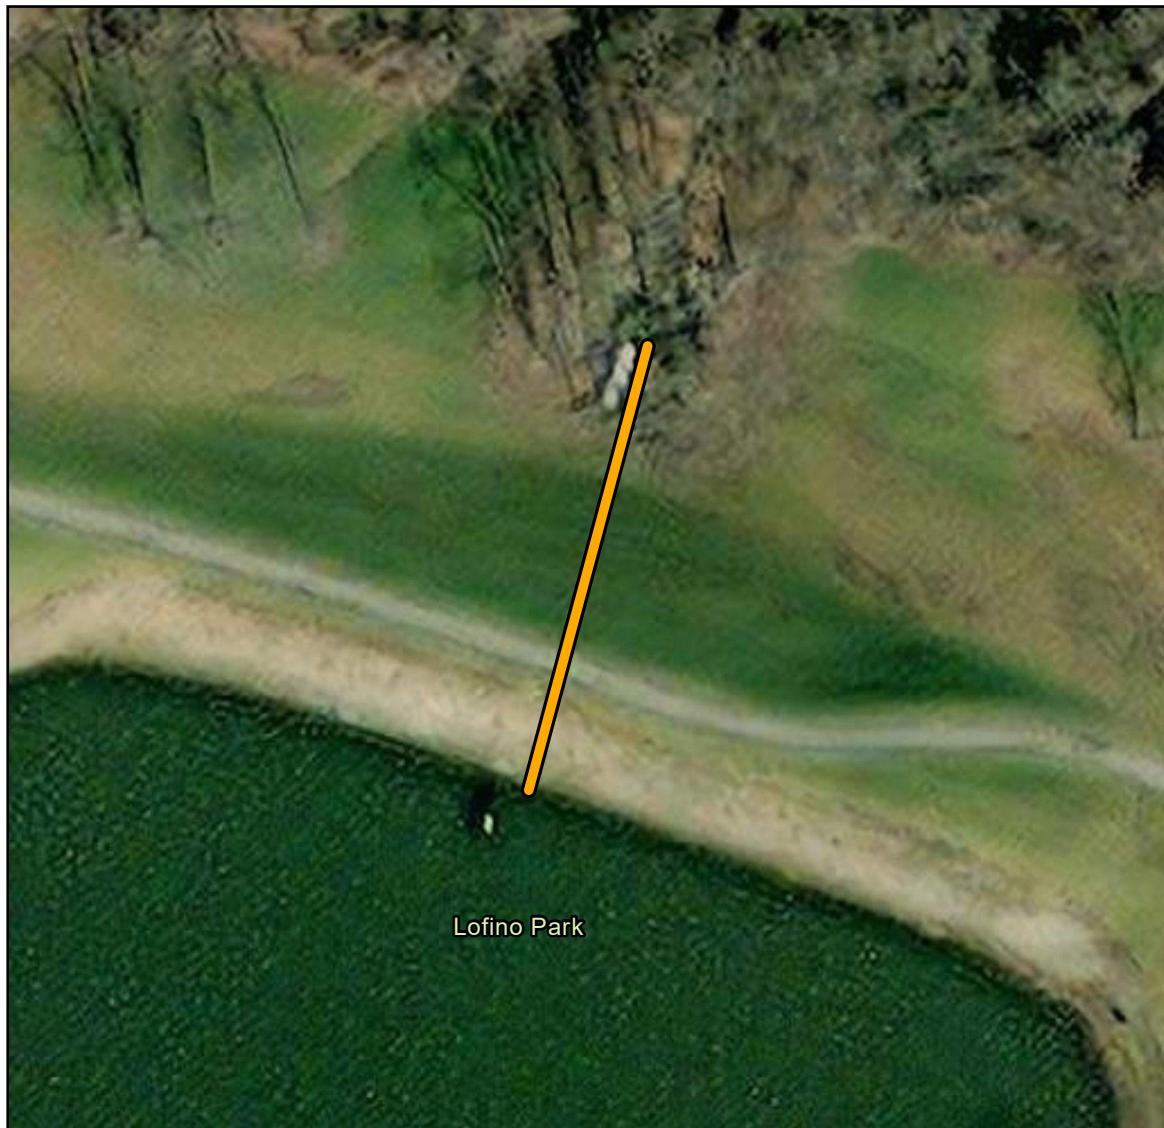
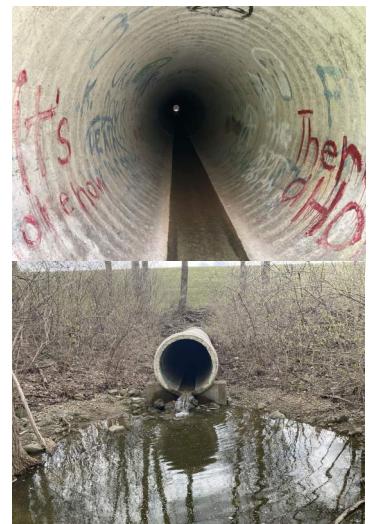
Culvert ID: D1_05

Structural Score: 1

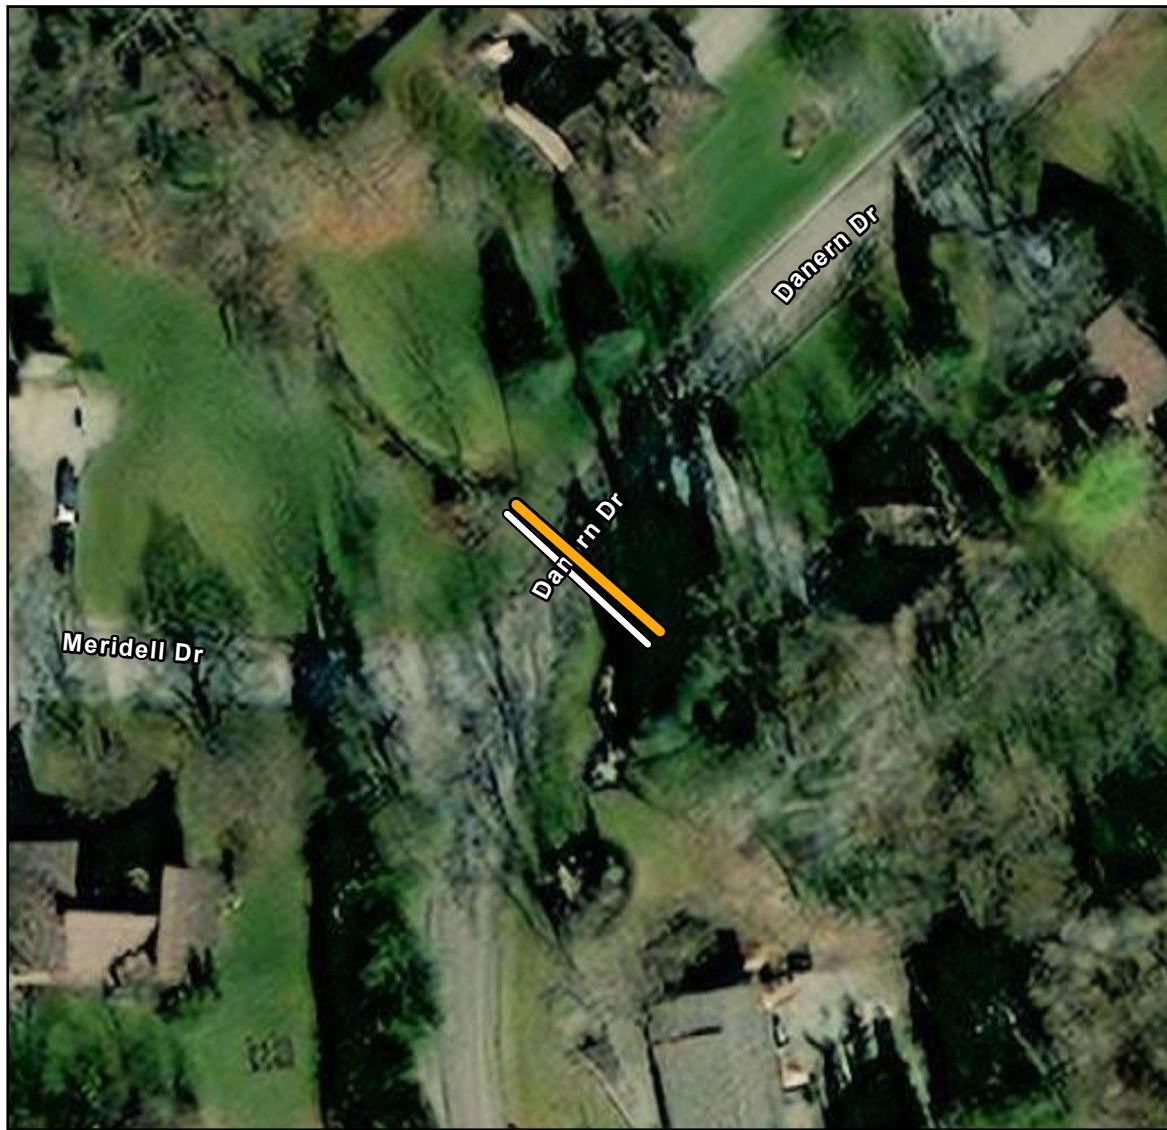
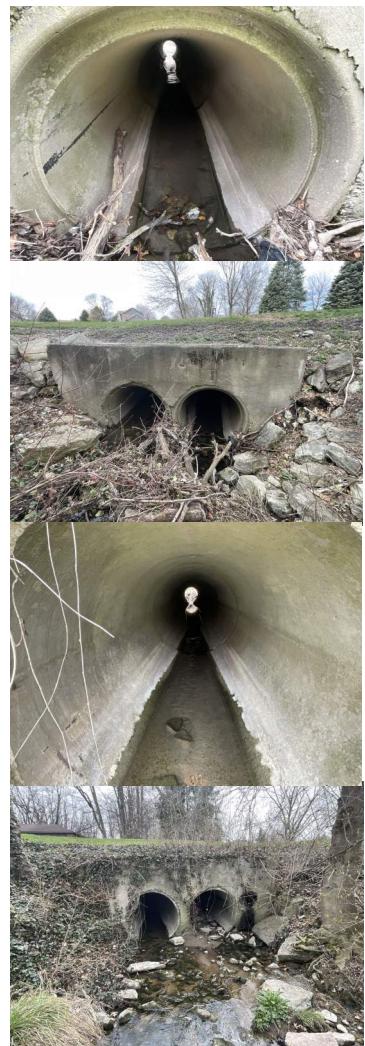
Culvert ID: D1_06

Structural Score: 2

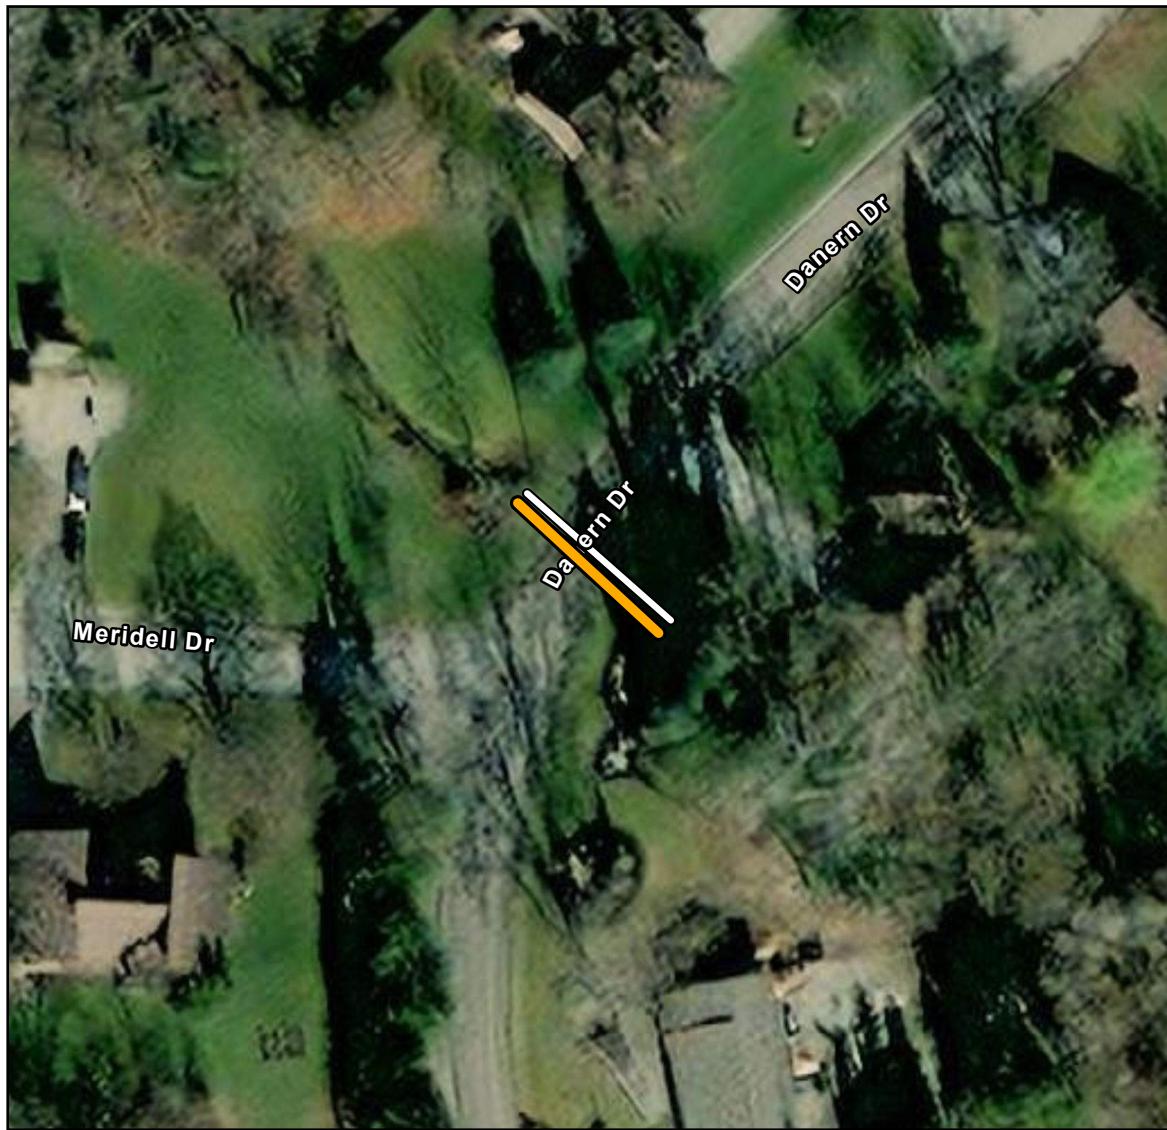
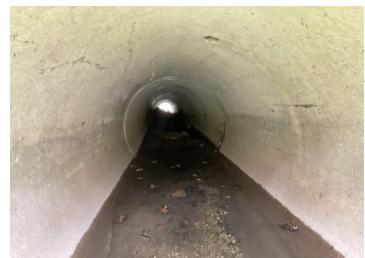
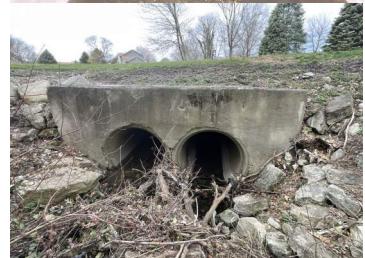
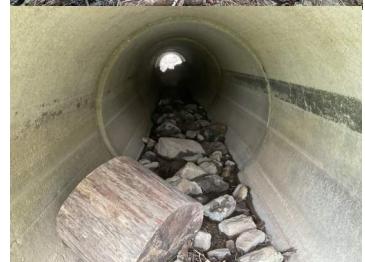
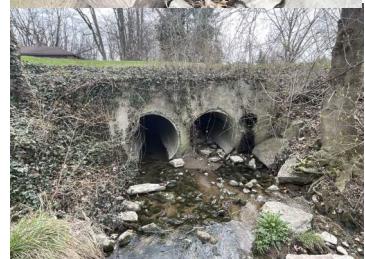
Culvert ID: D1_07

Structural Score: 2

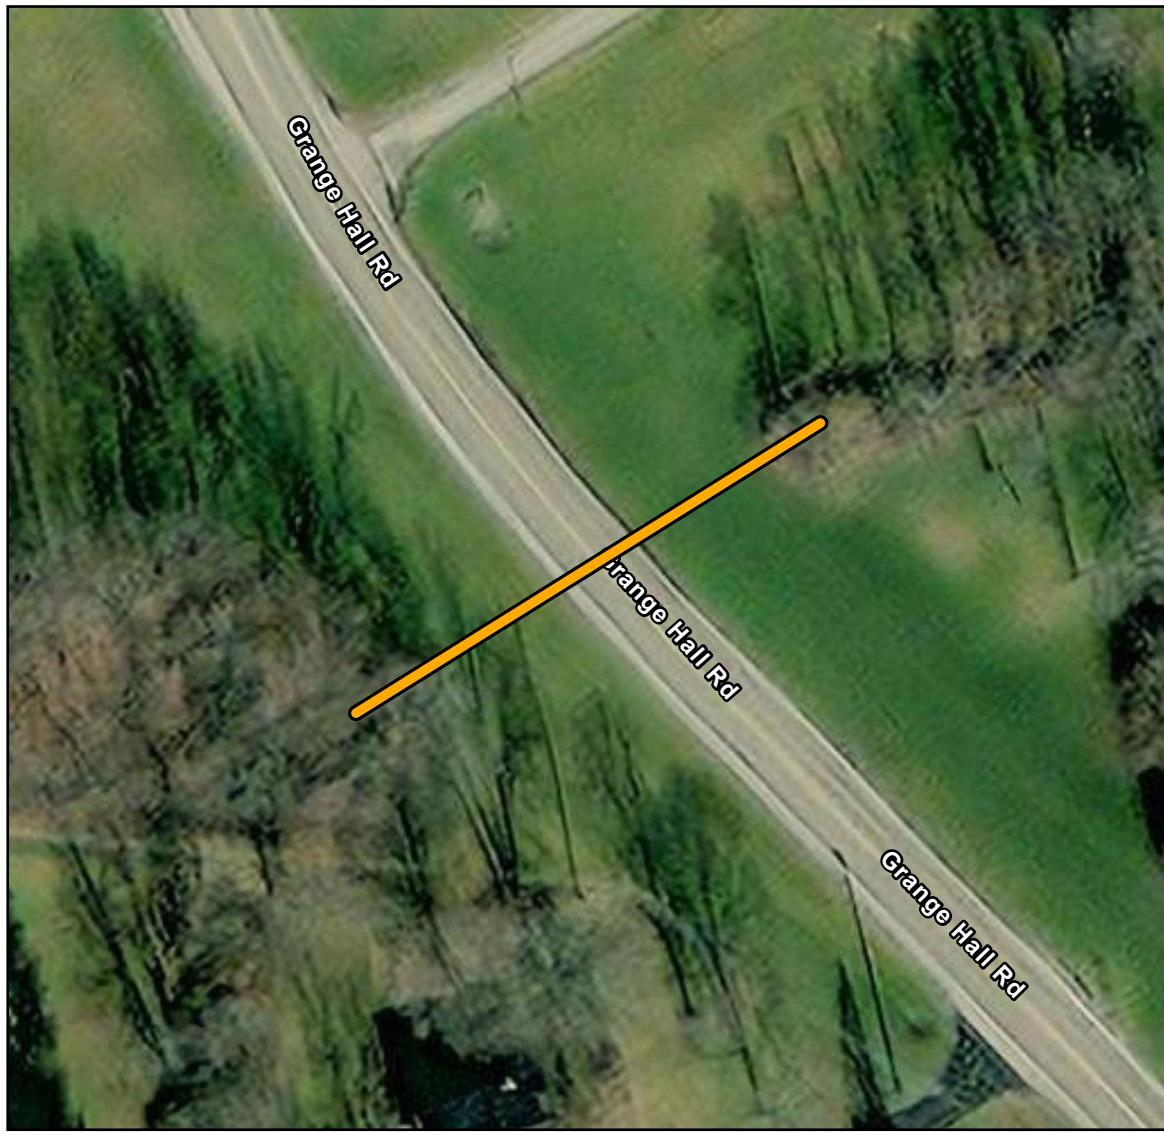
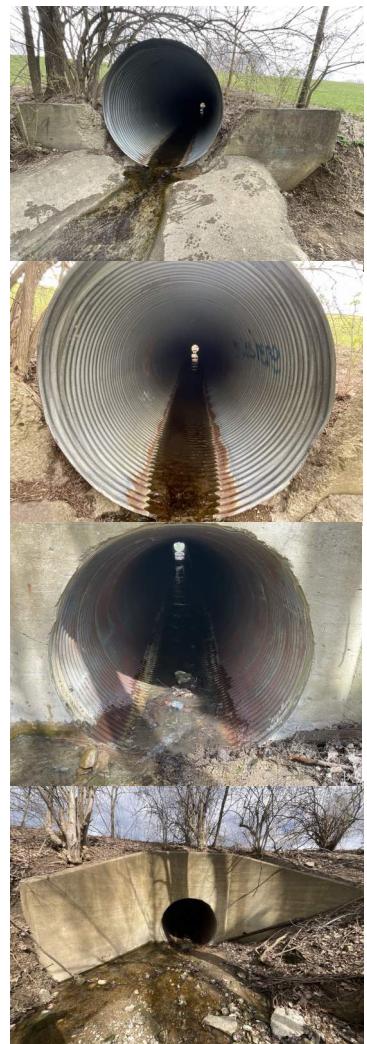
Culvert ID: D1_08

Structural Score: 2

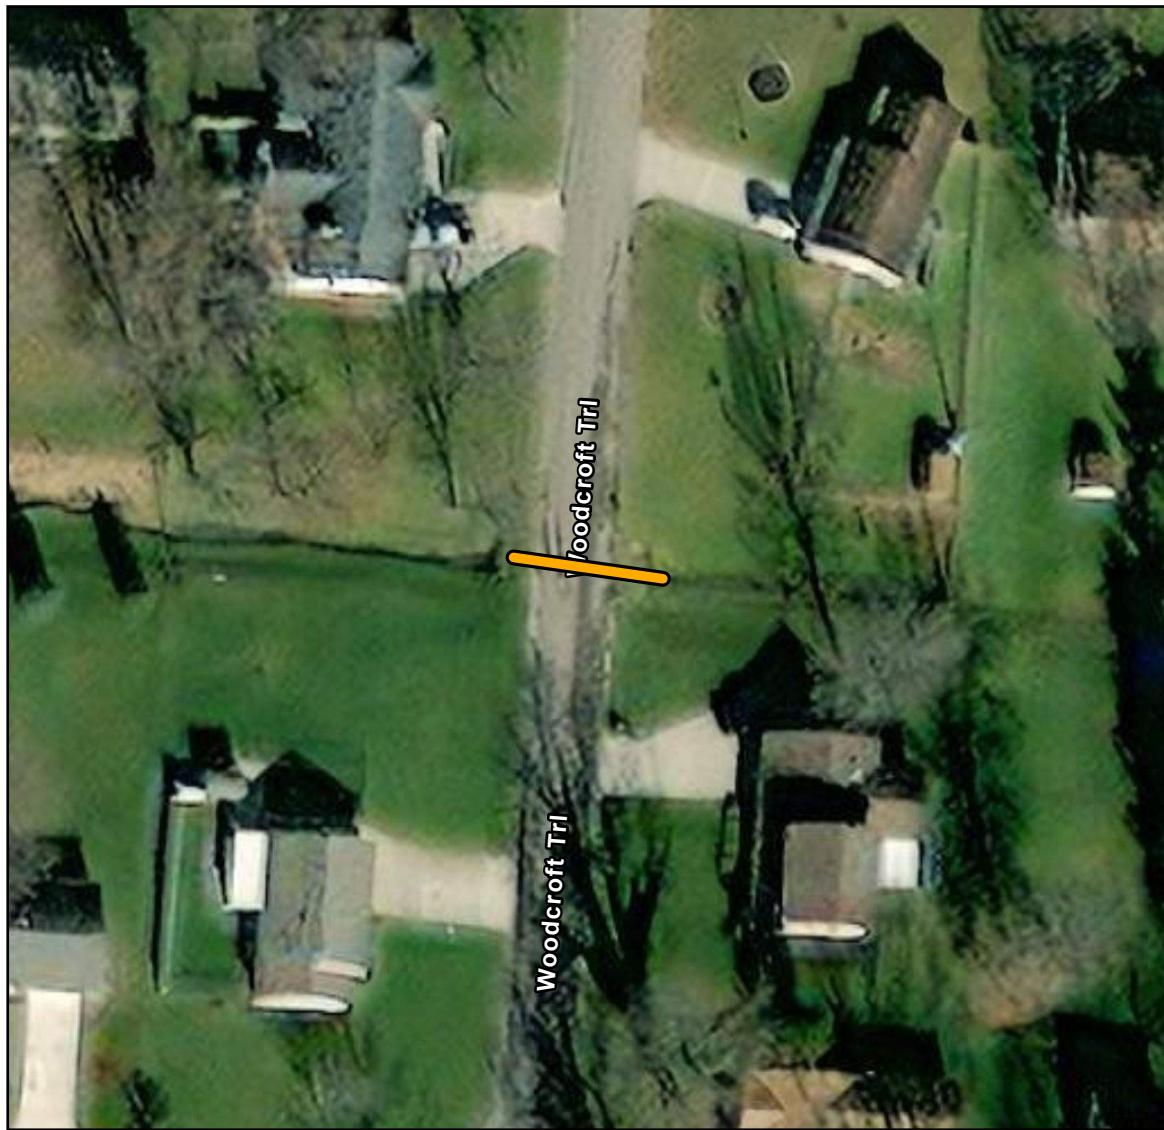
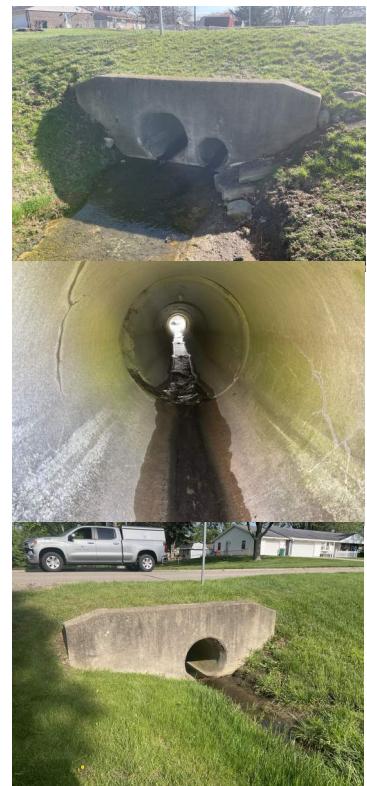
Culvert ID: D1_09

Structural Score: 1

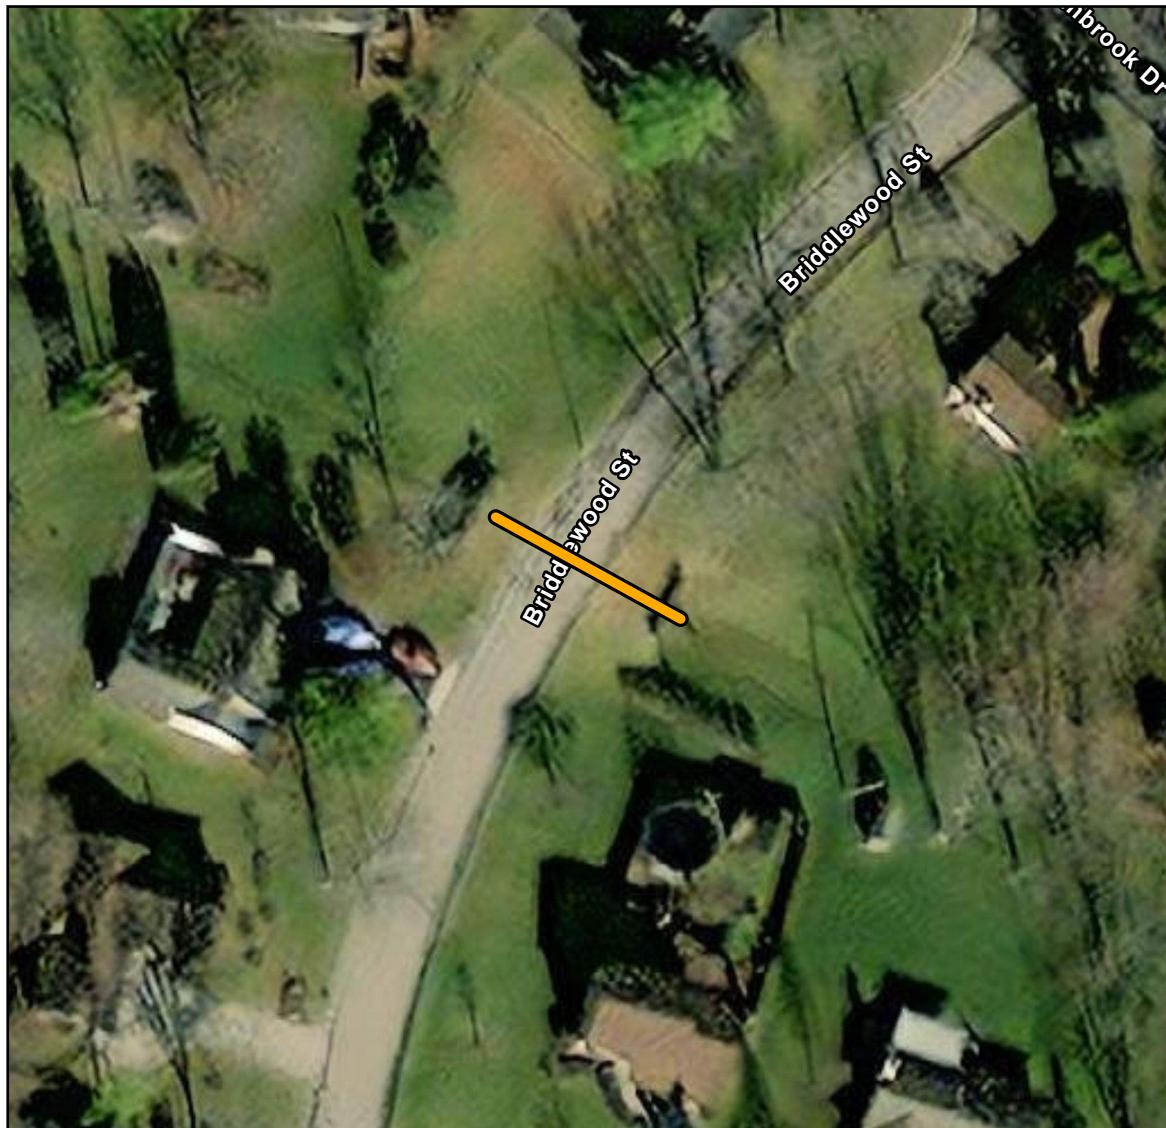
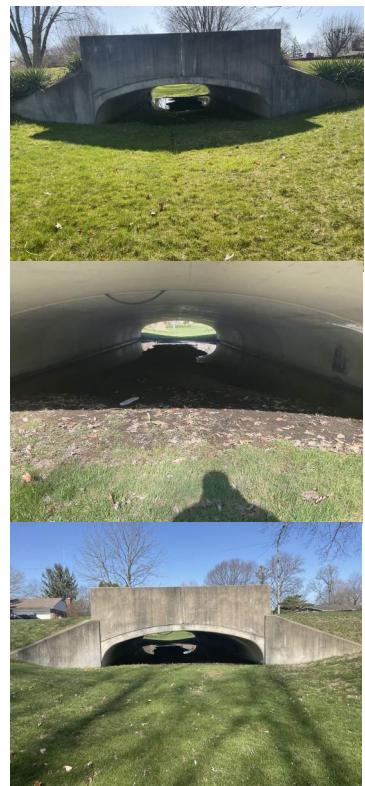
Culvert ID: D2_02

Structural Score: 1

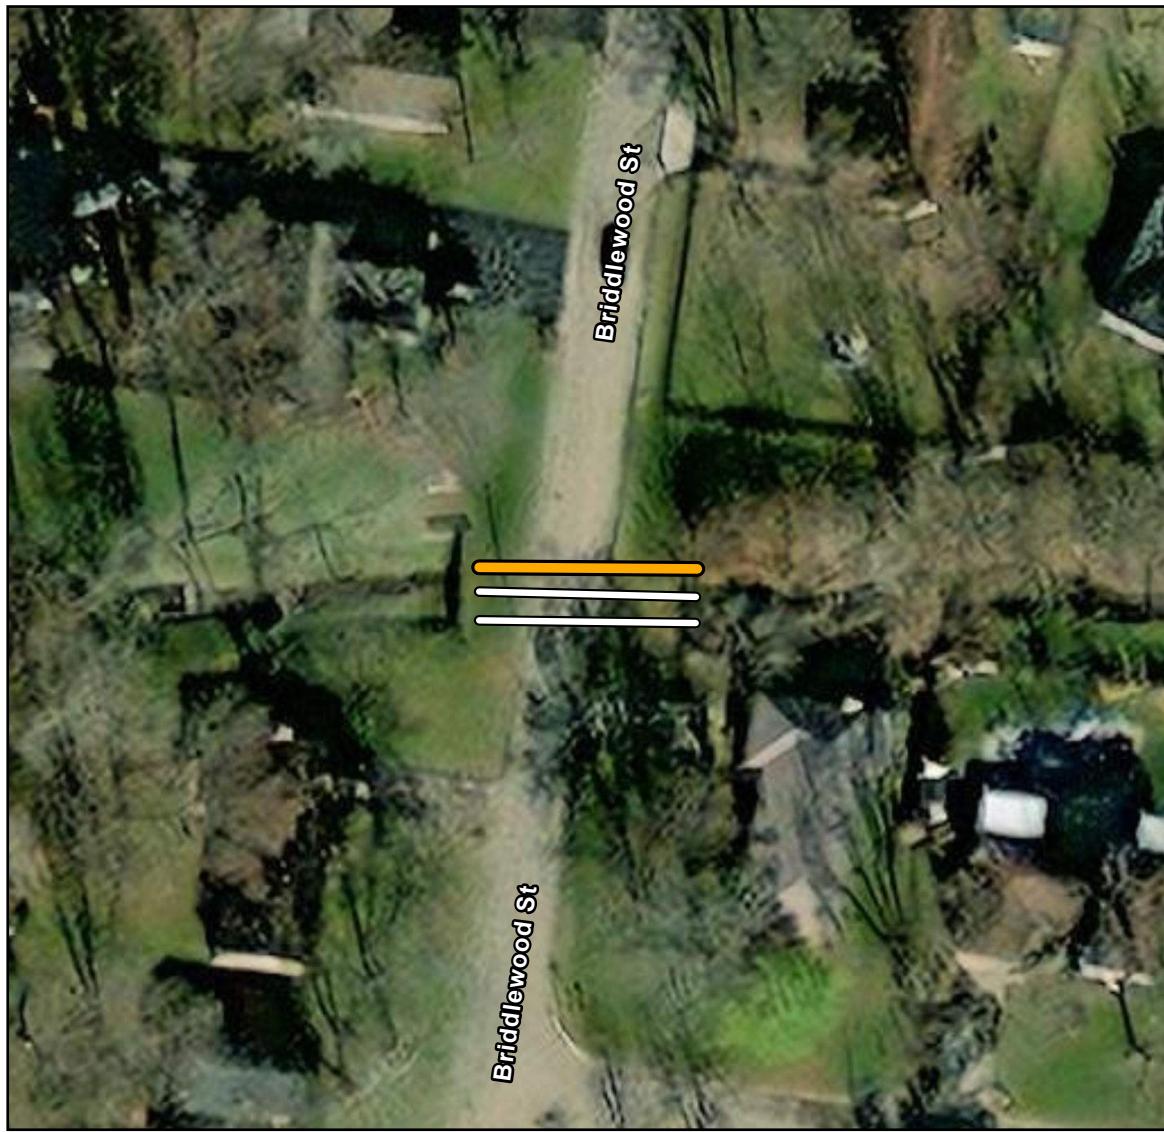
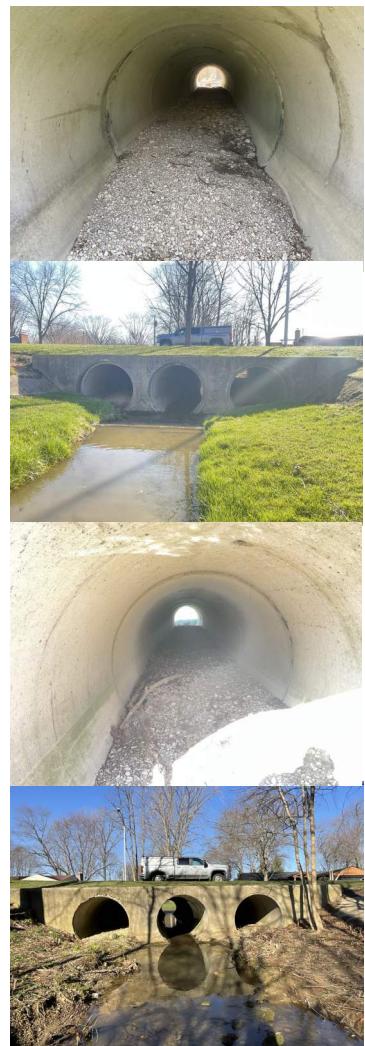
Culvert ID: D2_04

Structural Score: 2

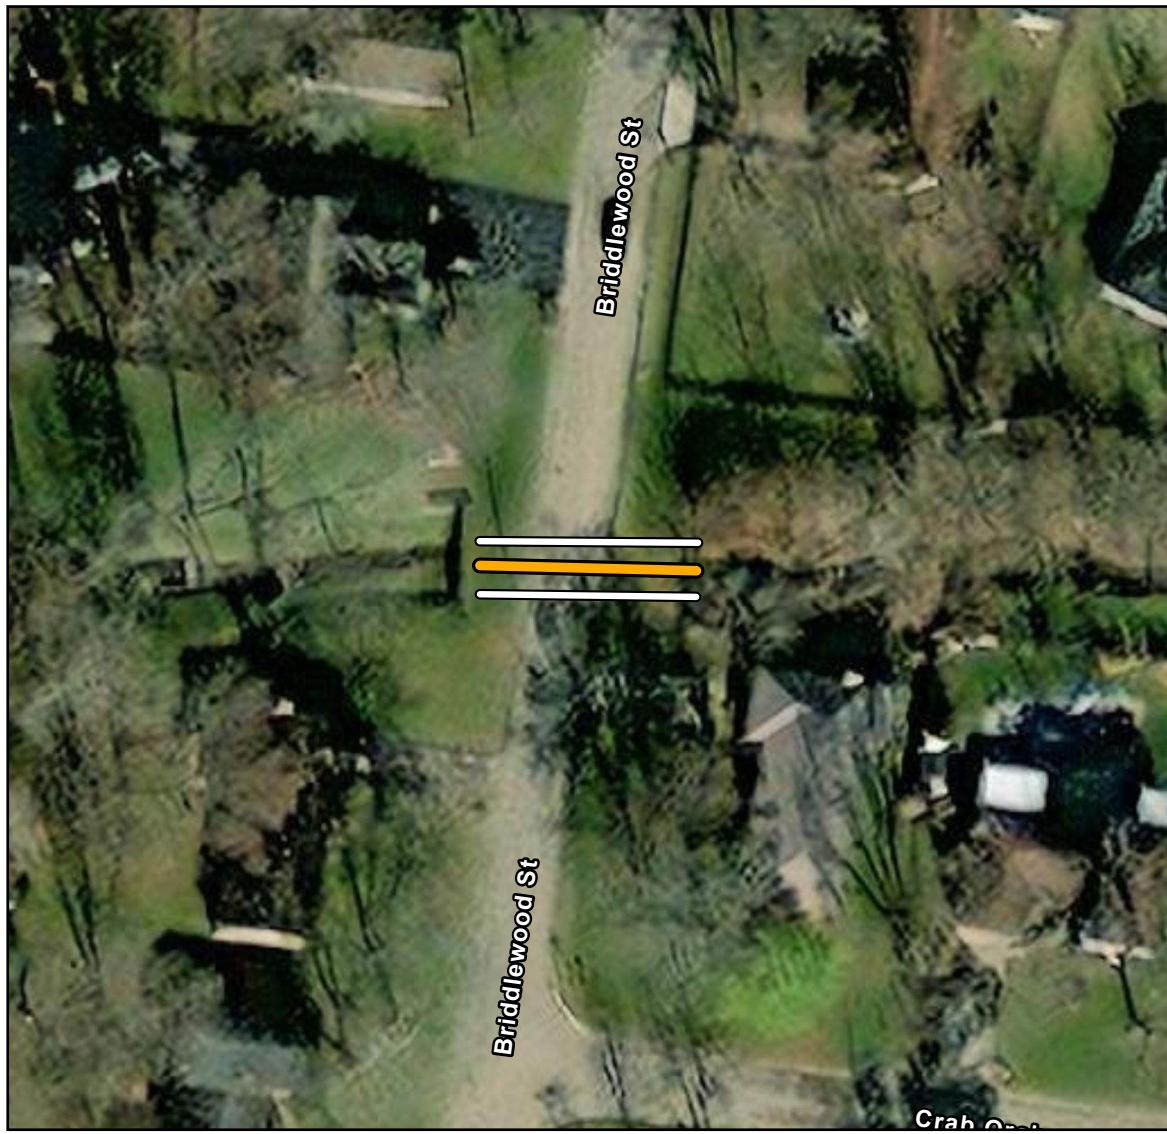
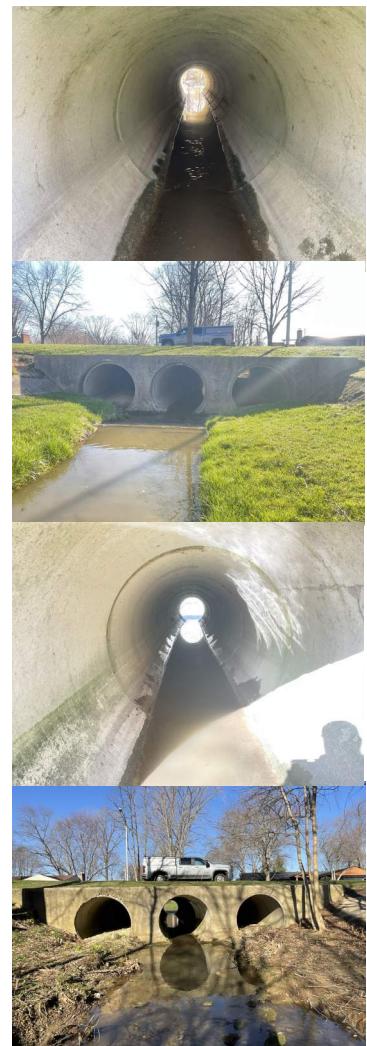
Culvert ID: D2_05

Structural Score: 2

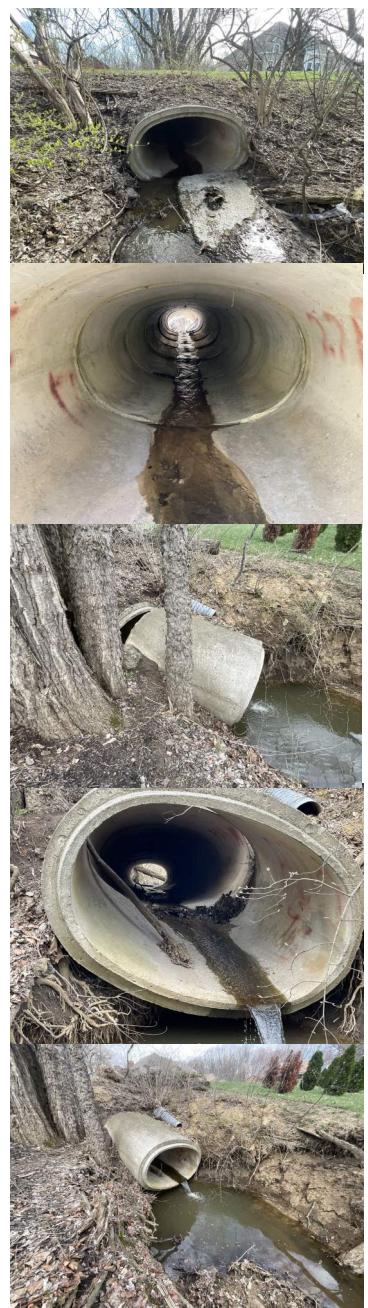
Culvert ID: D2_08

Structural Score: 3
