Project No. 10022676.00

City of Beavercreek Drainage Master Plan

City of Beavercreek

October 13, 2025

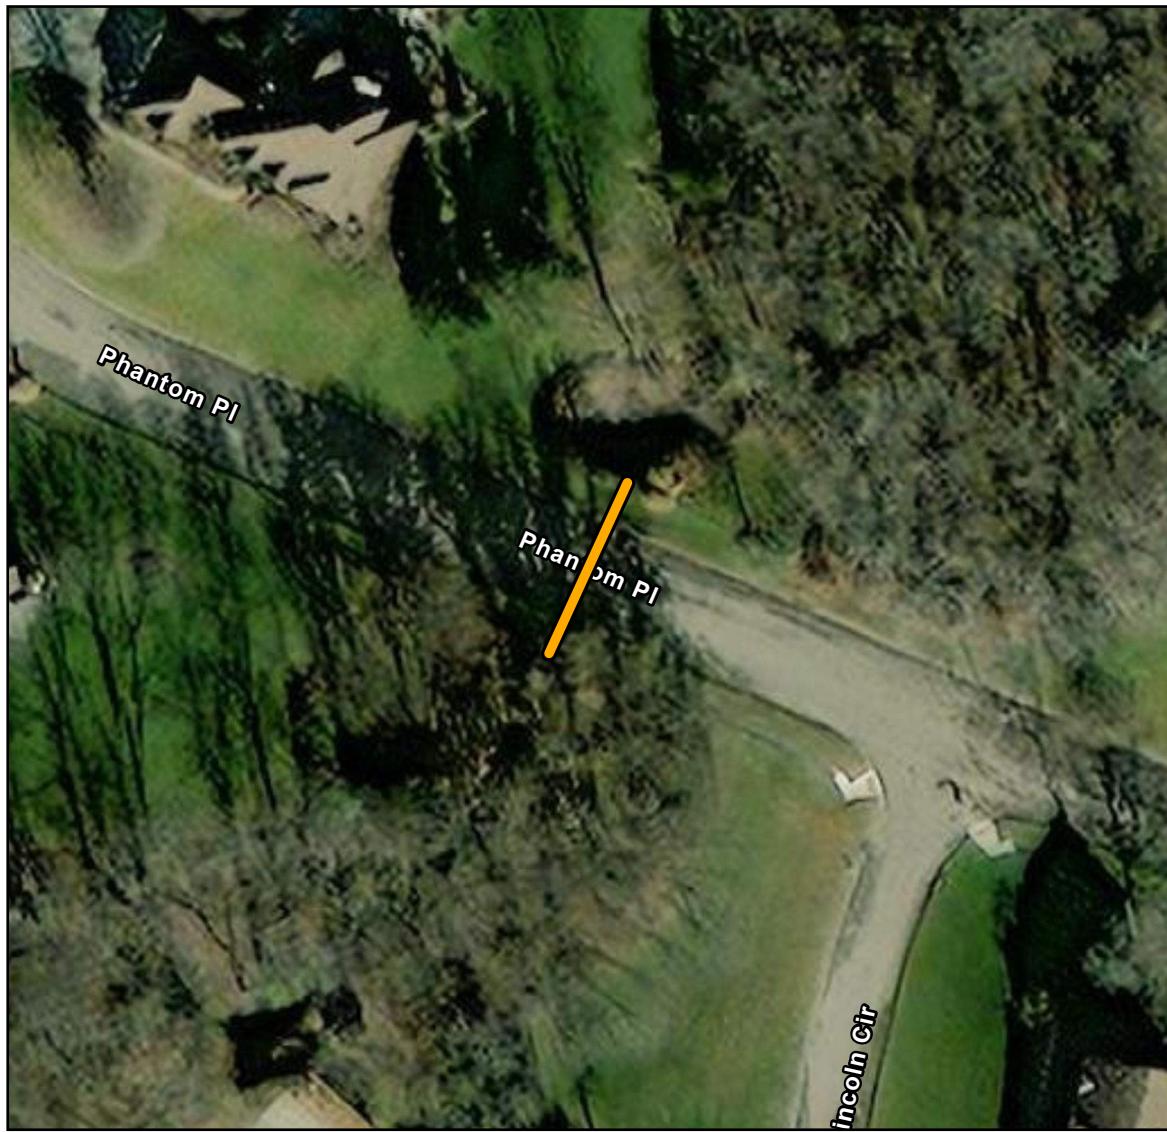
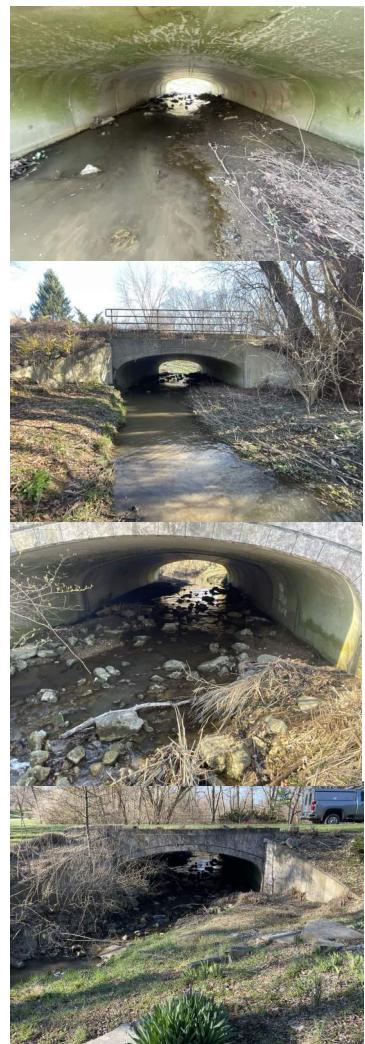
Culvert ID: D2_09

Structural Score: 1

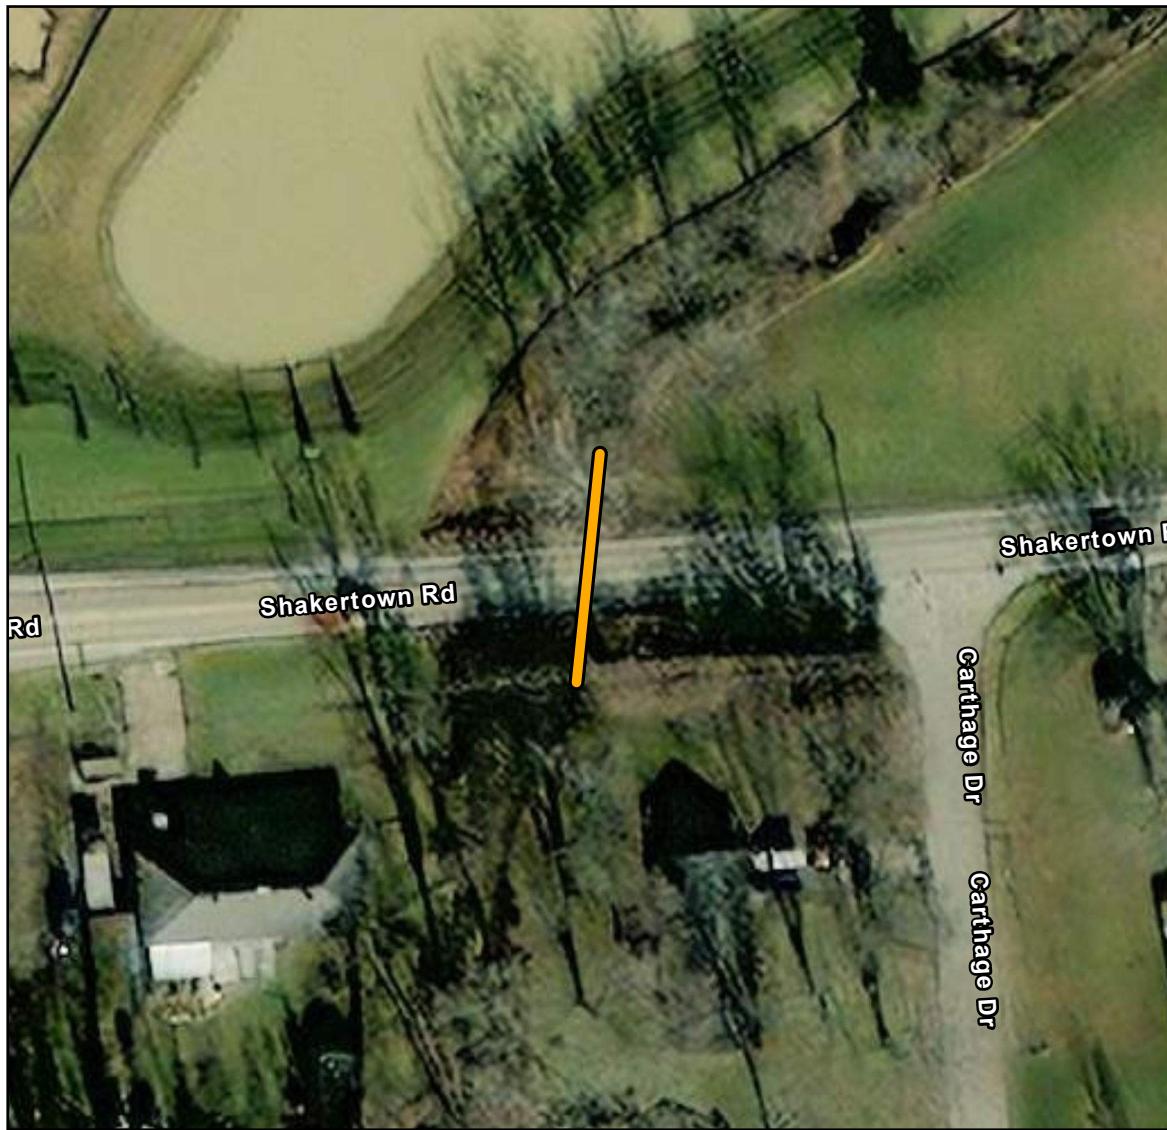
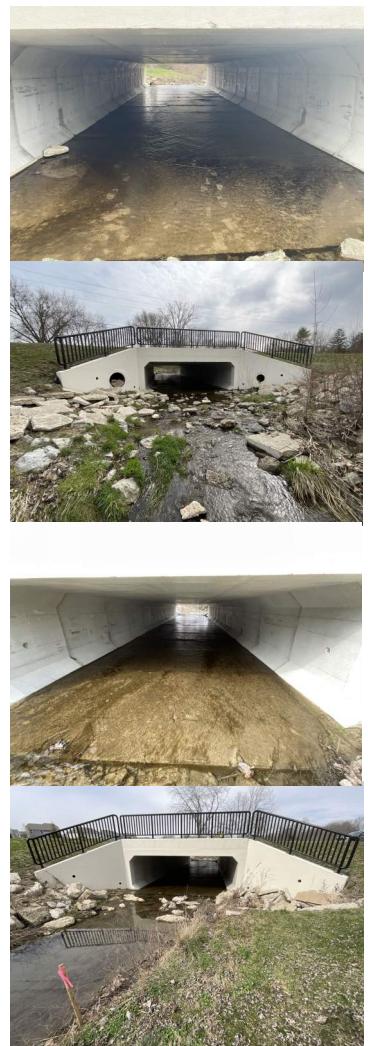
Culvert ID: D3_01

Structural Score: 1

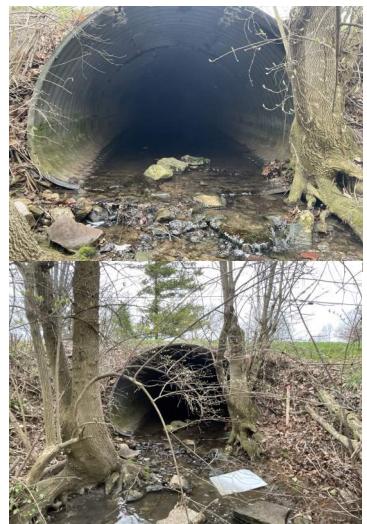
Culvert ID: D3_02

Structural Score: 2

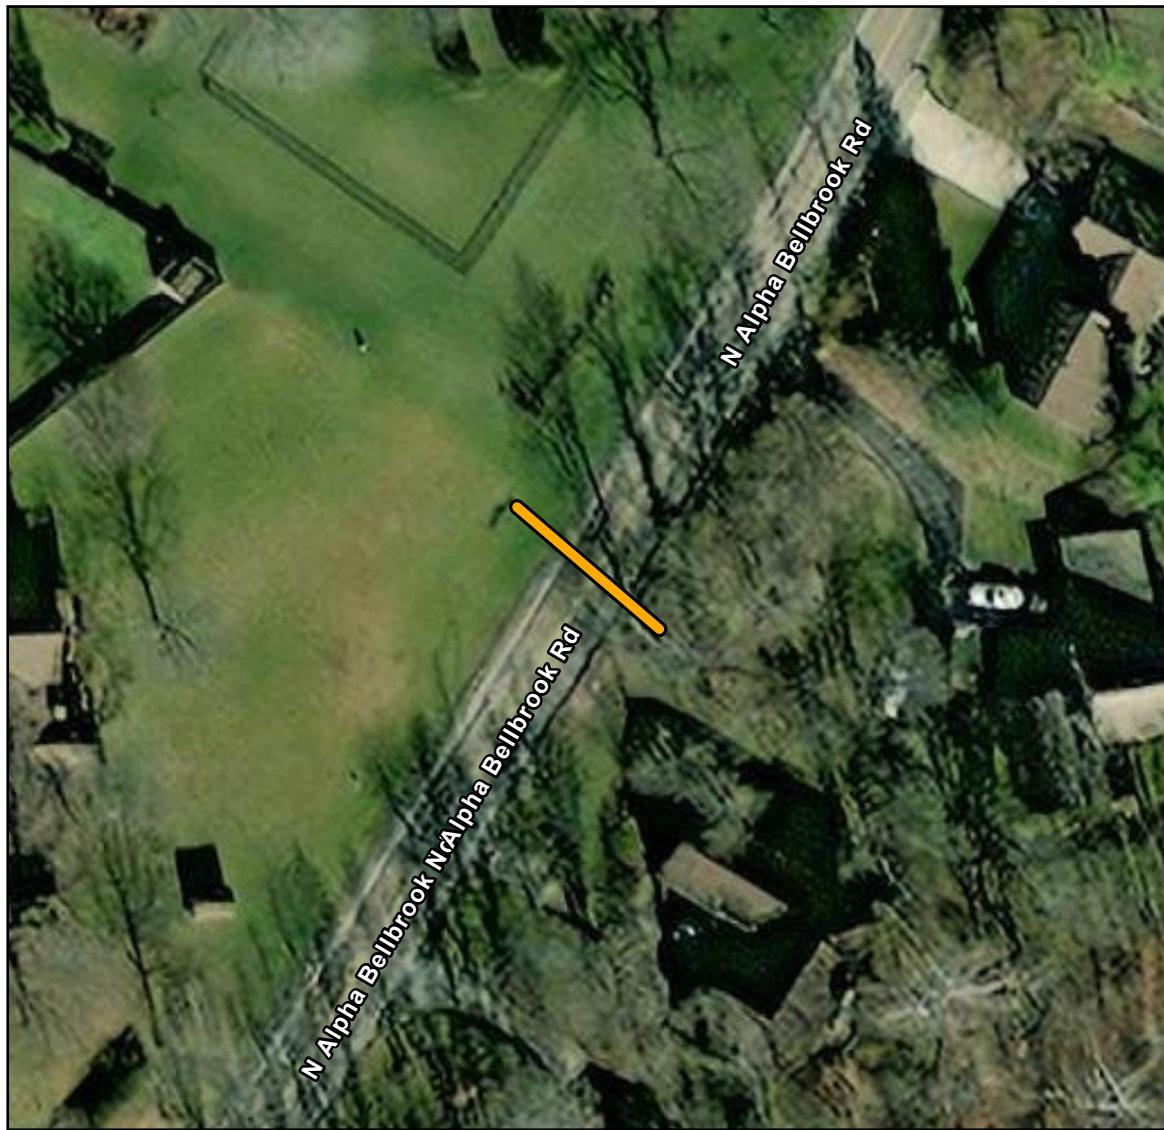
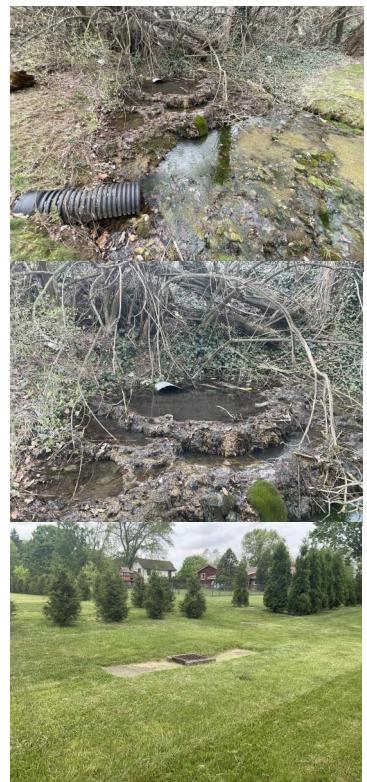
Culvert ID: D3_03

Structural Score: 2

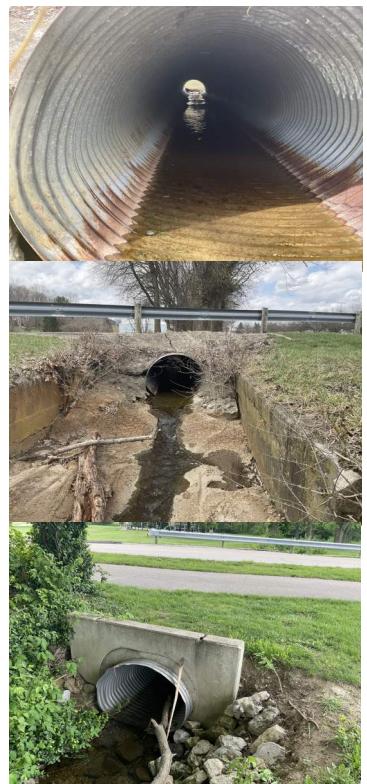
Culvert ID: D4_01

Structural Score: 2

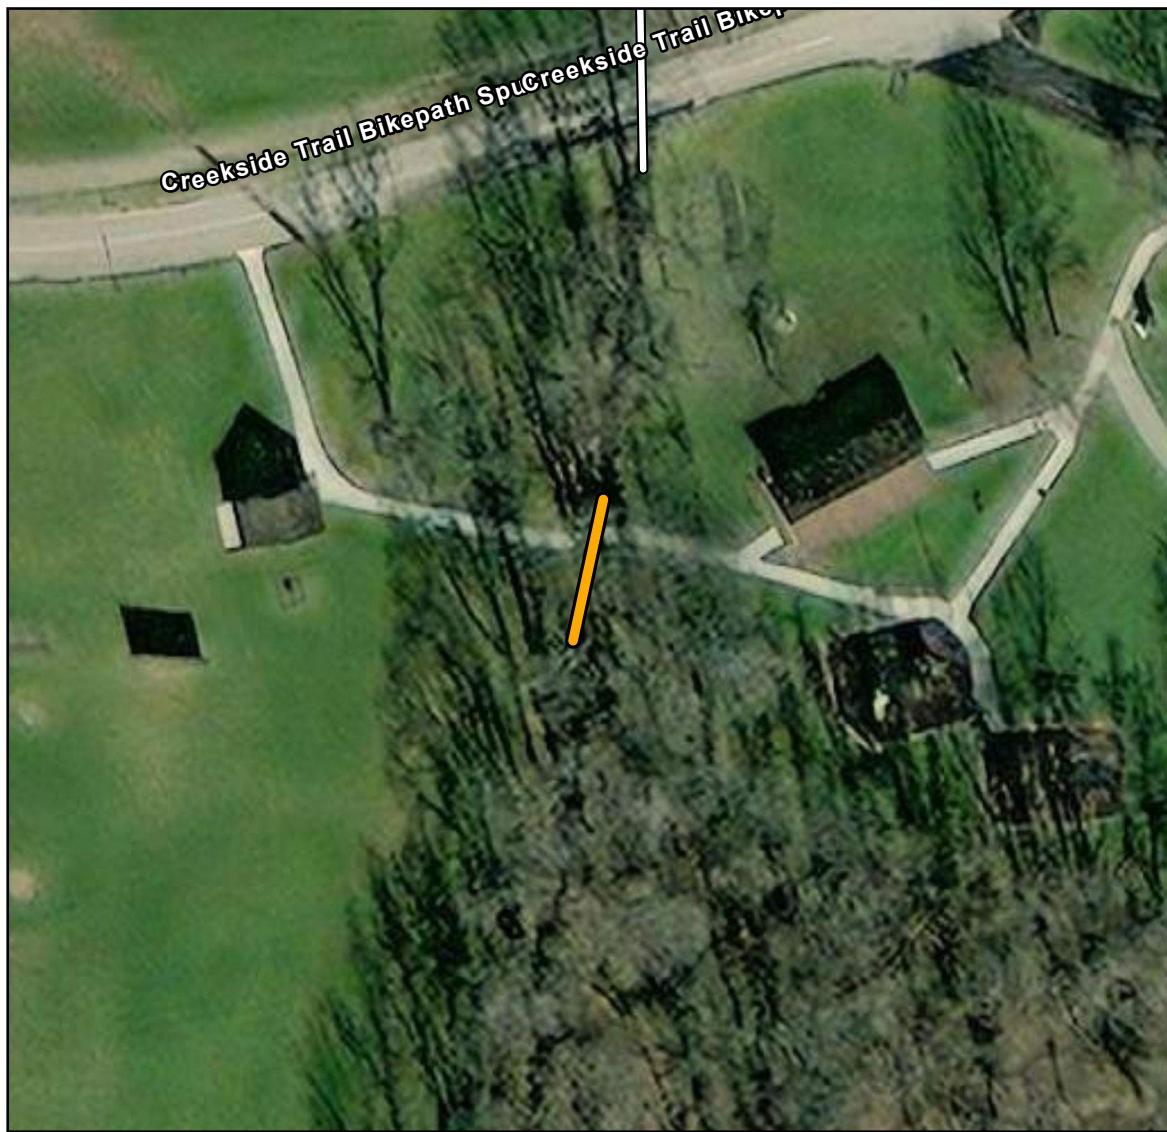
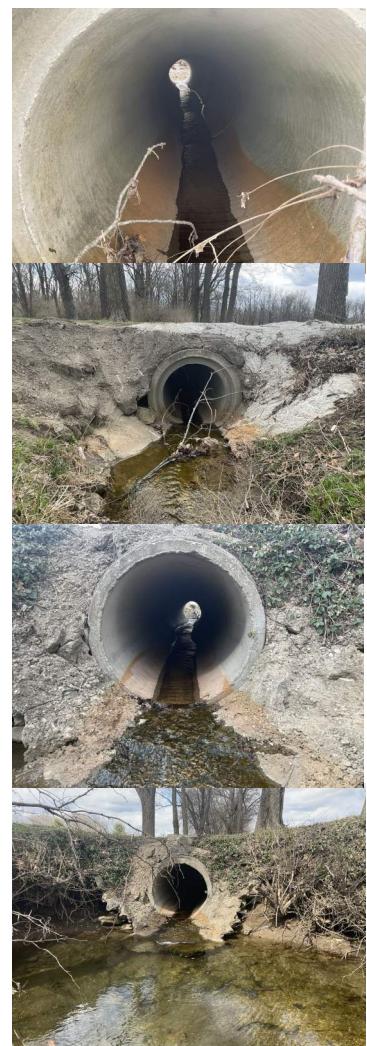
Culvert ID: D4_02

Structural Score: 2

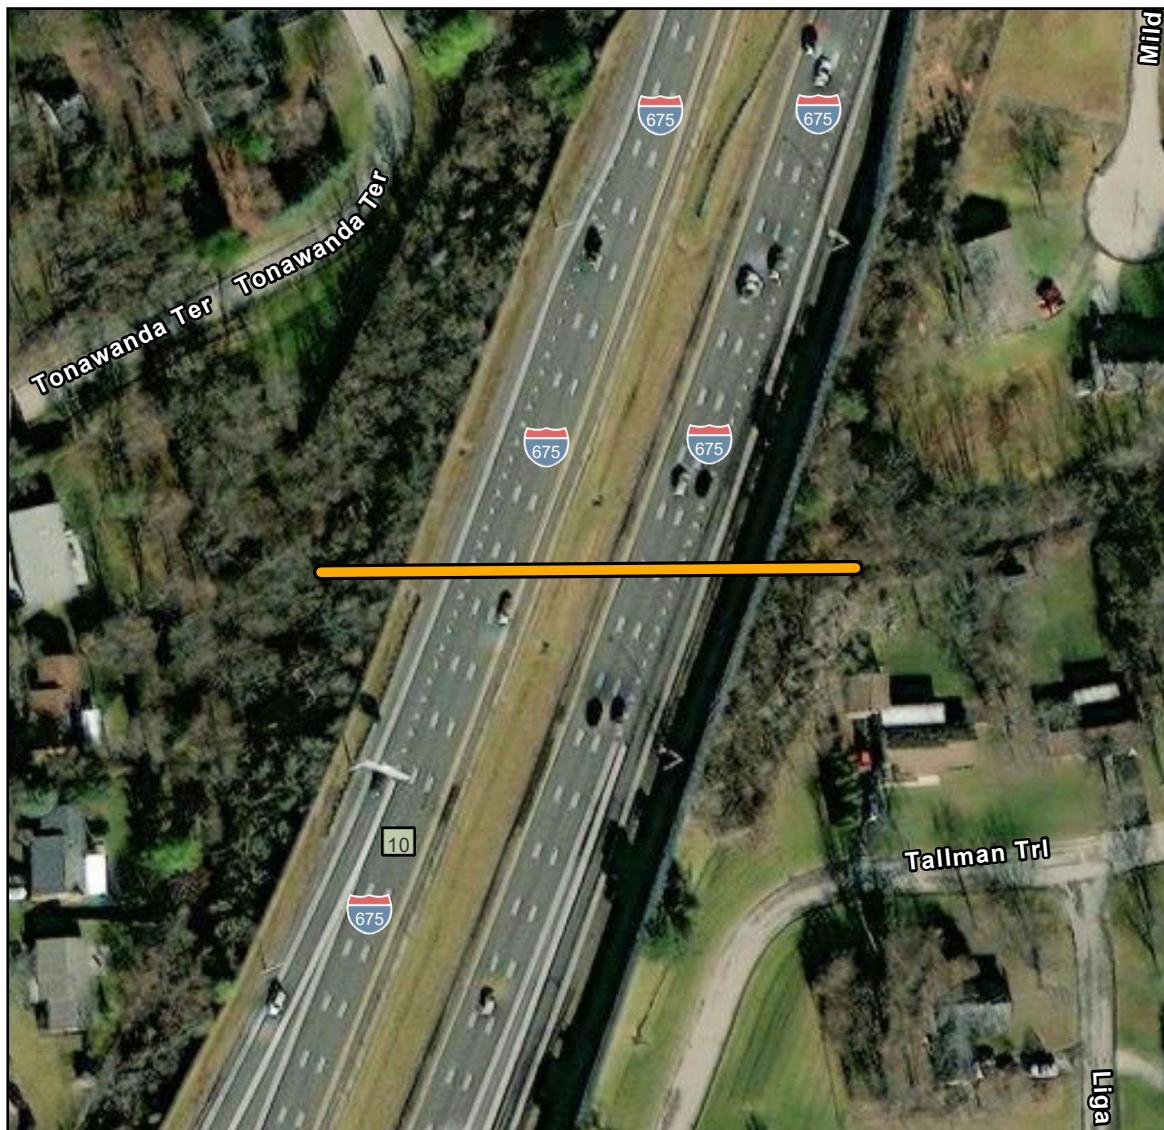
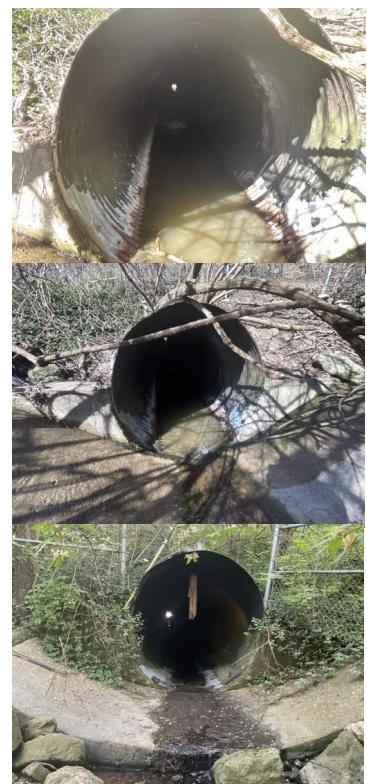
Culvert ID: E1_01

Structural Score: 2

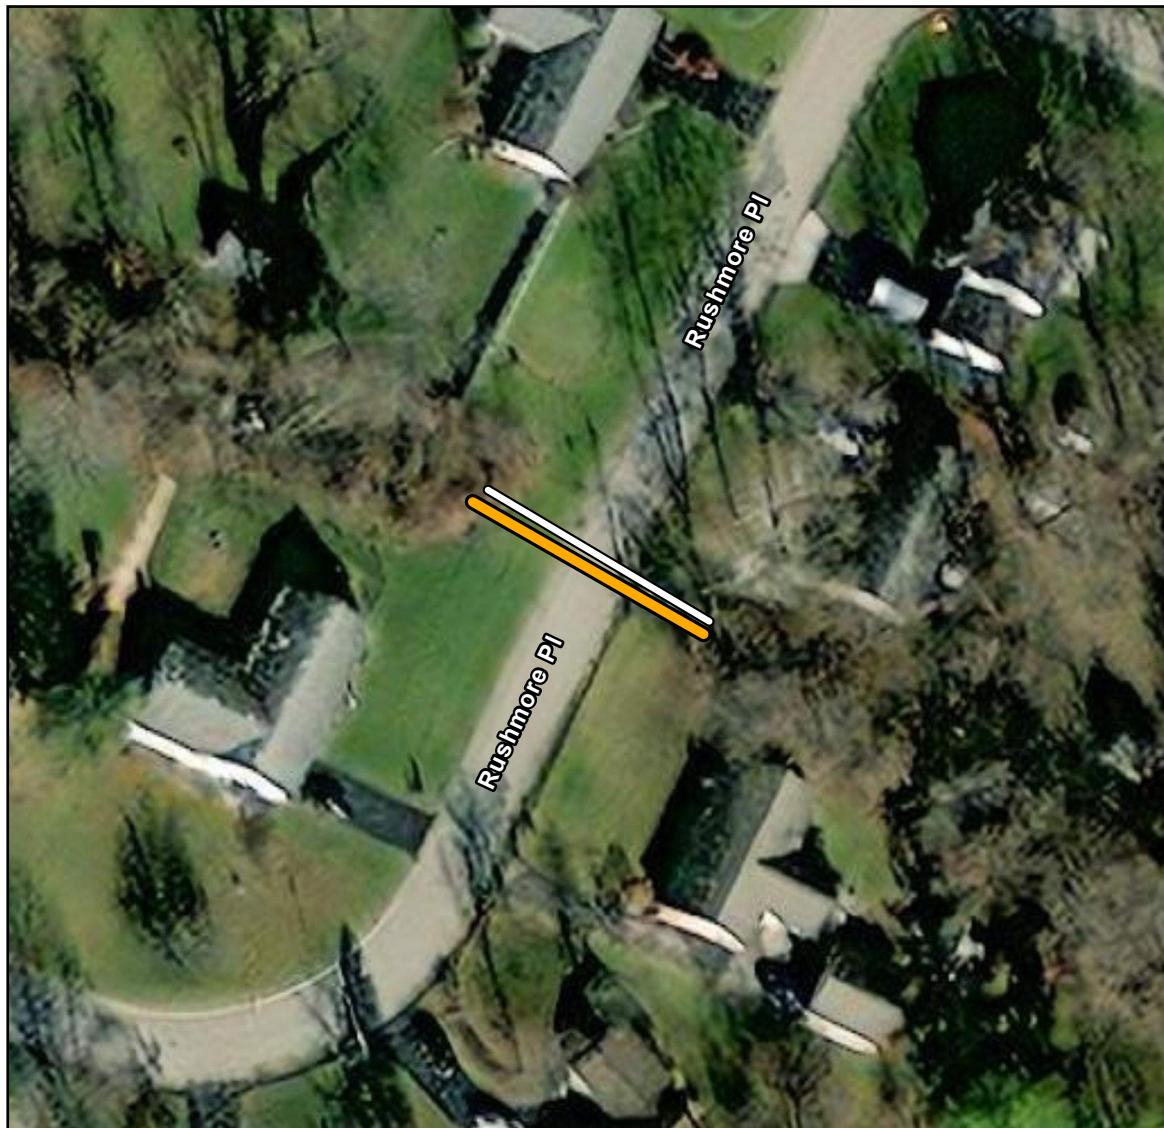
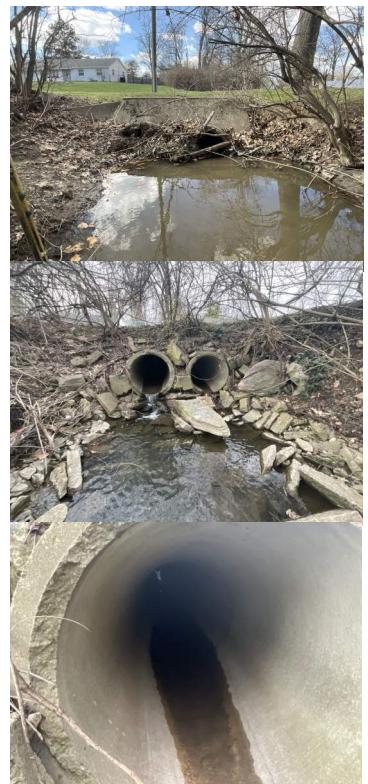
Culvert ID: E1_02

Structural Score: 1

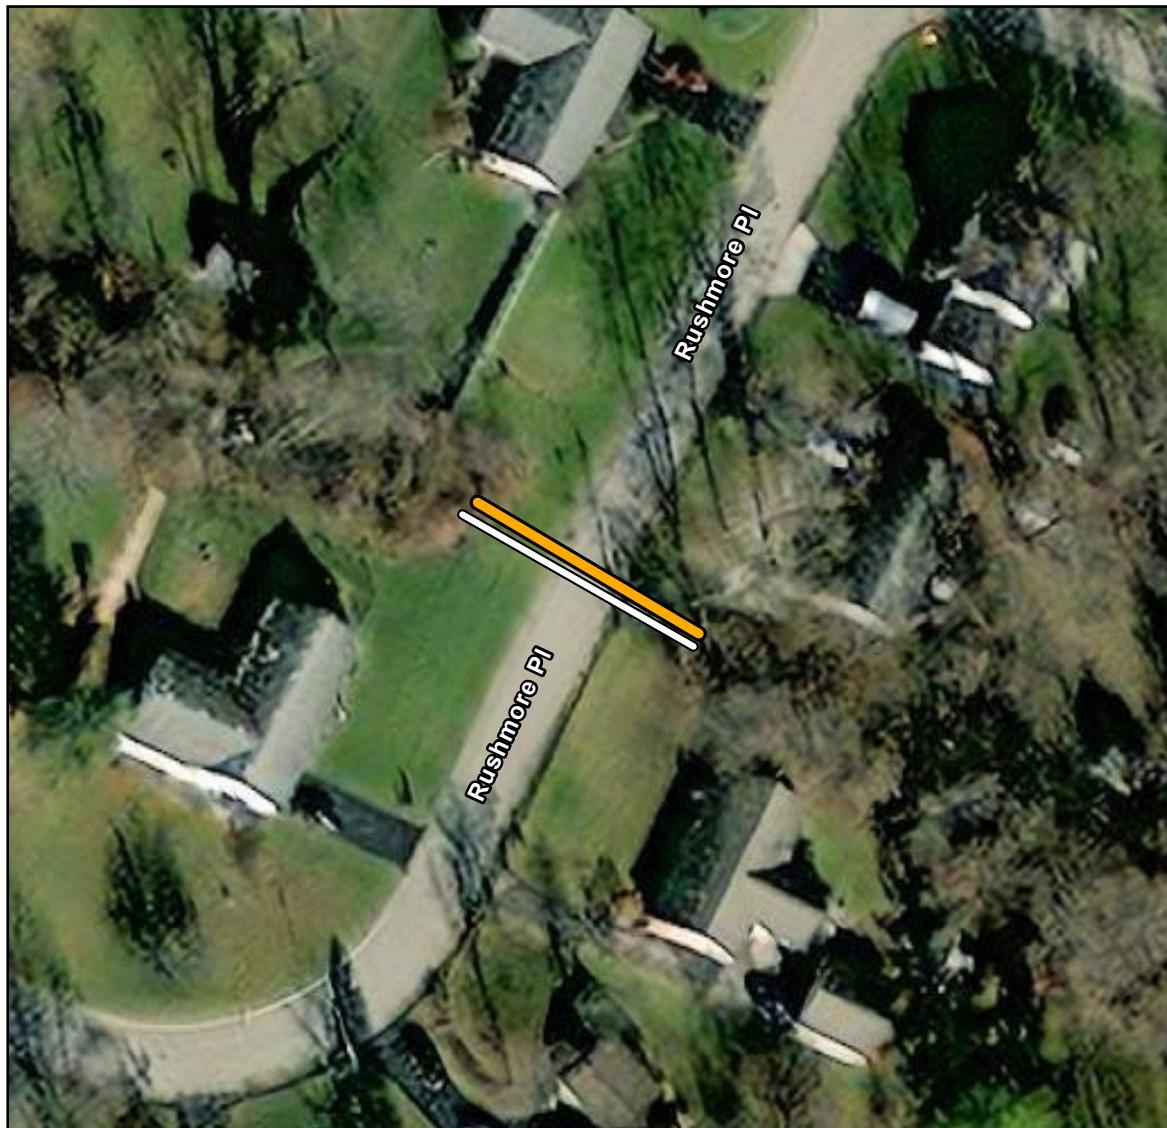
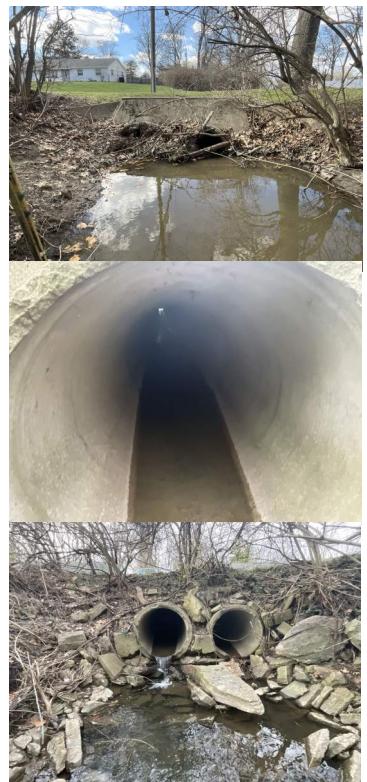
Culvert ID: E1_03

Structural Score: 1

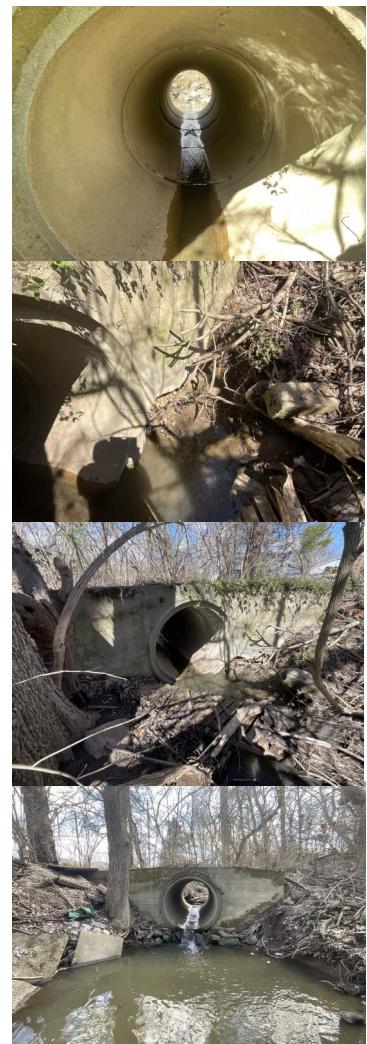
Culvert ID: E1_04

Structural Score: 2

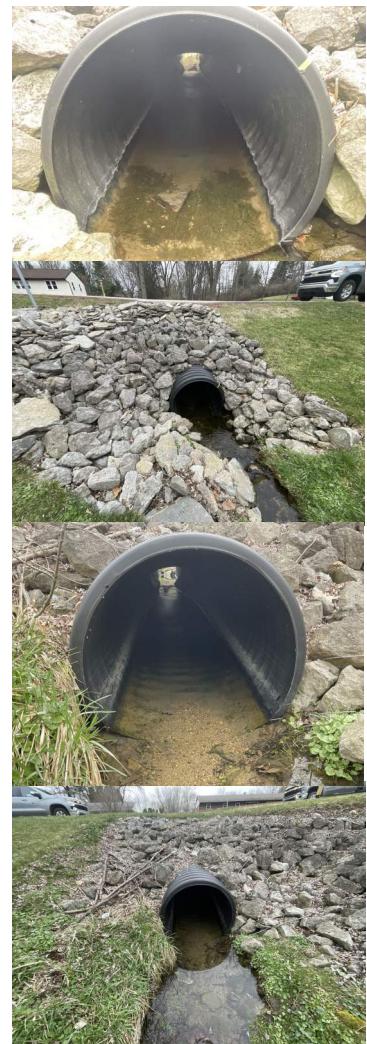
Culvert ID: E1_06

Structural Score: 2

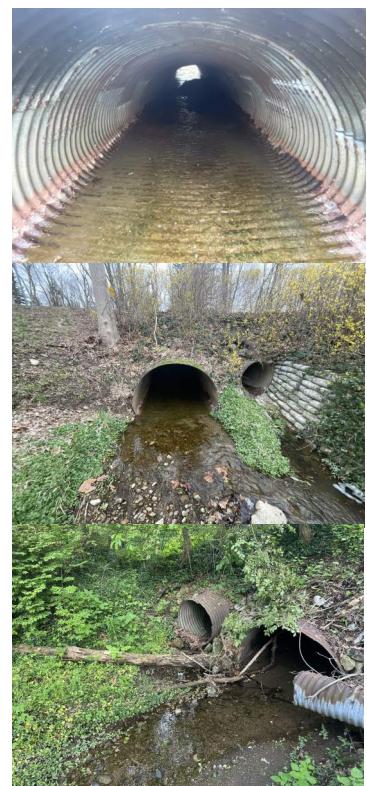
Culvert ID: E1_09

Structural Score: 2

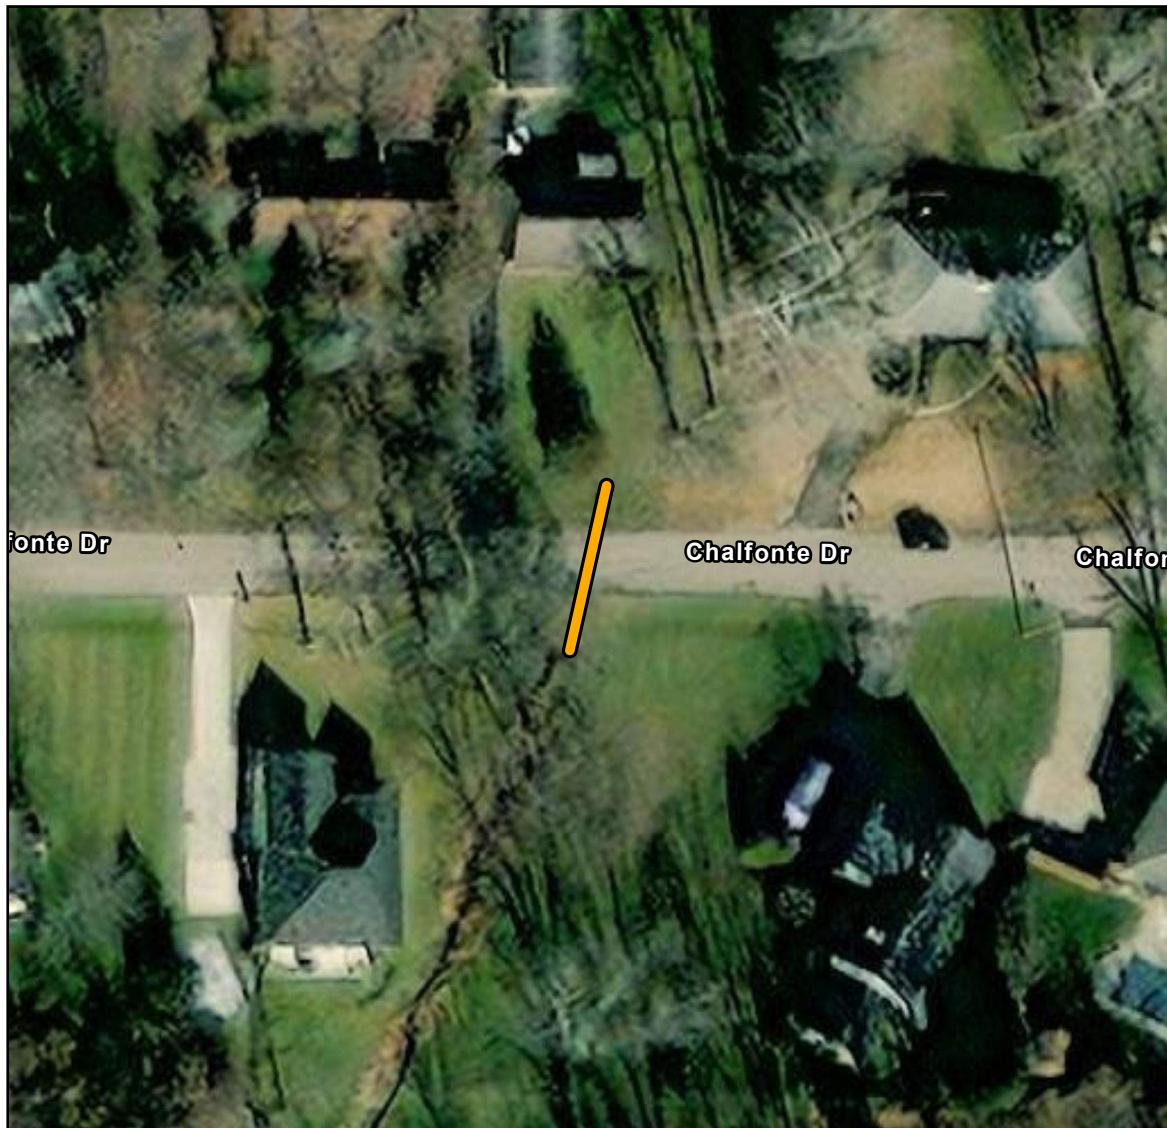
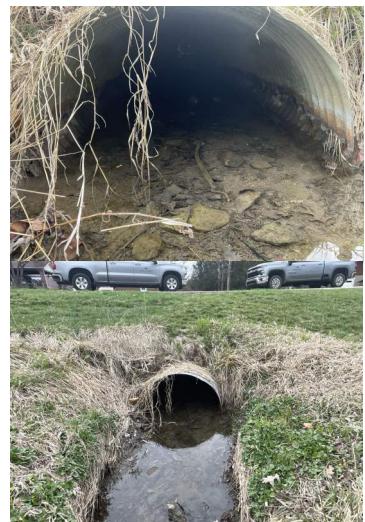
Culvert ID: E1_10

Structural Score: 1
